Periodic Report 2015-001

Granaries of Kot Diji

- The granaries lie on a low lying area at the base of the Fort of Kot Diji. This location makes them susceptible to surface water drainage and consequent water damage and seepage from ponding. To combat this issue, through advice from Structural engineer, Amin Tariq and Ar. Yasmeen Lari, it was decided that a retaining wall would be constructed around the property's periphery.

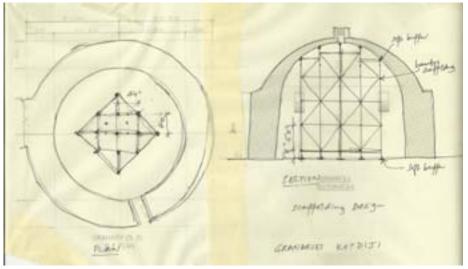
Concept sketch fro Internal scaffolding configuration

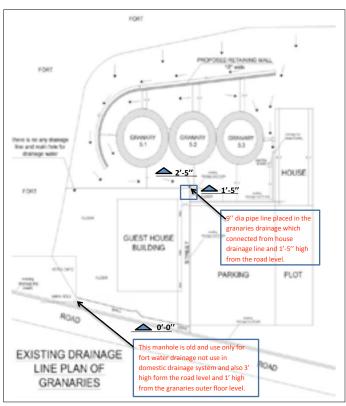
Study for existing drainage system around site

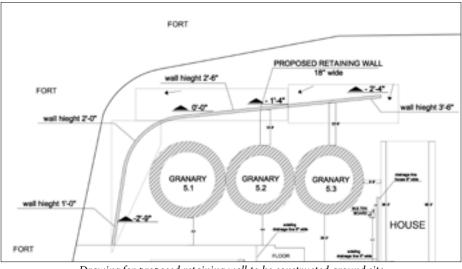
Drawing for proposed retaining wall to be constructed around site

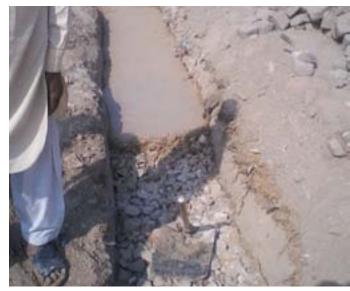
Construction of Retaining wall

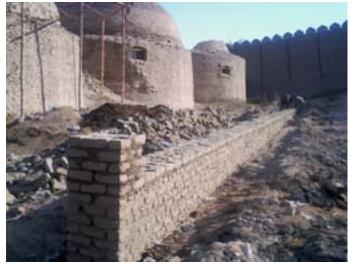
Construction of retaining wall

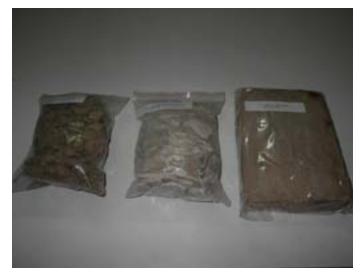
Samples of historic material collected from site

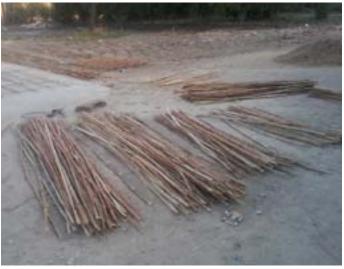
Splitting bamboo for preparation of lattice

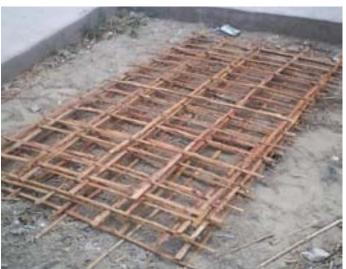
Bamboo lattice prefabricated for installation inside granaries

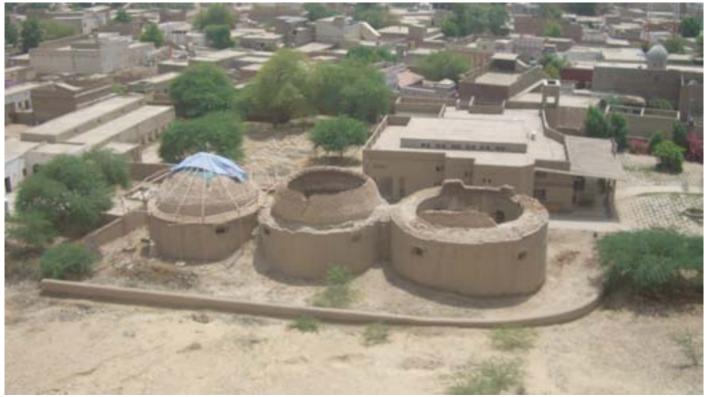
View of three granaries from the Kot Diji Fort. The domes of Granary 5.1 and 5.2 have been lost, while work on Granary 5.3 is in progress.

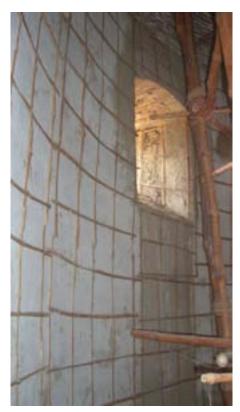
Work in progress on bamboo lattice fixing and re-plastering wherever necessary.

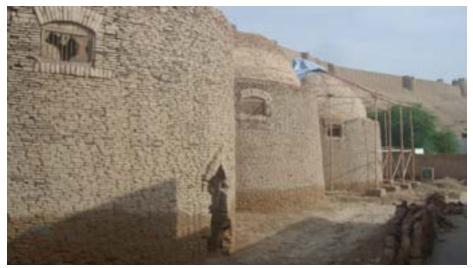
View from Granary 5.1 with Granary 5.3 on extreme right.

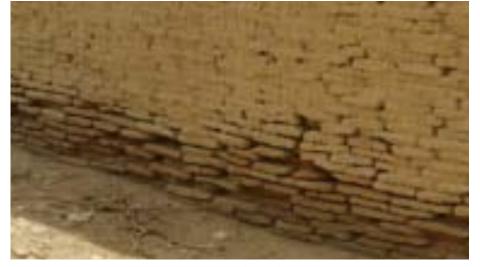
Work on external wall will require underpinning, filling of joints with new mortar and providing. plinth protection / toe arrangement with lime render to provide protection from rain water to the base of external masonry wall.

In September work will also be started on external walls. The masonry suffers from loss of mud mortar from brick joints.

The work consists of underpinning in all areas where cavitites have been formed. Due to the disintegration of mud mortar pointing, it is imperative to remove all loose mud mortar from joints and replace it with new lime sand mortar.

Accordingly, teams are being formed, who will painstakingly remove all loose mortar and clean the joints, if necessary with a blower. In view of the depth of the joint which vary from 1-1/2" to 2" deep pointing will be carried out in three steps to allow curing and drying before the next mortar is applied.
