US Ambassador's Fund for Cultural Preservation Tombs of Sultan Ibrahim & Amir Sultan Muhammad at WHS Makli, Thatta Progress Report No - 2017/7-9 July - Sept 2017

TOMB OF SULTAN IBRAHIM

Progress Report No - 2017/10-12 Oct - Dec 2017

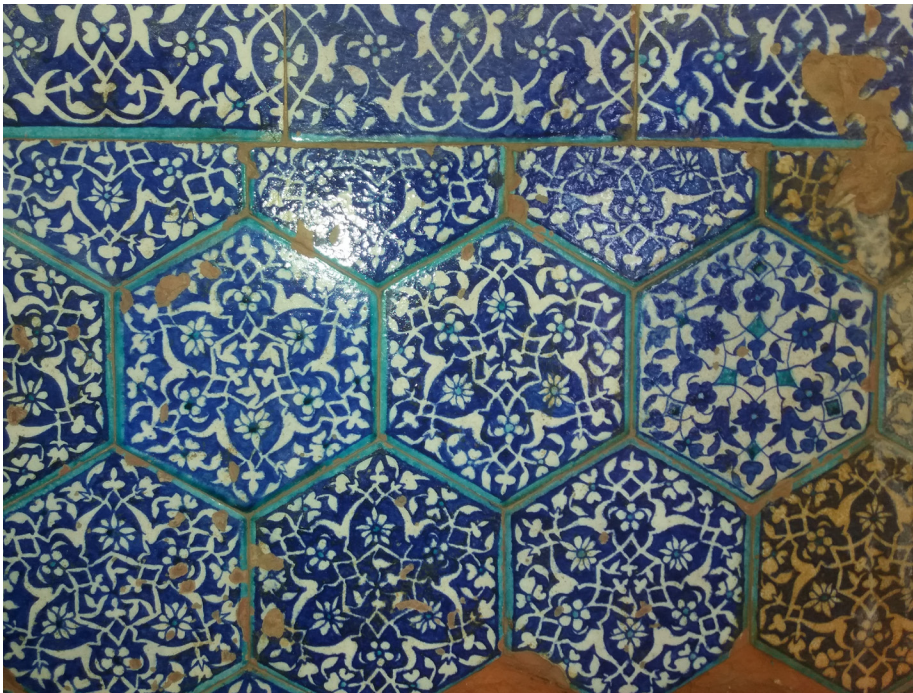
Cleaning and consolidation of original glazed tiles..

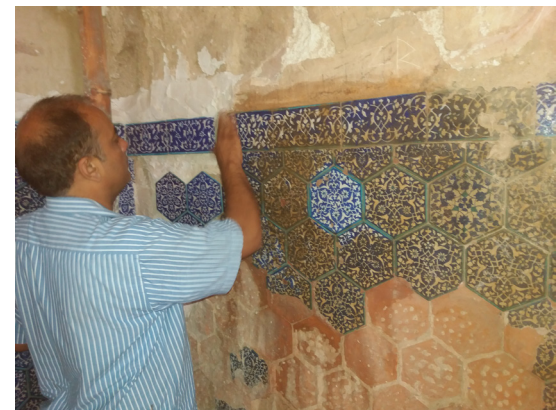
Glazed tile replicas being checked for size and pattern on interior panels carrying hexagonal vegetal interlacement.

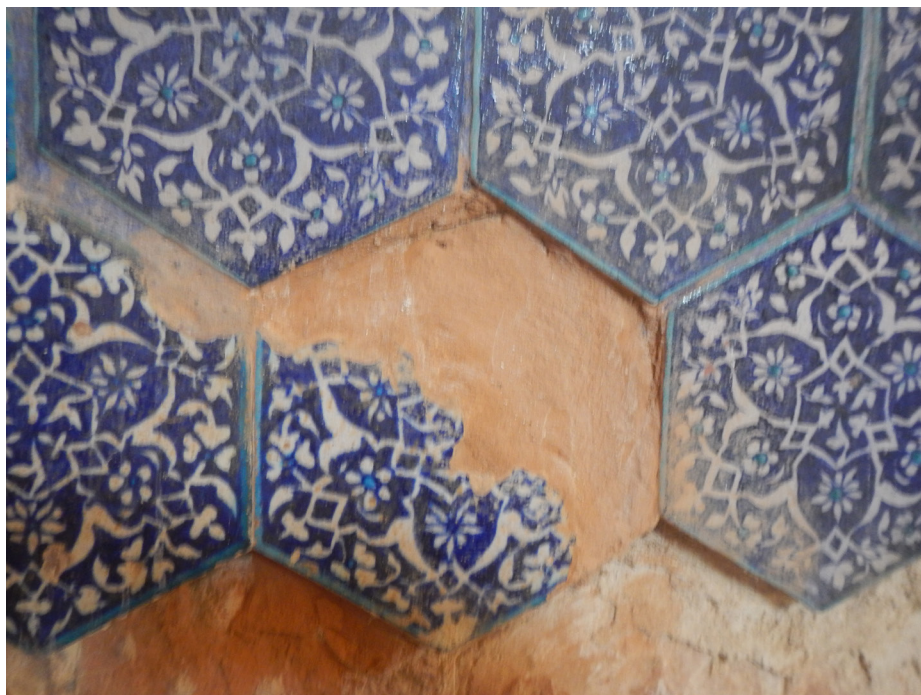
Saving all evidence of original extant kashi, even when in a damaged condition.

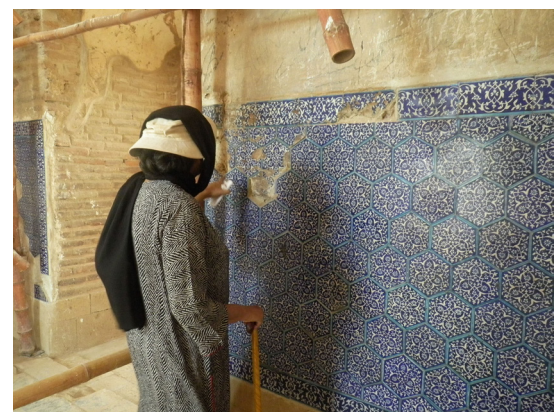
Checking for matching and compatibility of glazed tiles with extant original tiles.

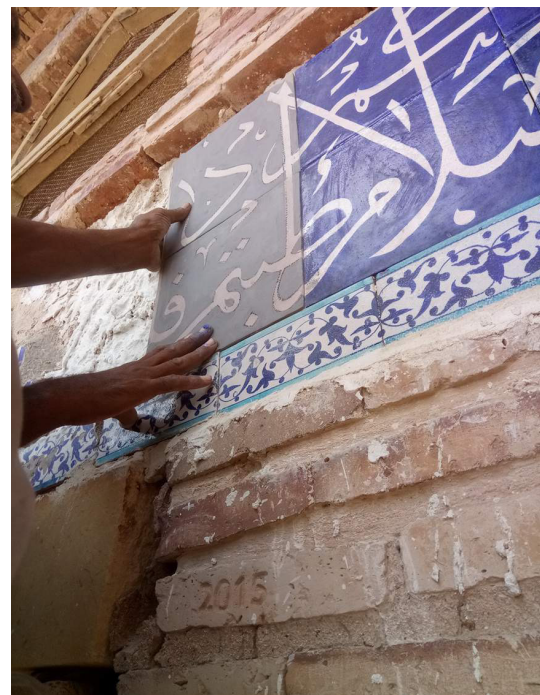
Challenges in production and placement of calligraphy tiles for matching with original extant tiles. Tiles being checked before firing to ascertain continuity with existing calligraphy.

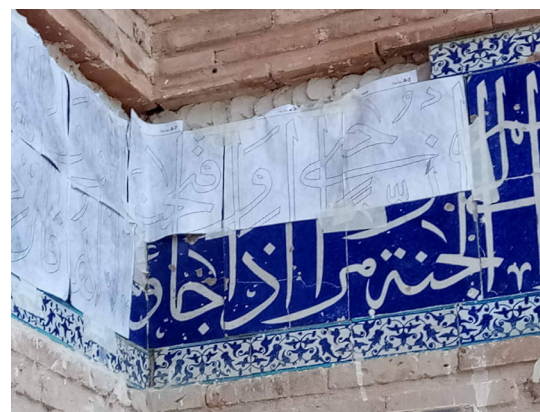
Checking drawings to assure continuity with original extant calligraphy.

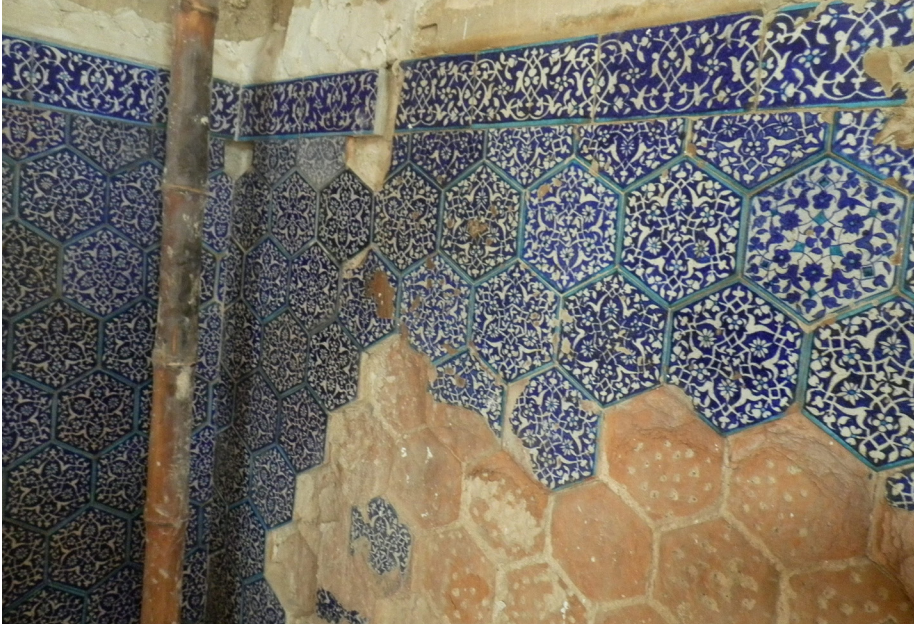
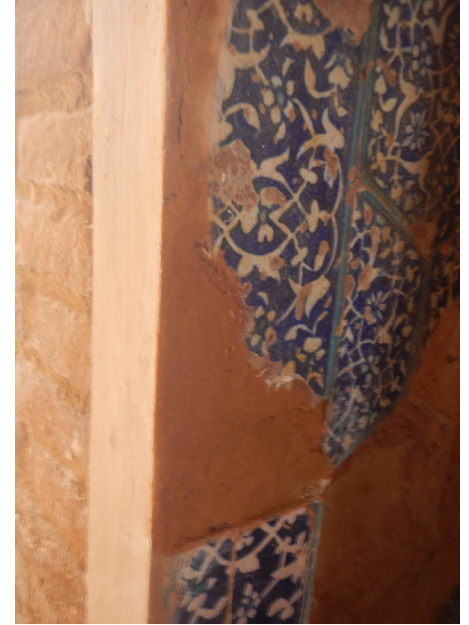
(Above Left) Tile panel showing remains of original glazed tile, bisque and terracotta body as well original preparatory surface for placement. All the original evidence has been carefully maintained.
(Above Right). Consolidating all edges of original extant tiles to provide protection from further loss.

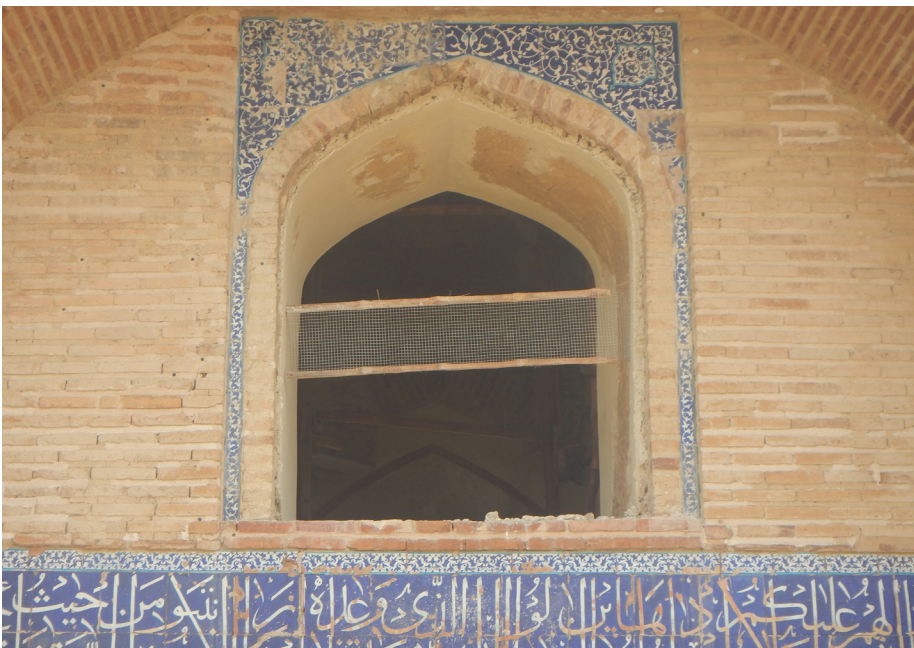
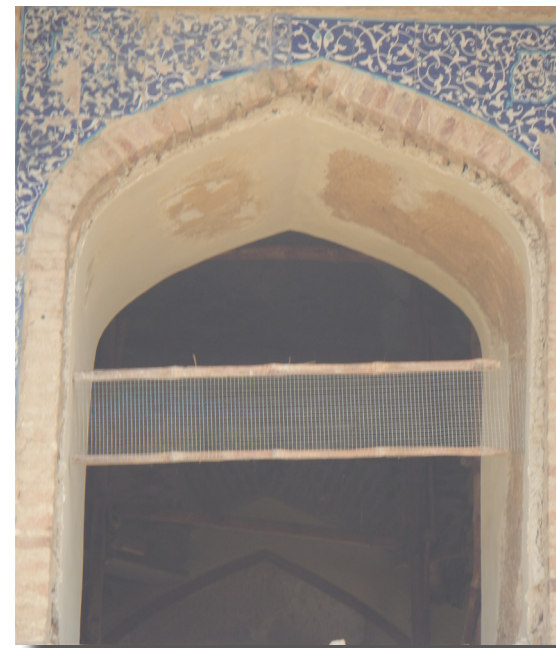
(Below) Views of spandrel tiles. The left is original while matching tile replicas are on the right.

Since sufficient evidence of spandrel tiles was found when remains of four spandrels above calligraphy were compared, the lacunae according to available evidence in all the four spandrels has been filled. Its floral interlacement overflowed from one tile to another, and considerable expertise was needed in the production of these tiles in order that they would match with each other and with the remains found in the original tiles.

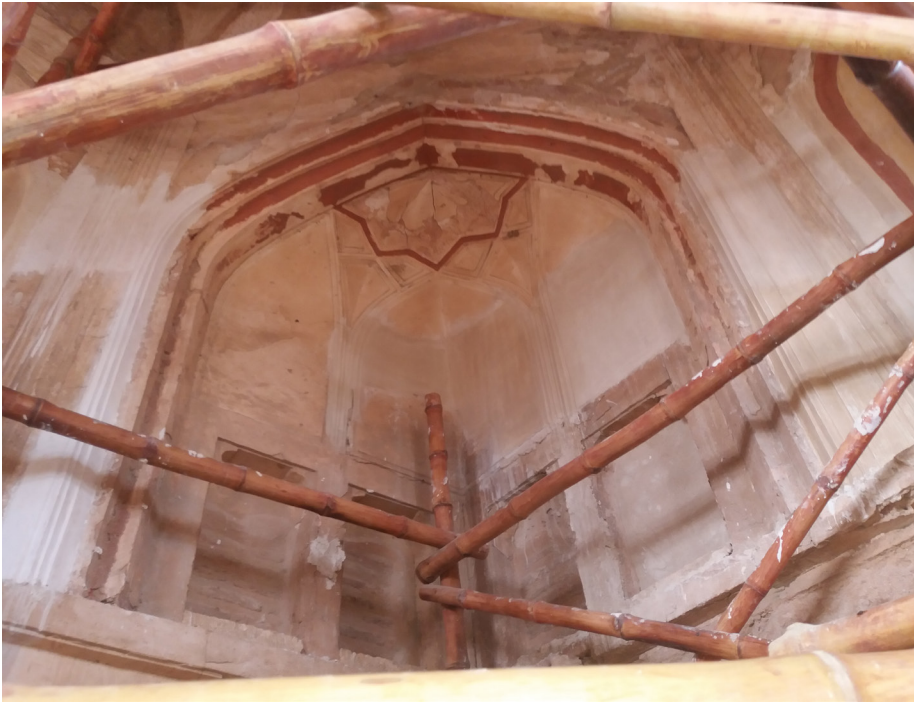
Work in progress on restoration of stucco layers in internal squinch alcoves.

In this quarter the work on repairs and consolidation of damaged and detached surfaces of interior stucco work was continued. This had to be taken carefully as all evidence of the original stucco, even though fragile and detached, had to be maintained. It had been decided that the repairs must be handled very carefully, in order that no evidence of the past is lost. This also required that the bare surfaces as found should not be rendered over, as these provided evidence of structural methods and the wear and tear the monument has gone through over several centuries.

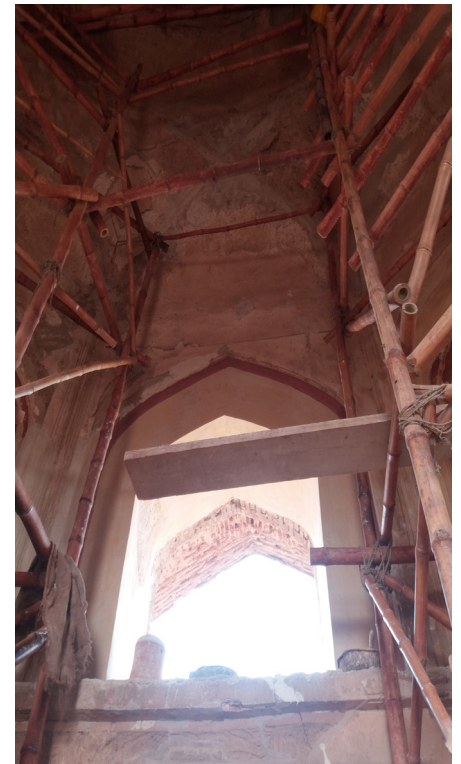
Repairs to window soffits.

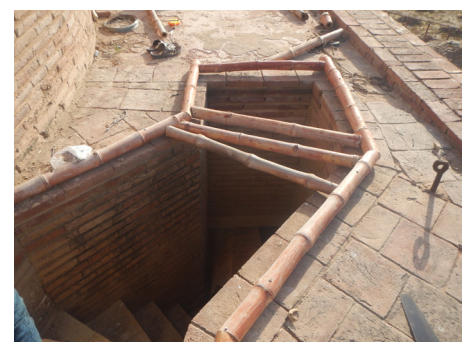
In addition to the cleaning carried out around the site, major effort went into the construction of a roof over the open-to-sky staircase. This void in the roof had created a havoc with the internal conditions of the chamber, as it allowed unrestricted flow of water during rains. The water ingress in the walls of northwest corner were instrumental in retaining dampness in the wall due to which all the glazed tiles in the corner had been lost. Several drawings for alternatives for the profile of the roof and accessibility to the top were prepared. It was finally decided to build a bamboo flat roof, which was easily reversible at the same time it was light and in-

Bamboo roof and trapdoor under construction to prevent water seepage in the stairwell.

flicted only very light load on the walls of the monument. Since an opening was a pre-requisite for access to the roof for maintenance purposes, a trap door like solution was developed in order that the skyline of the monument would not be affected, which would have been the case in case the new bamboo roof was constructed higher than the parapet wall.

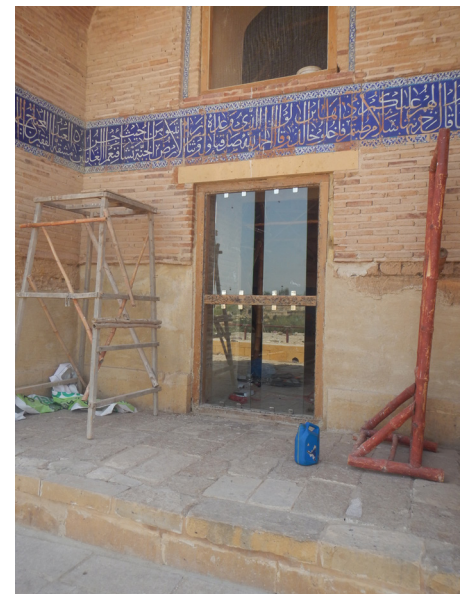
View of glass panels in openings. The use of glass prevents entry of visitors, animals and birds. It allows viewing of the interior without the need for entry. Wooden frames installed at some later date have been retained after a thorough cleaning and polishing.

The month of October was utilized to finish off all the works. It was decided to maintain the wooden frames that had been placed at some later time but which were in an excessively bruised condition with many nails and screws. The surface had become highly damaged and required repairs to make place them into a presentable condition. The paint had blistered and was in a highly blemished state. The entire paint was removed, the holes were filled in and the entire surface were provided natural polish.

The other important addition was the fixing of thick plate glass doors and fixed glass in the openings to prevent entry without concealing the interior view. For this purpose special arrangements were made to install stainless glass fastenings and locks to secure the glass in as firm a position as possible.

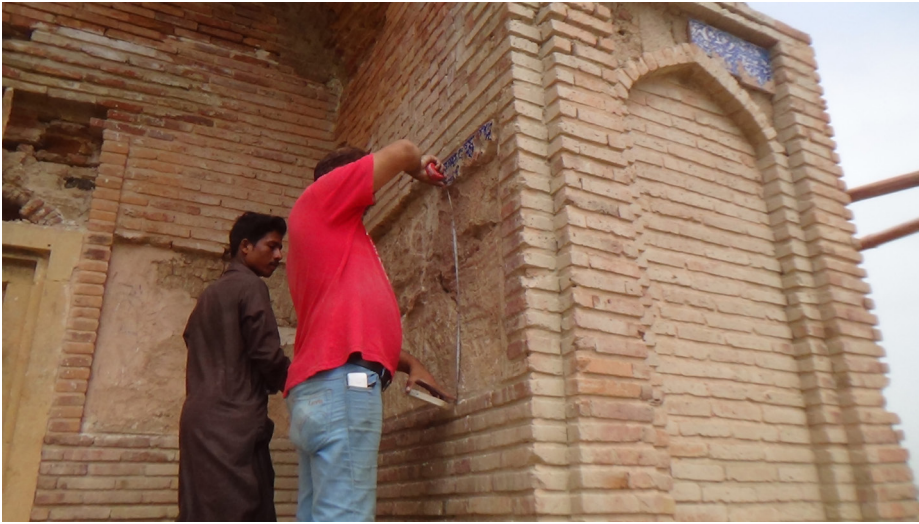
Entrance Archway

The Entrance archway had suffered from severe degradation. Its archway was at risk of collapse due to loss of masonry and ingress of water. This was a major work that needed to be taken up after the main structures had been conserved. Although much work had been done earlier, during the month of October, the remaining work consisting of consolidation was started. It was a challenging task to ensure that the archway was stabilized, especially as many of the bricks, being soft, were in an extremely poor condition, with many voids in the masonry. The work was carried out carefully by gradually building up the voids in the masonry walls before taking up the restoration of the top part of the arch.

Work in progress on east side of Entrance Archway. The remains of kashi are visible at extreme right (spandrel of arched panel).

Along with masonry work, the glazed tile work in the spandrels of the archway panels in the east was also taken for completion. The remains of the original tiles of the two archway panels were studied and it was found that the original panels could be completed by utilizing the evidence found on the west side. Thus, special tiles for the spandrels were fabricated, and installed, bringing about a semblance of how the original view from the east could have been.

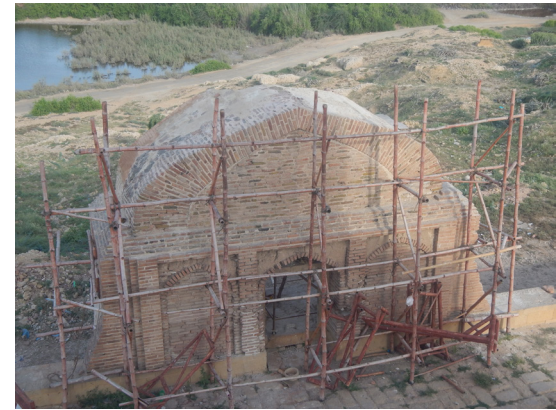
Work in progress on the west side of Entrance Archway.

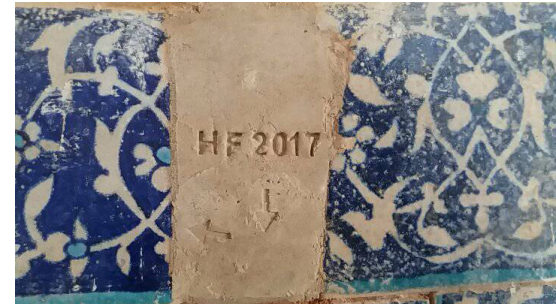
Marking dates to mark interventions.

The stamping of arrows and date of execution of intervention was taken up seriously after major part of the tilework had been completed. This is an important requirement for conservation in order that the new can be distinguishable from the original. Special stamps were made after several experimentations, which would provide a discreet identification of the extent of kashiwork carried out both externally and internally.

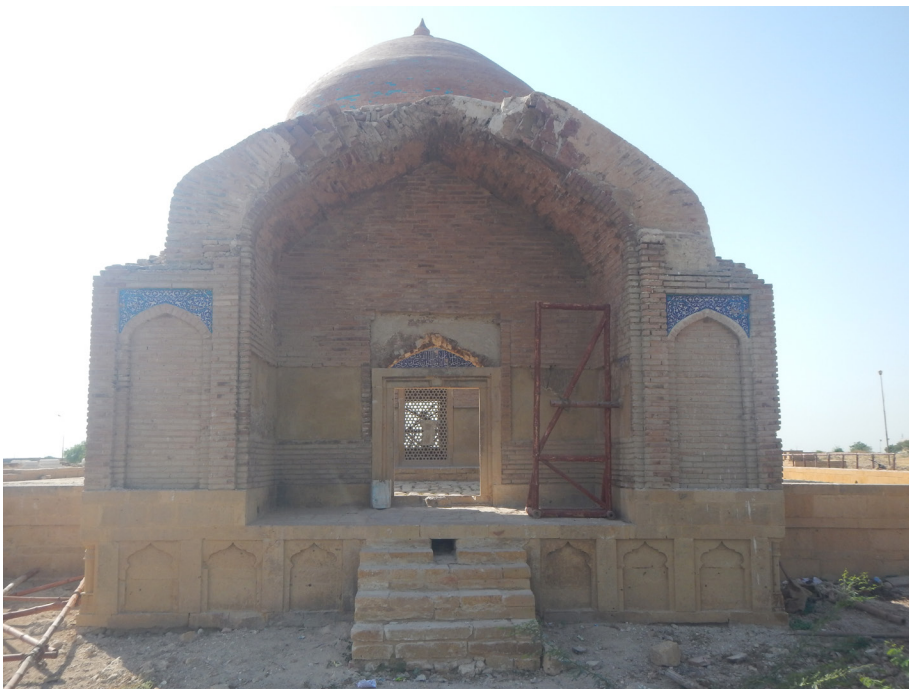
(Left) Stabilized and consolidated archway with restored kashi spandrels.
