CONDITION OF SETHI HAVELI AT THE OUTSET

Condition Survey by Documentation Centre and Heritage Foundation of Pakistan

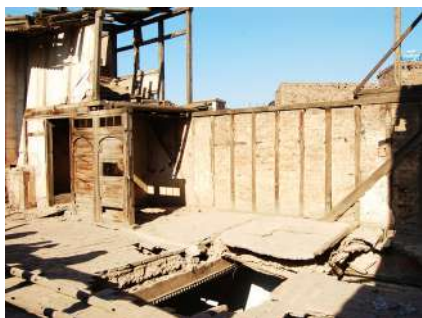
Damaged condition of a neighbouring Sethi haveli.

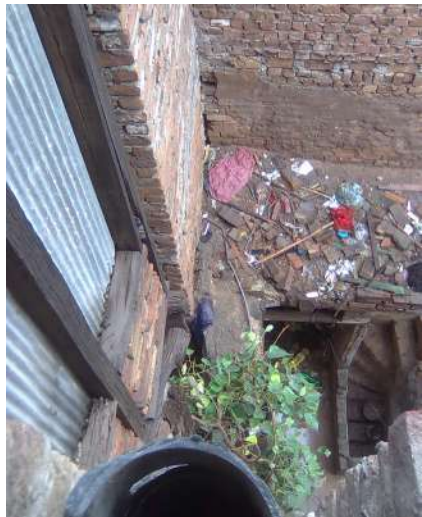
Damages to Non-historic section of the house.

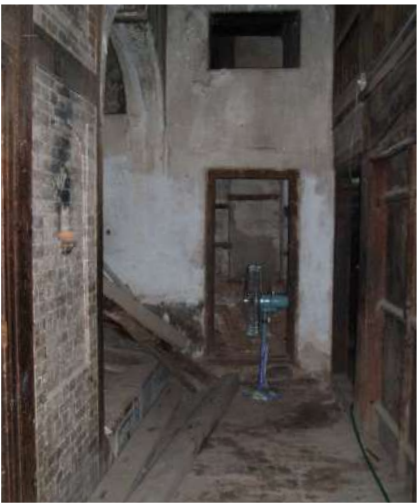
Mid-historic section before conservation work.

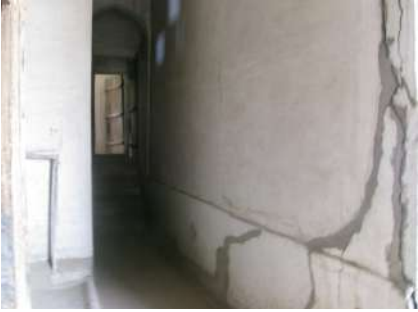
Cracks showing structural failure in Mid-historic section

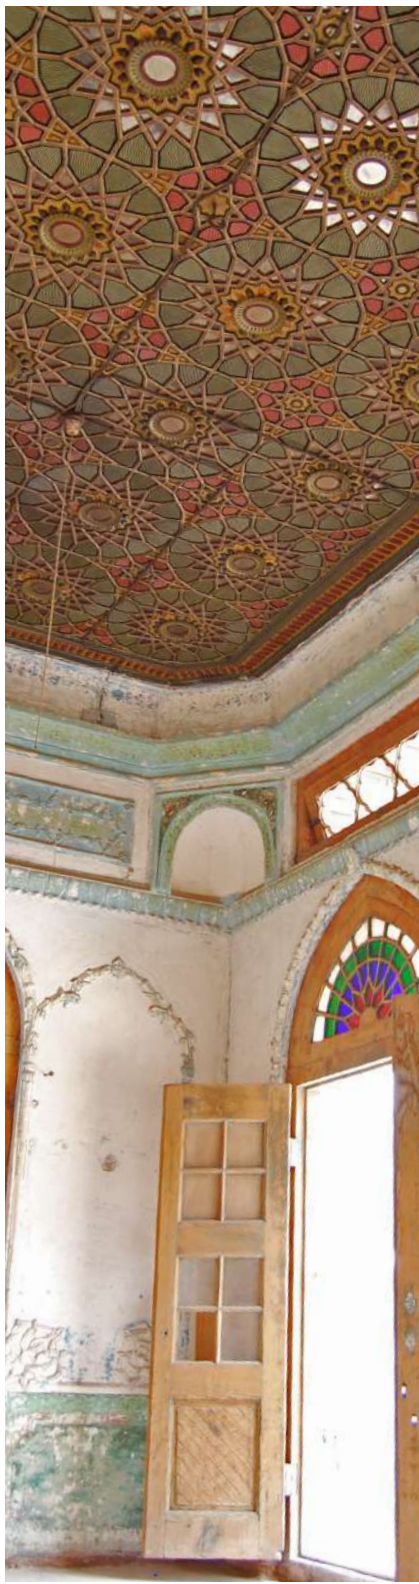
Room 3/01 during paint removal

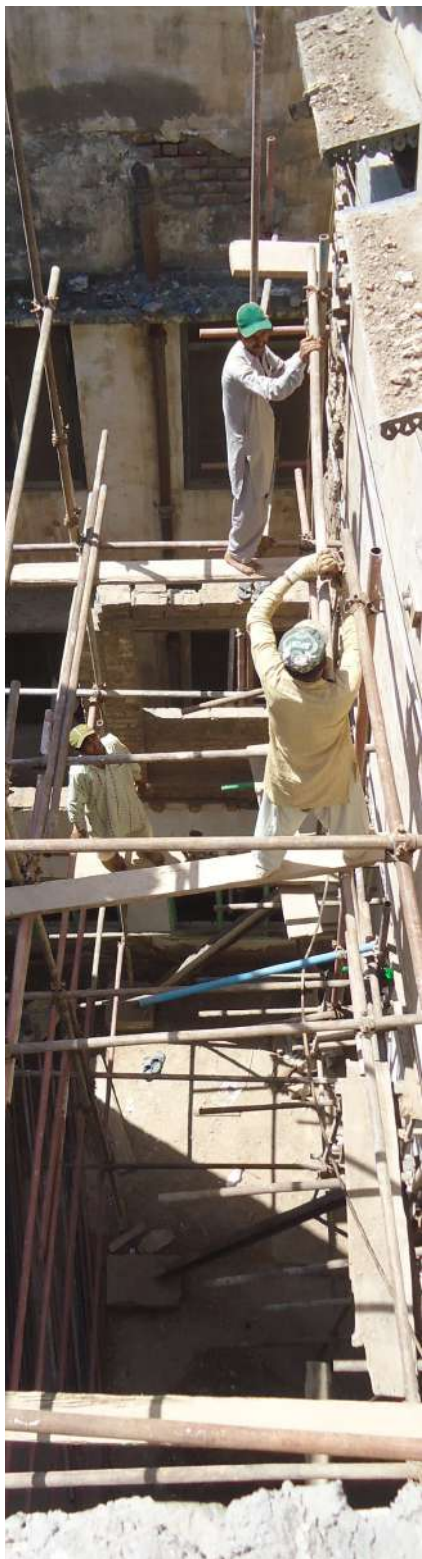
Workers stabilizing wall adjacent to school building

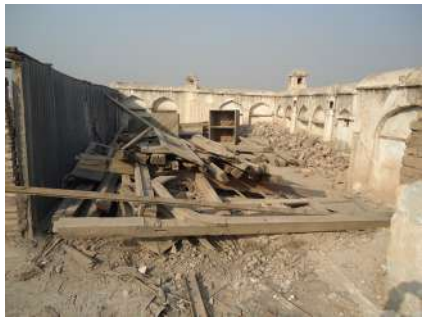
Condition of roof before conservation.

All roofs were found to have suffered extensively due to rains and insufficient drainage arrangement for prevention of water ingress.

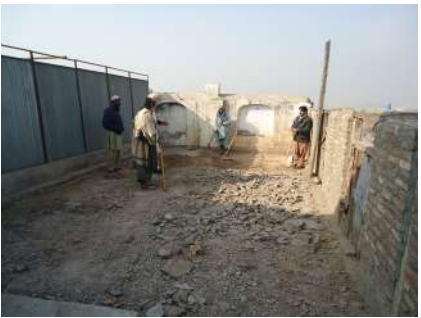
Removal of bricks and compressed earth from roof.

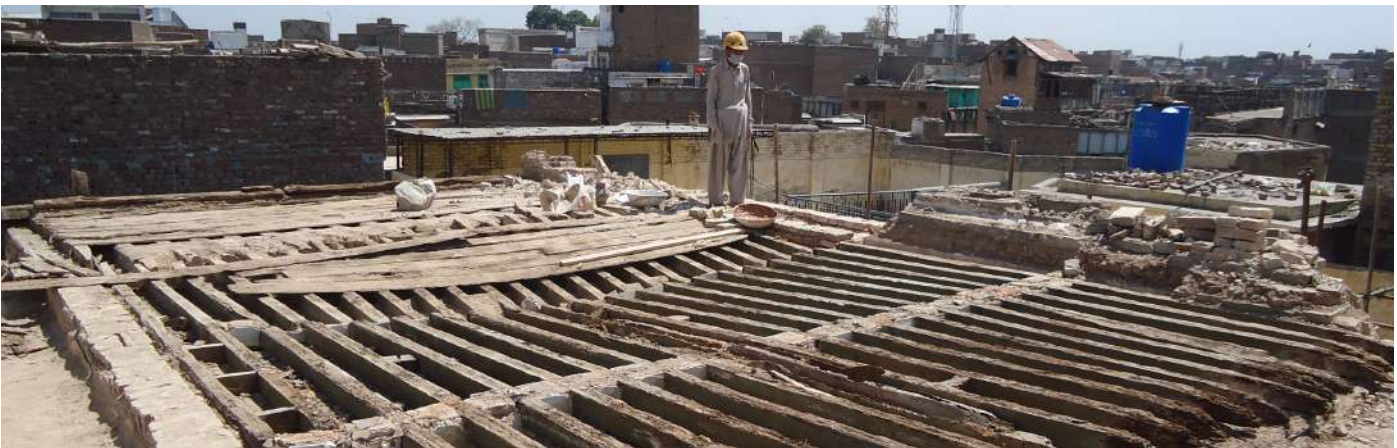
Restoration of Mid-Historic section Roof 4/03 and 4/04.

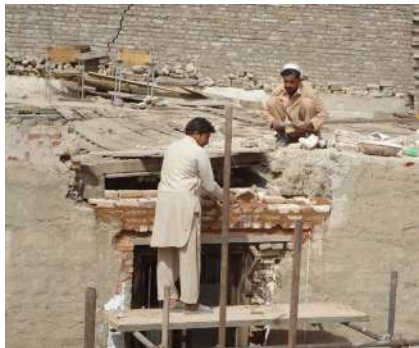
Workers replace masonry and fill cracks in damaged Mid-historic section.

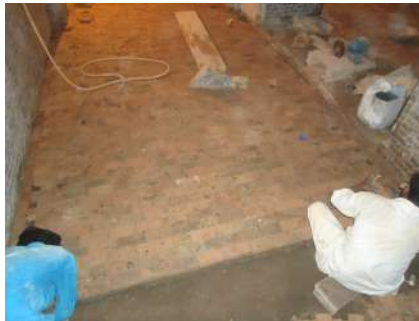
Laying salvaged historic brick after cleaning and new waterproofing in Basement.

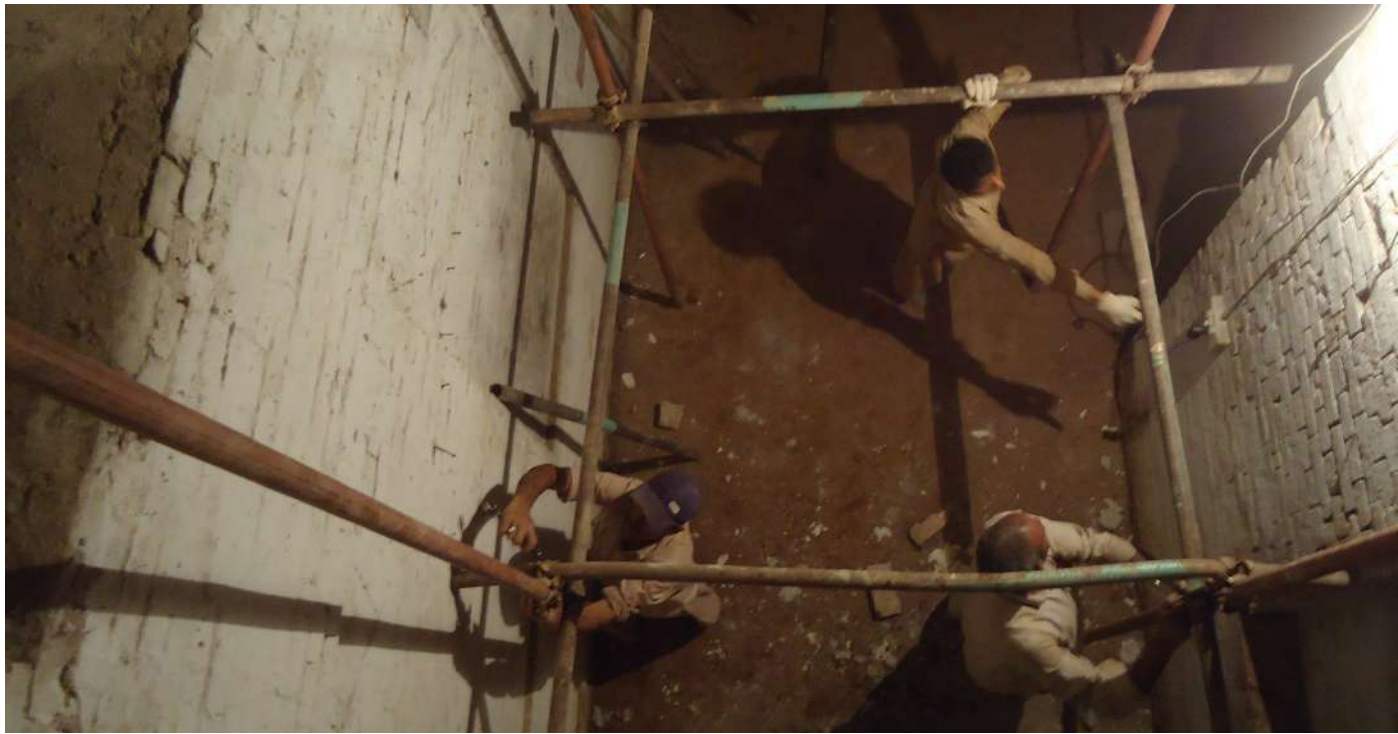
Restoration work in Basement.

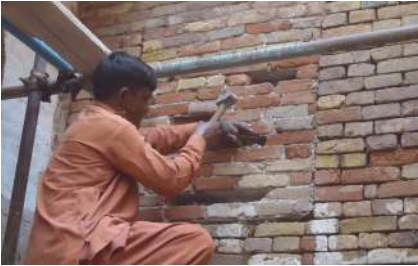
Filling missing bricks and re-pointing.

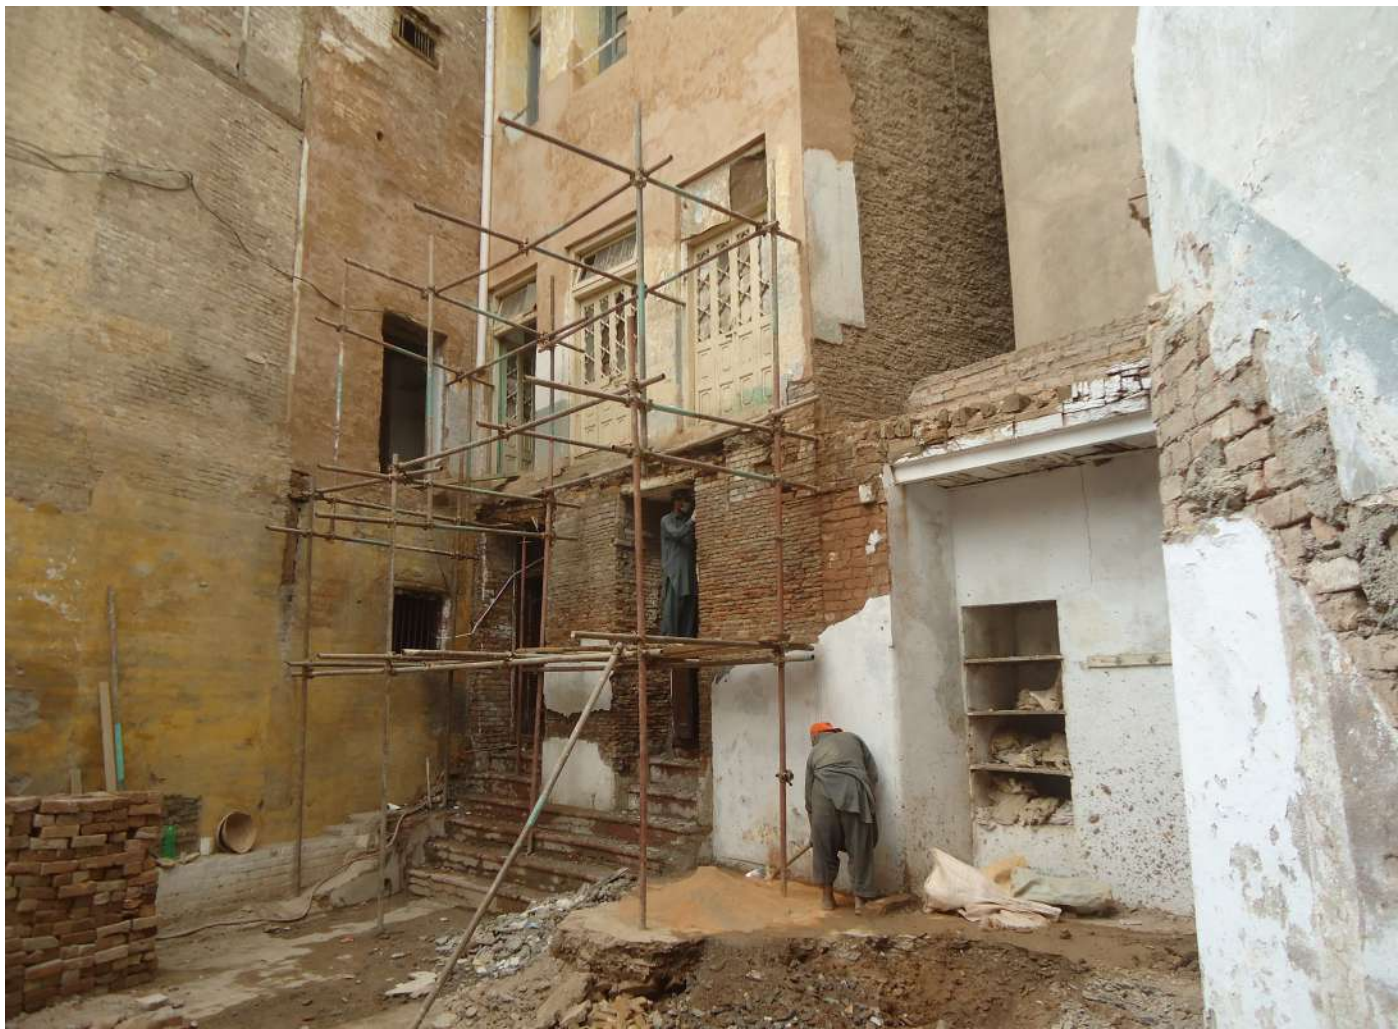
During demolition of Non-historic front portion.

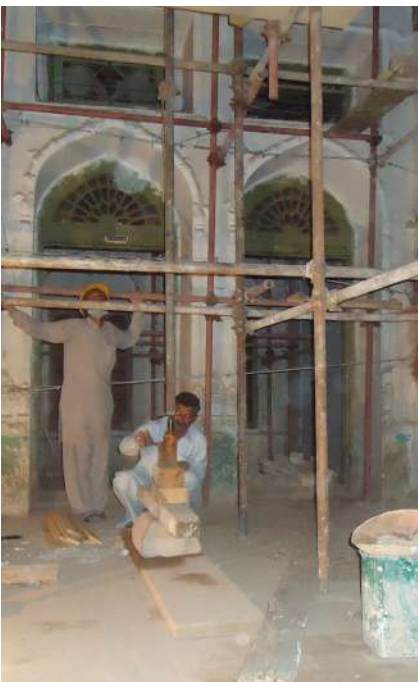
Scaffolding to stabilize Mid-historic section of the house.

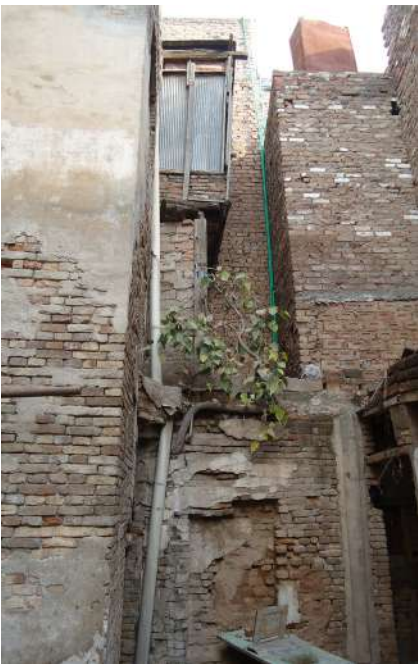
Rear Non-historic section showing damaged brick masonry.

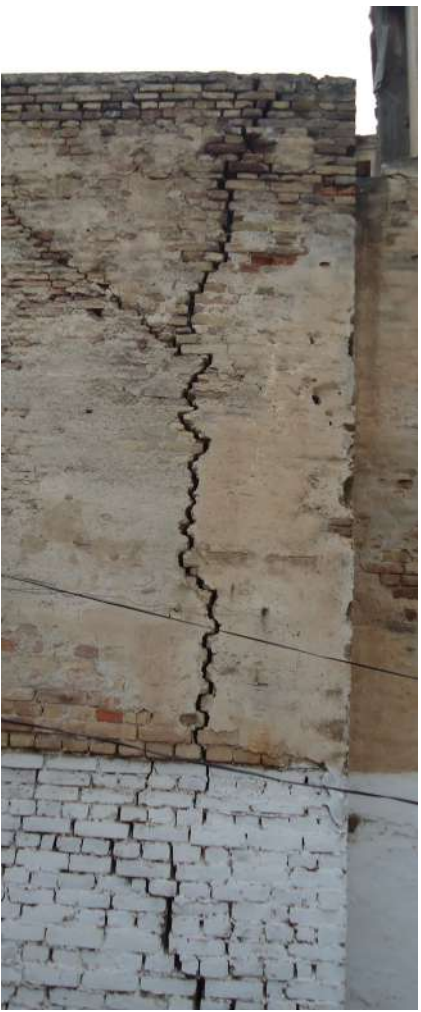
Cracks display structural failure of Mid-historic section.

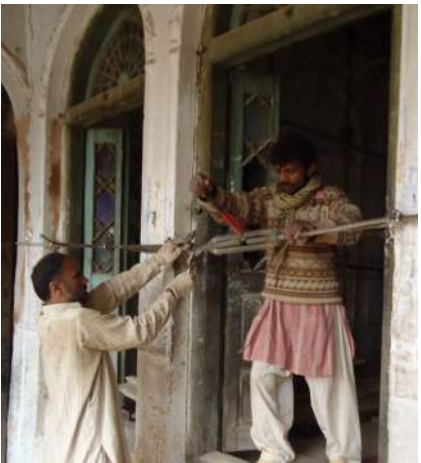
Restraining arrangement of Mid-historic section with cables and clamps.

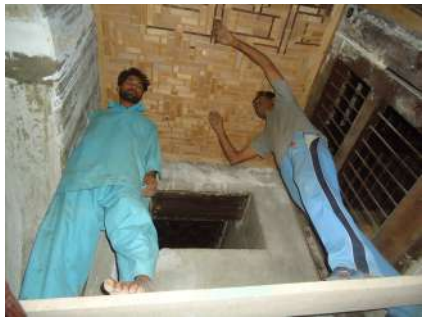
Replacing damaged tarseem bandi.

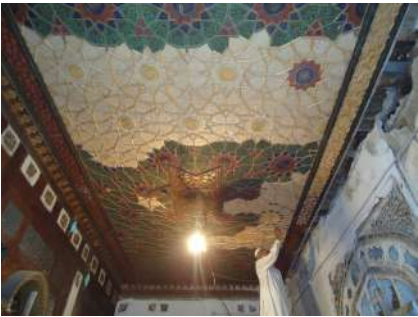
Replacing damaged tarseem bandi.

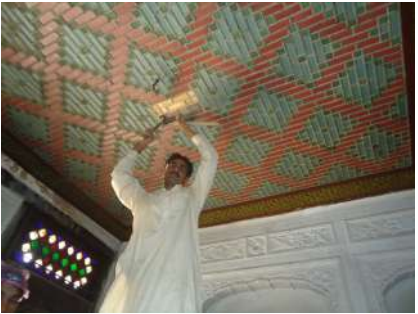
Replacing damaged tarseem bandi.

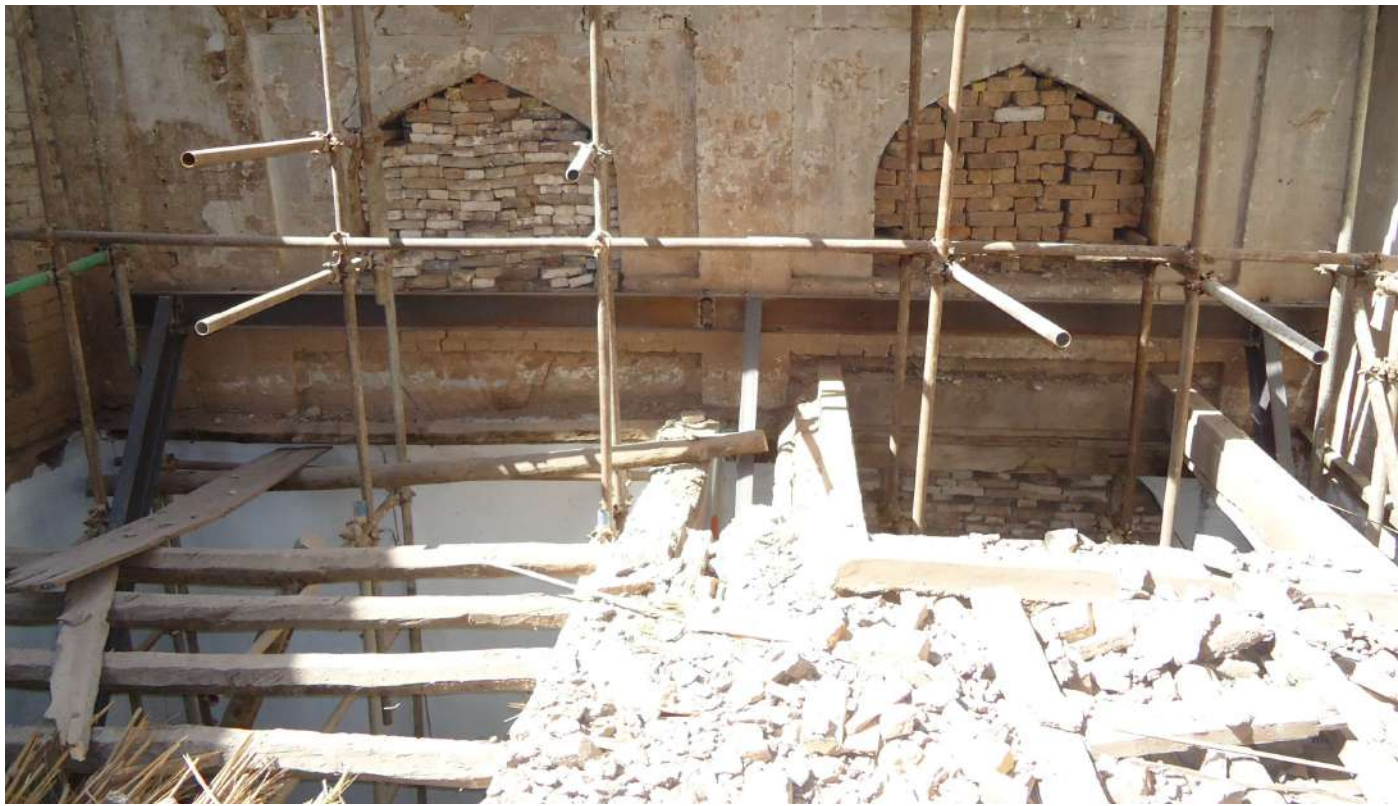
Removal of flooring to reapply water-proofing courses at Level 3,

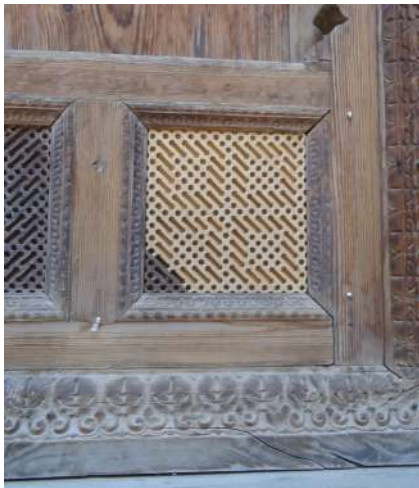
Replacing damaged punjali.

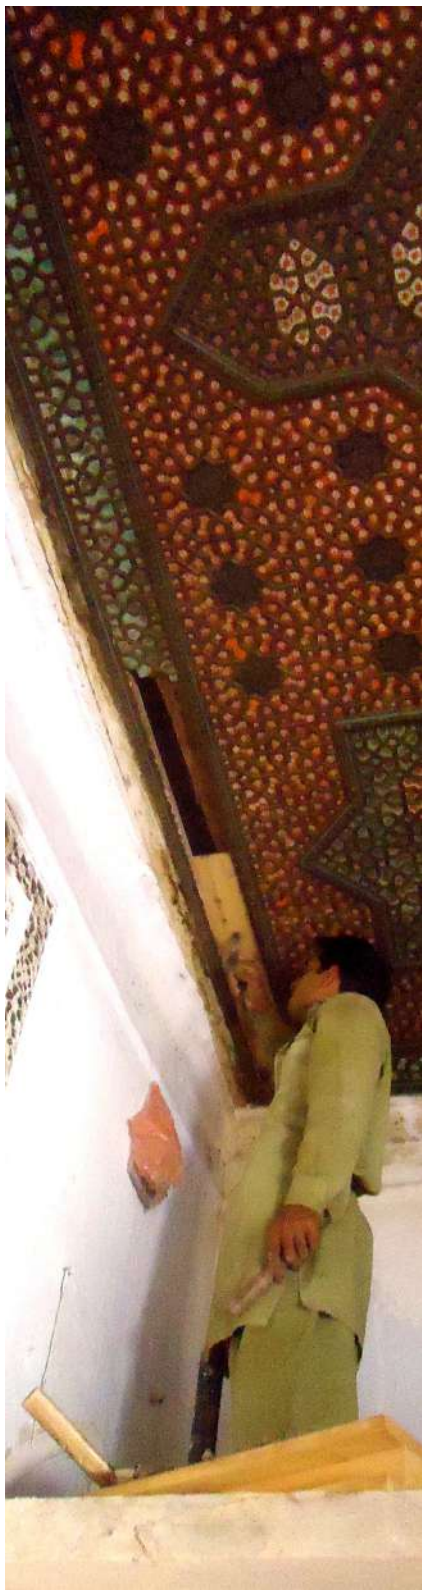
Replacing damaged *tarseem bandi*.
