Sepulchre of
Mirza Jan Baba
Father of Isa Tarkhan the Second

Yasmeen Lari
2017

© HERITAGE FOUNDATION OF PAKISTAN 2017

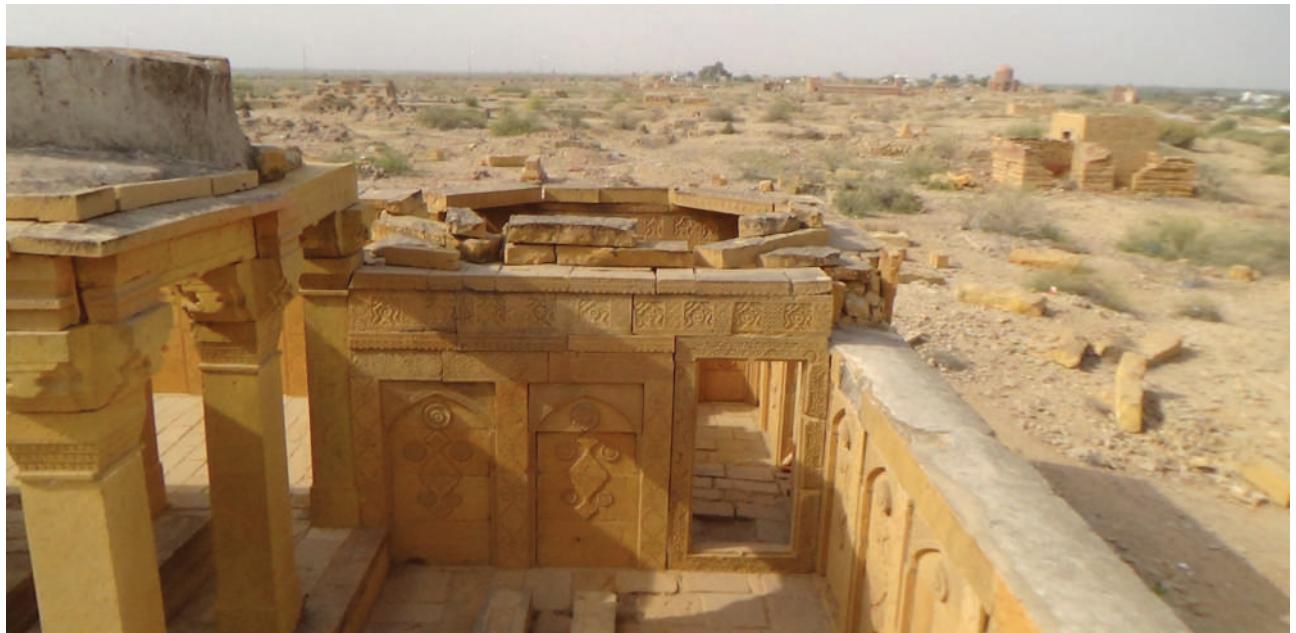
Void left by collapsed roof of Graves Canopy (left) and Zenana Chamber (right) can be seen.

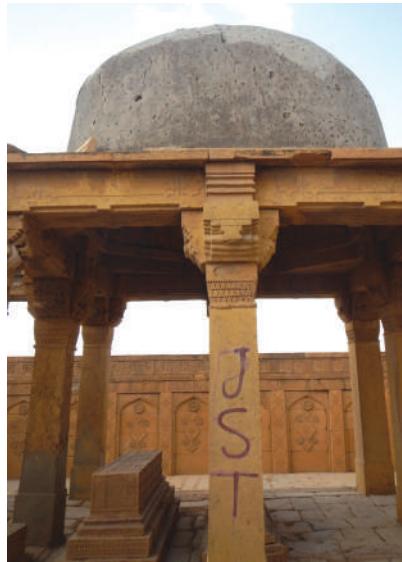
The structural study emphasized the vulnerable central bay of the Graves Canopy where evidence of settlement had been found.

Central bay of Graves Canopy.

During the studies, settlement in the central bay of the Graves Platform was detected. This condition had been aggravated due to rain water which found its way into the flooring of the platform, endangering the pillars and the central dome itself. The tilting of pillars and the deformation of the beams spanning between them were also a cause for alarm.

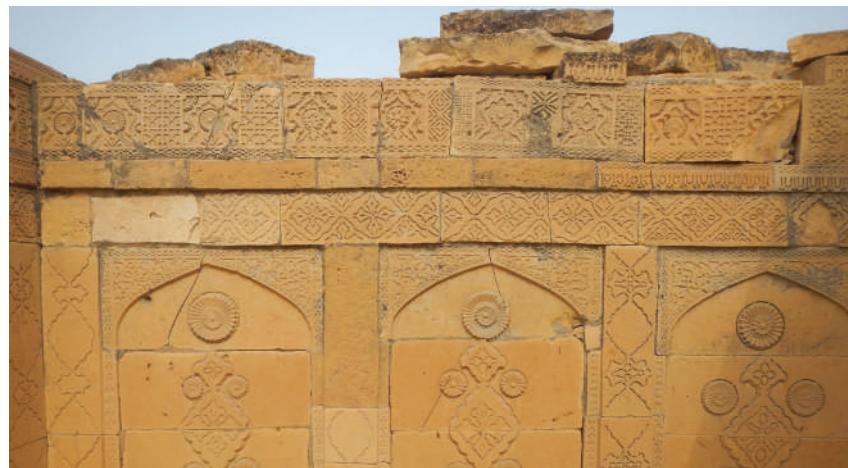
In the enclosure Perimeter Wall, defects consisted of fracture, hairline cracks, star cracks, black crust formation, and discoloration along with widening of joints. Walls and pillars carried a high degree of soiling and graffiti. The flooring in all areas was found to have alveolization / coving and differential erosion. Through an area-wise survey of damage, necessary treatments, following the principle of least intervention, were worked out.

Damaged stones of Perimeter Walls.

A study was carried out for missing stones in the Perimeter Wall. While those in the lower parts of the wall would be made up with new dressed stones, duly marked with the date of intervention, any other stones, particularly those in the roof upstands could only be taken up after careful deliberation. It was finally decided to complete the rows at the top of walls and roofs with plain dressed stone pieces; however the *kanguras*, evidence of which was limited, would not be made up. In any case all existing battlement *kanguras* were stabilized in their place.

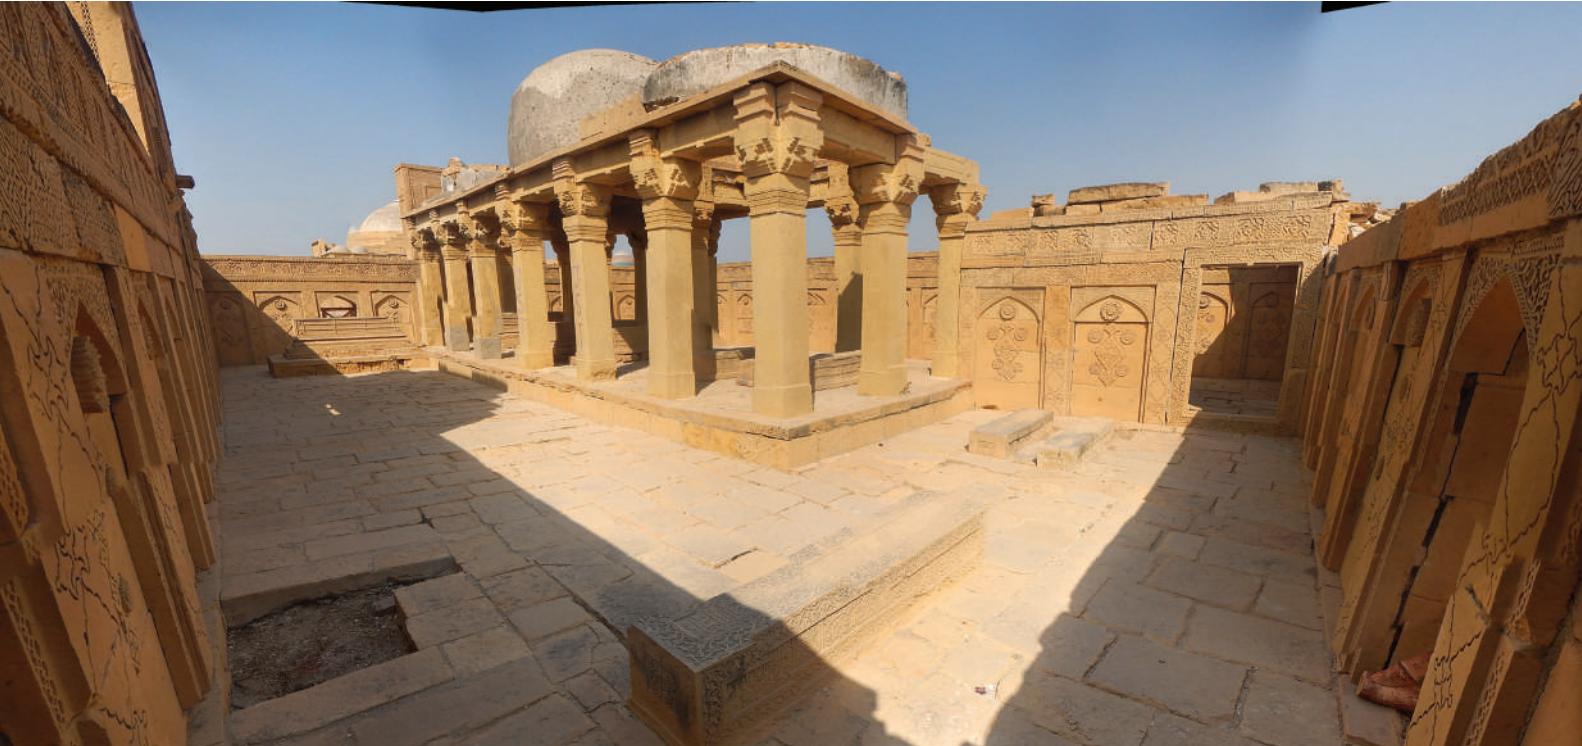
*View from southeast corner of enclosure.
Extant and lost cupolas can be seen in Graves
Canopy.*

The damage highlighted in Folio XI showed the condition of the extant central dome and surviving stone rings of two cupolas that had collapsed. The cracks in the plaster of the central dome were also noted. The internal condition of the central dome showed widening spaces between stone joints due to settlement of stone pillars located in the west of the central bay. The most affected stone pillars were found on the south western part of the Graves Canopy.

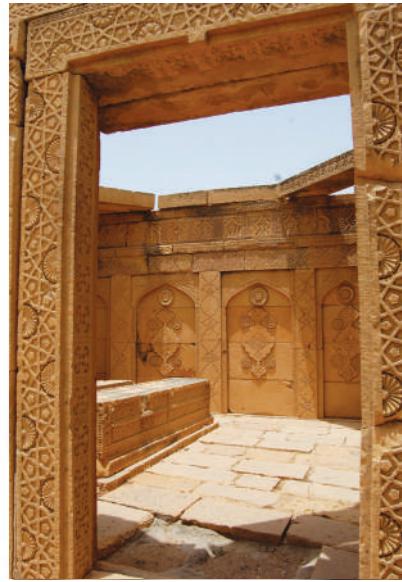
Zenana Chamber. Damaged state of flooring.

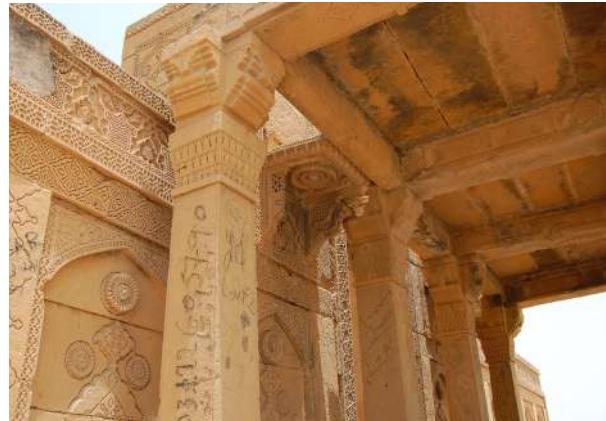
Entrance Canopy. Ravaged roof slabs.

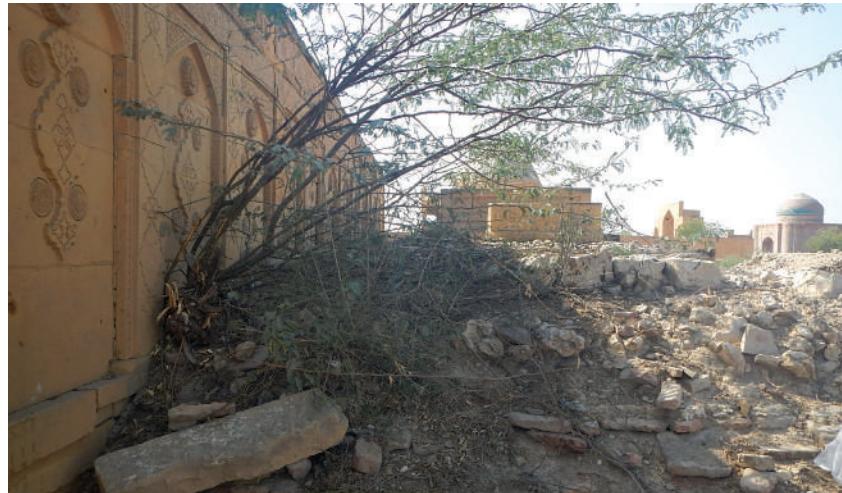
North Perimeter Wall. Grave mounds exerting pressure on the monument wall.

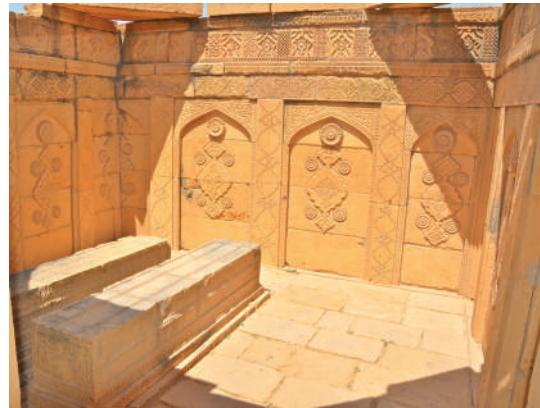
Damage caused due to lack of roof in Zenana.

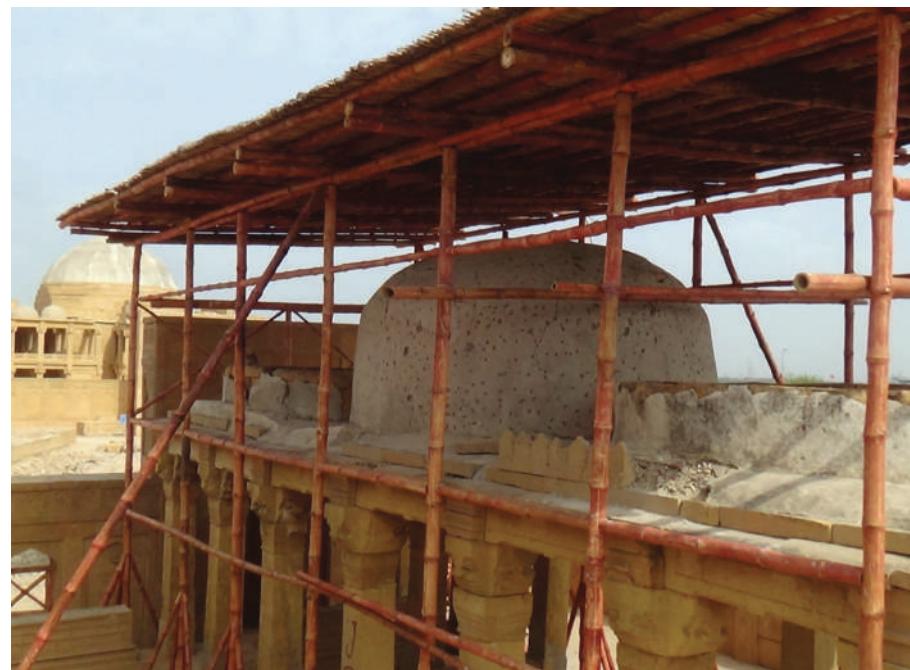
Temporary bamboo roof cover provided to Graves Canopy.

To provide protection to the remains of the valuable Graves Canopy, an elaborate bamboo roof was constructed. The temporary structure was built in a manner which would not

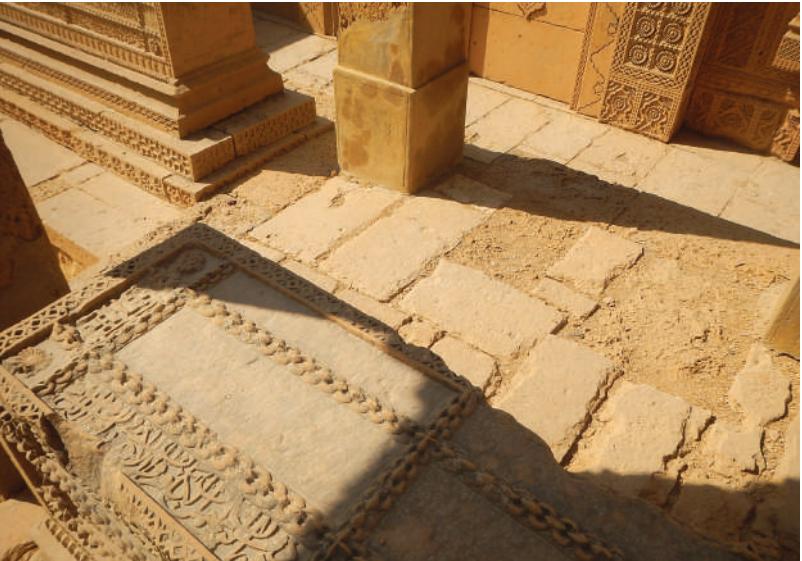
The state of the sarcophagi was no better. Due to exposure to weather and subjected to willful wreckage, some of the graves had moved from their original position. Although the date could not be confirmed, new stone insertion below one of the graves was noted.

Damaged state of flooring and sarcophagi on Graves Platform.

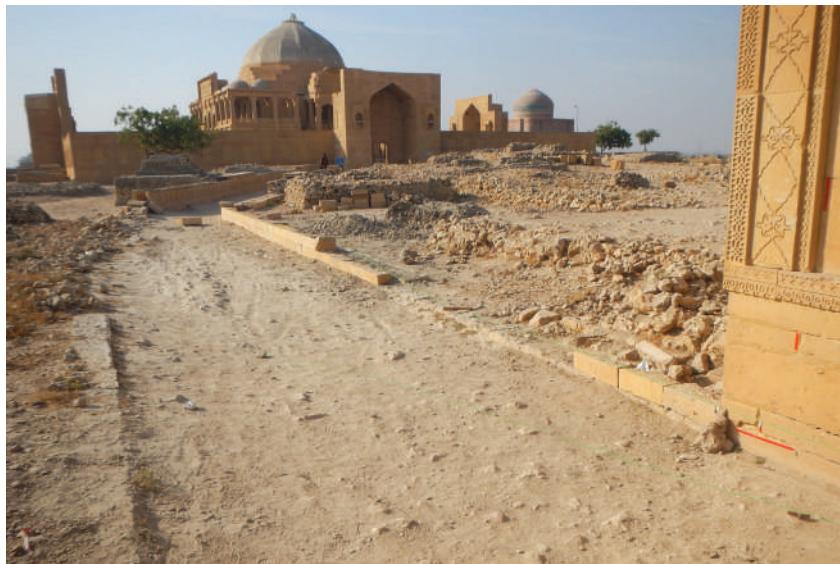
View of highly damaged Walkway from east.

Only in a few cases an attempt would be made to make up lost stone pieces, however, in the case of the Walkway dwarf walls reconstruction would be undertaken. The Walkway had presented a disorderly and fragmentary outlook, negating the very purpose for which it was built. It had originally been designed as a ceremonial path that articulated the linkage between the mighty mausoleum of Isa Tarkhan II with the comparatively restrained tomb of his father Jan Baba. Many dislodged pieces

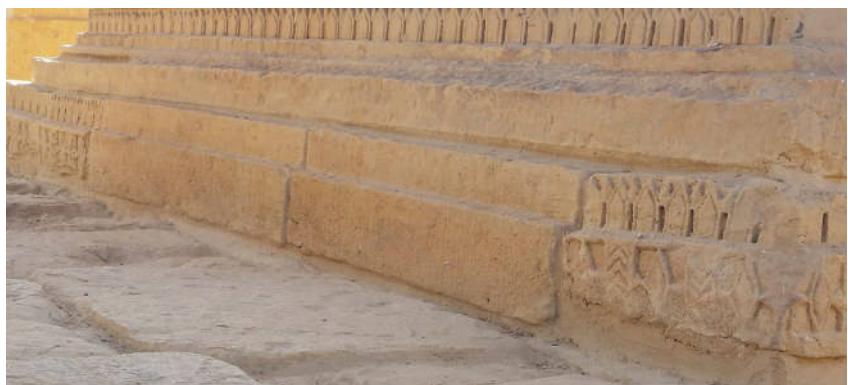
View of sarcophagus after resetting the damaged stones.

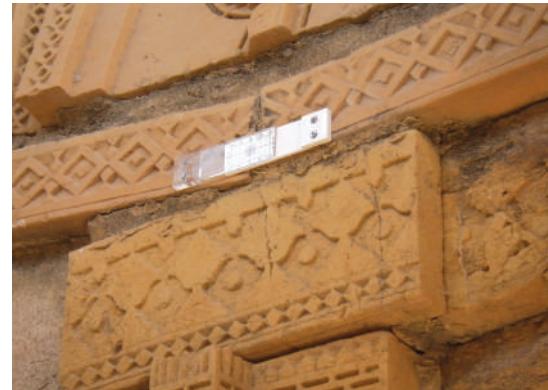
Placement of crack monitors for checking movement.

been filled with loose earth. To determine conclusively regarding any movement in the structure, arrangements were made for regular scientific readings through Total Station measurements and placement of crack monitors. The appraisal enabled monitoring for movement in north-south and east-west directions, and a separate log, along with pictorial evidence, was maintained for the data. After carrying out the study for 10 months, it was concluded that there was no longer any movement in the structure, as the deformities appear to have stabilized over several decades. Accordingly, filling of open joints in the cupola would suffice for providing protection from the weather.

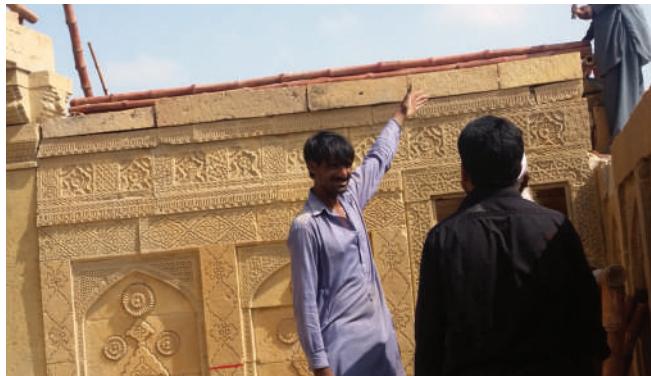
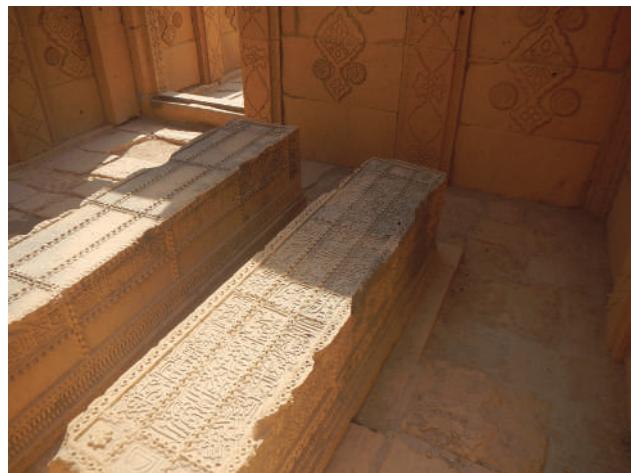
Damaged sarcophagi with elegantly carved verses from the Holy Quran.

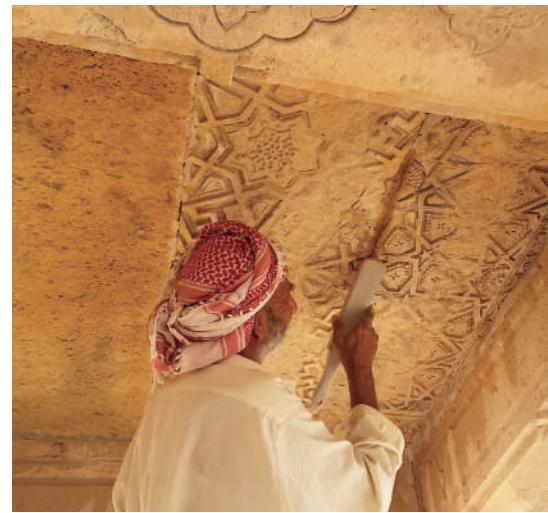
Pointing in gaps of stone slabs of highly eroded roof slabs.

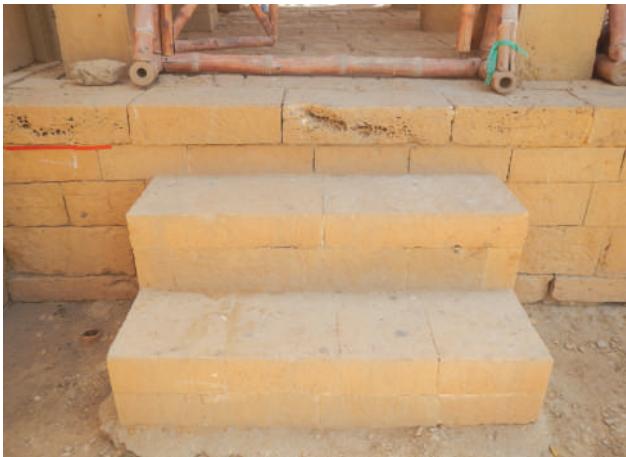
Damaged stone riser at entrance to the canopy.

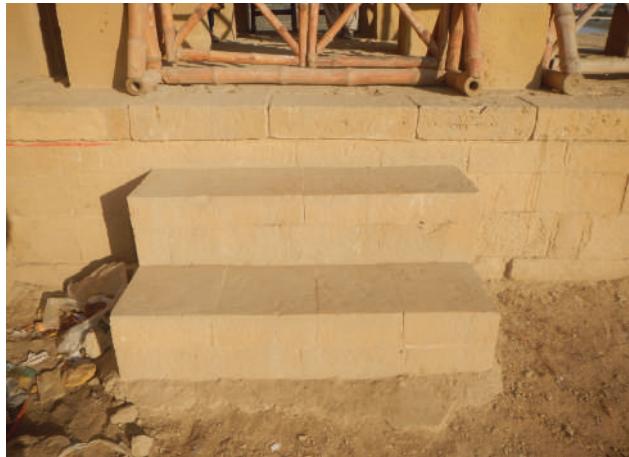
The damaged stone riser at entrance inverted to provide clean edge.

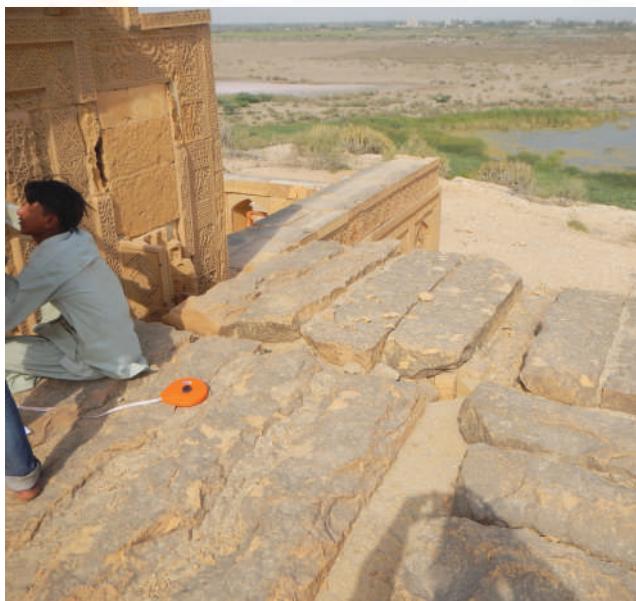
State of joints between damaged roof slabs.

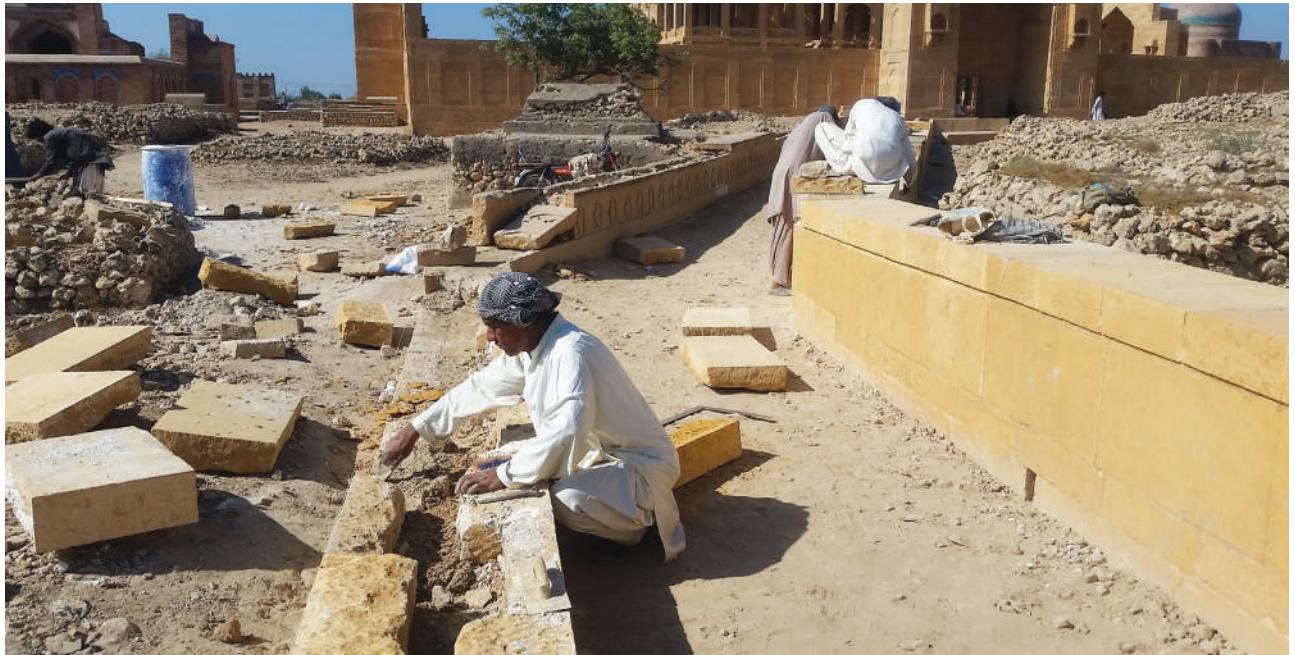
Walkway dwarf wall being restored.
