SETHI HOUSE, PESHAWAR

SITE INSTRUCTIONS

CONSERVATION RECORD DOCUMENT
Site Instructions Sheet

Sethi House

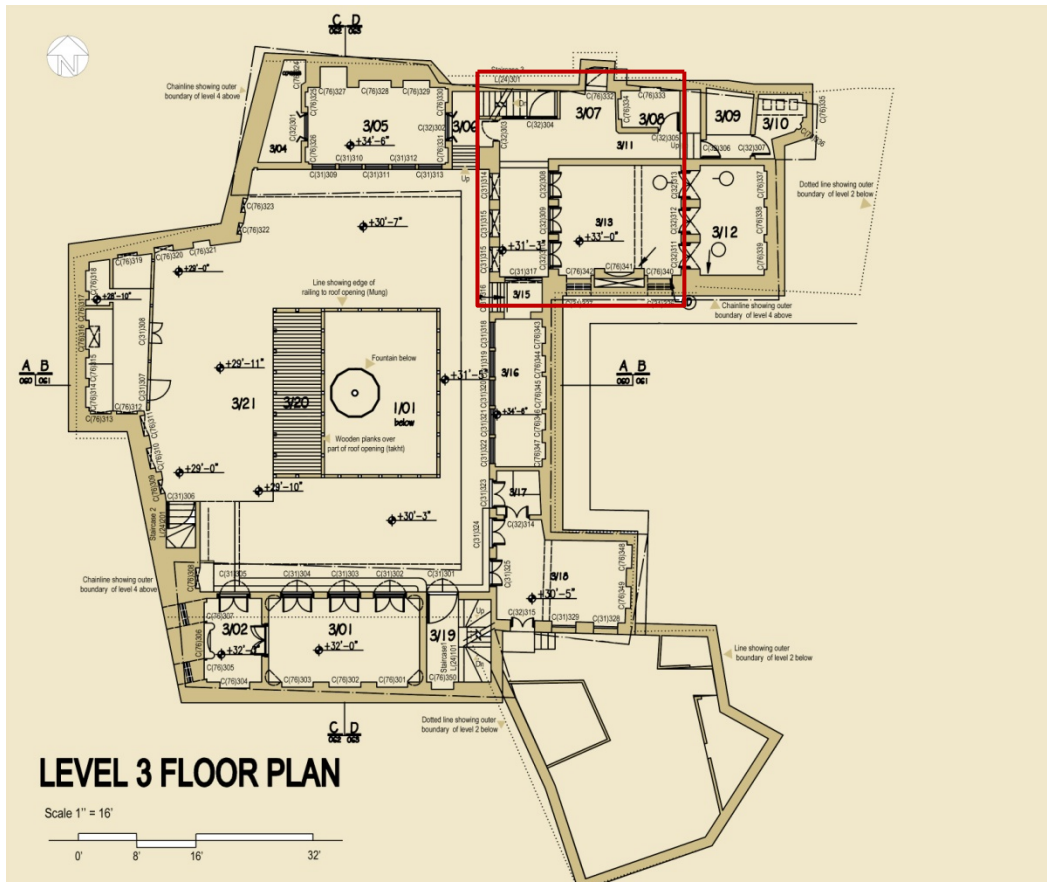
10.2 LEVEL 3

Rope Loop Placement before dismantling of Non-Historic Portion

1. In view of the dangerous and precarious mid and non-historic section of the Sethi house, structural consultant, Engr. Amin Tariq has advised that the structure in danger must be tied together with "rope loop placement" before demolition.
2. The rope is to be 3 strands of stainless steel post tension wire, 8mm in thickness roped together
3. The wall is to be divided into 3' high centres, which will result in 4 loops along level 3
4. U Clamps and Buckle Clamps must be used to tighten the loops.
5. Work must be undertaken before dismantling of non-historic portion

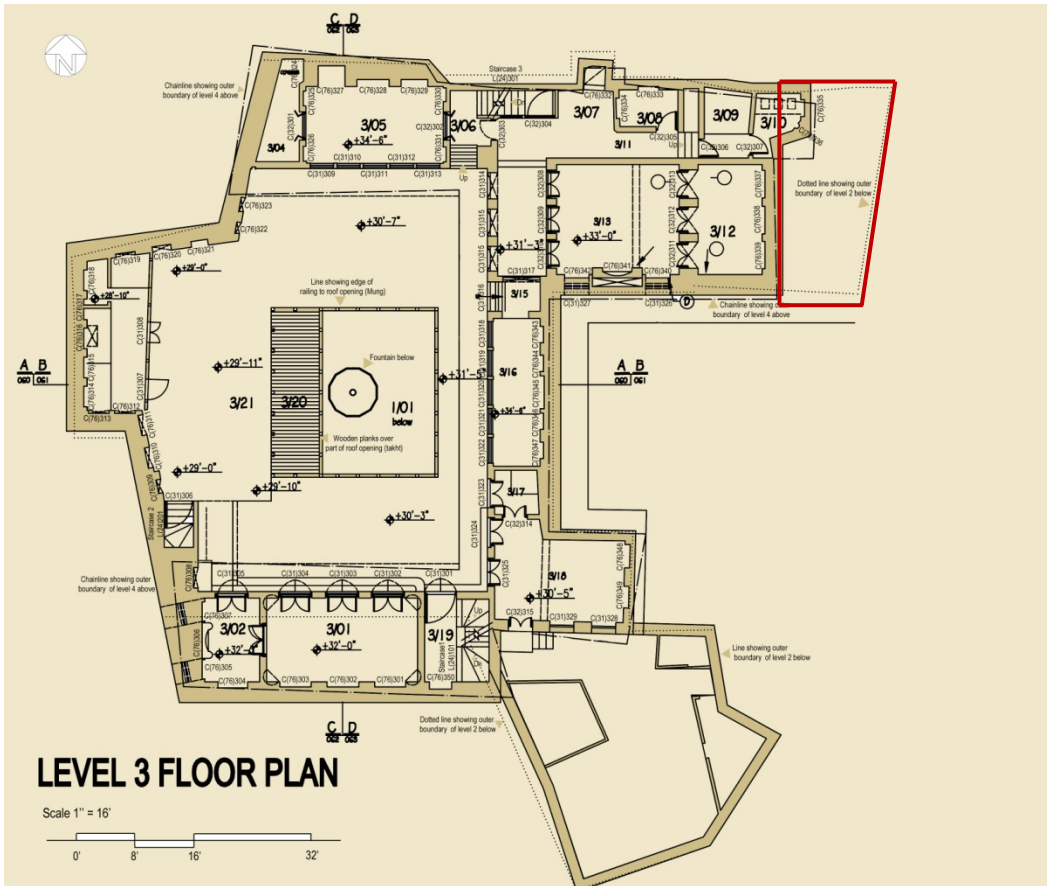
10.2 LEVEL 3

Title of Works:
Demolition of Non-Historic portion

- Conduct demarcation and thorough inspection of the area to be demolished
- Check the structure for likely hazards are cut off or diverted, such as electric power lines or cables, gas reticulation and unsafe structural members
- Provisions like warning signs shall be installed clearly for the safety for pedestrian and vehicle movement.
- Check the relationship and the condition of adjoining structures and buildings and work out to minimize the disturbance to surroundings during demolition work
- Prepare a method statement which shall detail all aspects of proposed dismantling and demolition work. It must describe the extent of work, the type of equipment to be used and the proposed method of removing each part of structure e.g. roof, walls, floors

- All temporary works and protective structures should be erected by contractor before demolition begins
- Where there is a danger of material falling on the workers or public below, the entire face of the scaffold must be covered with small mesh netting.
- Where a structure's stability may be affected by the dismantling temporary bracing, and guys, are to be provided to restrain the remaining members.
- Maintain safety precautions as required for the protection of persons and property on or adjacent to the site
- The use of excavators, vibrating rollers or any disturbing/vibratory equipment is strictly prohibited in historically valued building vicinities.

- Dismantling of roof materials like brick and mud; Woodwork dismantling and preservation for future use; Dismantling of Brick Masonry Walls
- Once dismantling and demolition work has started, the same is to be continued till the completion, promptly and expeditiously.
- Support is to be provided for members of framed structures before cutting them.
- Conduct operations in a manner that minimizes the spread of flying particles and dust.
- Remove any additional small "out" or miscellaneous structures that have not been indicated in the documents unless otherwise instructed by the Client.

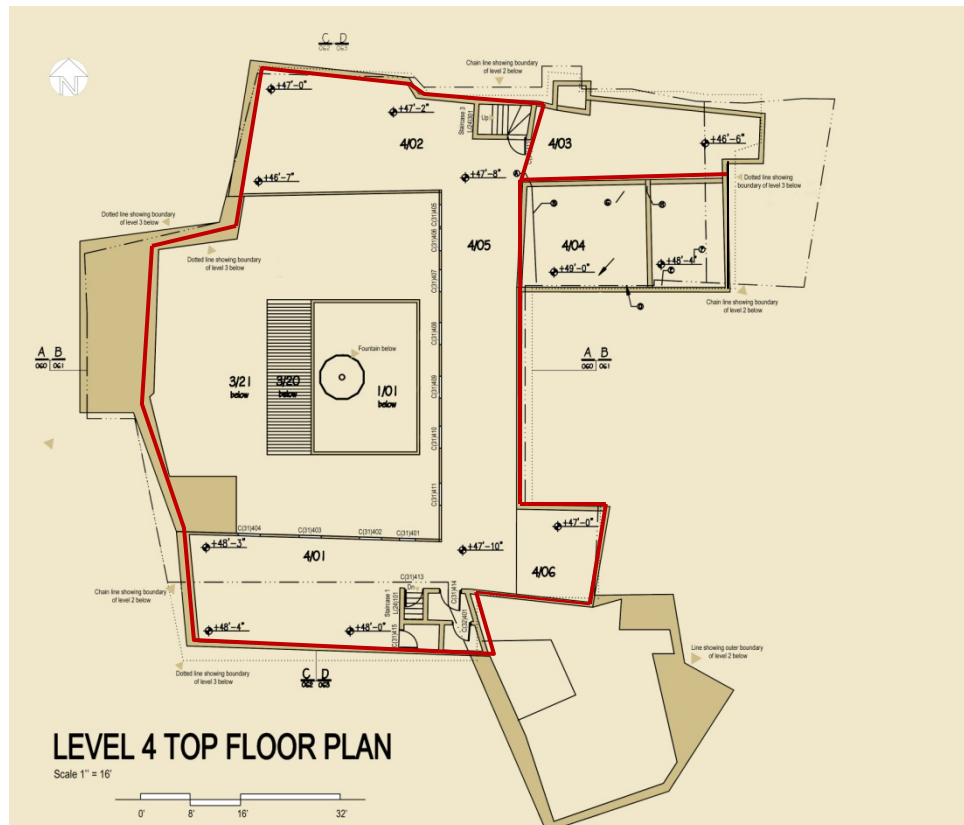
2.2 LEVEL 4

1. Reasons for Opening Roof
 - Waterproofing: Damaged waterproofing affecting structure. Treatment to structure cannot be possible unless the roof is opened and assessment of damage made.

- Structural Overloading: Layers of earth filling have been placed over time, reaching up to three feet in some areas. This is causing unnecessary load on the structure, as well as allowing water to seep through.

- Damage to structural Timber: Upon removal of layers of earth fill, the condition of the wooden joists was observed as being highly damaged. Rainwater retention and the absorption of moisture in the earth fill has caused the structural timber to be highly damaged.

2. Structural Advise: Upon discussions with the structural expert, Engr. Amin Tariq, it has been advised that the earth filling must be removed to relieve structural overloading, hence extending the life of the structure.

3. Timber Rafters: It has been concluded that as much as possible the timber structure must be maintained, treating them in situ. Damaged rafters will be dealt with depending upon their degree of decay:

- 80% Damage: Rafters must be replaced with new Deodar, treated with anti termite
 - 50% Damage: Rafters must not be removed or replaced, except the decayed or damaged section. This segment must be strengthened by attaching new timber (deodar) pieces. The additions must be jointed with a special Wooden joint known as 'Qalam'

- 30% or less: All those found in reasonable condition must be cleaned and left in position

All rafters must be treated with anti termite 'Biflex' of German origin.
4. Date Palm Matting: Remains of date palm matting must be removed as it is in a highly damaged condition and is fulfilling none of its intended use

5. Khajji Planks: Planks found between rafters must be removed and replaced with deodar wood planks, treated with anti termite.
6. Anti-Termite: All structural woodwork must be treated with 2-3 coats of anti-termite, BILFEX, of German origin.

7. Bitumen: In order to avoid a fire hazard, the process of cold application of bitumen must be undertaken. The rate of application must be 7 lbs/ft² on all timber planks

8. Polyethylene layer: for protection against rain, a layer of polyethylene minimum of 5mm must be placed. The sheet must be larger than the area of the room it is being placed in so that it can be turned.

9. Insulation: A minimum 8mm layer of Jumbolon must be placed on the entire surface for protection against water and moisture.
10. The entire surface must be covered with a 2" minimum layer of lime-kankar mix. This must be laid in order to provide slop according to the rainwater disposal plan

11. Water-proofing layer of bitumen and polyethylene sheet to be taken up to parapet walls in order to form a fillet hence providing

protection to the joint of parapet and roof.

12. Brick and Mortar: The entire surface must be laid with 6"x12"x2" and 8"x4"x2" bricks. It is essential that the original bricks removed from original roof. These must be laid with 1:3 mortar, where 1 part is lime water also known as Kalie and 3 parts is file lime. The bricks must be used on a 1" thick base. A final layer of grouting must be applied with a white lime-fine lime 1:1 mix.

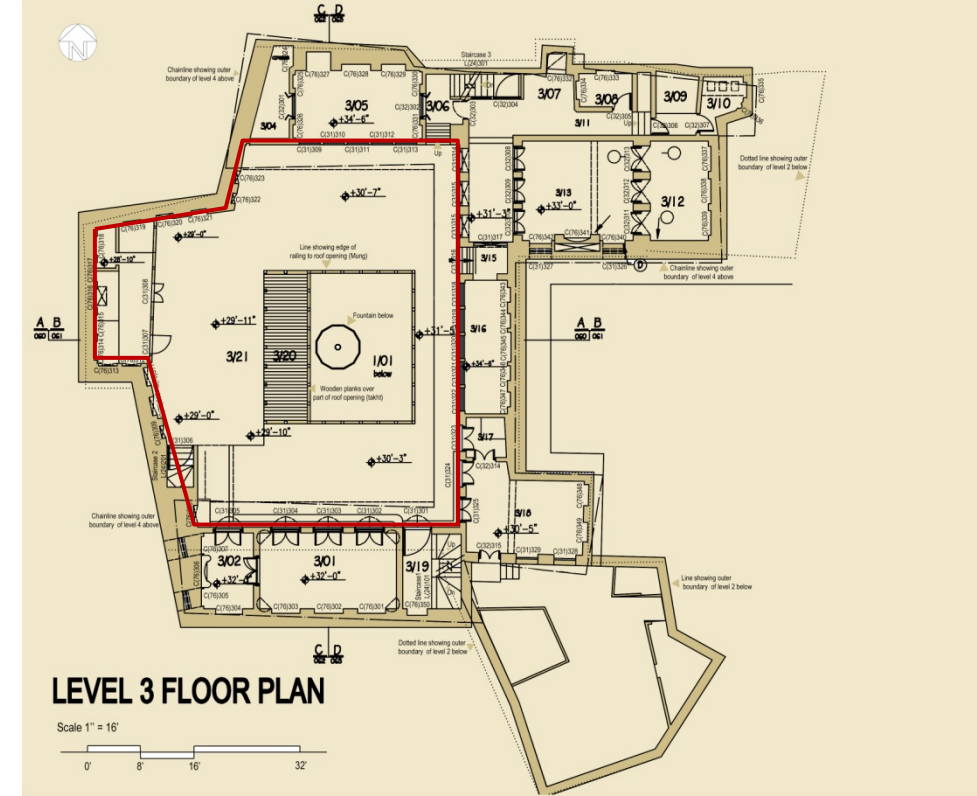
10.2 LEVEL 3

1. Reasons for Opening Roof
 - Waterproofing: Damaged waterproofing affecting structure. Treatment to structure cannot be possible unless the roof is opened and assessment of damage made.

- Structural Overloading: Layers of earth filling have been placed over time, reaching up to three feet in some areas. This is causing unnecessary load on the structure, as well as allowing water to seep through.

- Damage to structural Timber: Upon removal of layers of earth fill, the condition of the wooden joists was observed as being highly damaged. Rainwater retention and the absorption of moisture in the earth fill has caused the structural timber to be highly damaged.

2. Structural Advise: Upon discussions with the structural expert, Engr. Amin Tariq, it has been advised that the earth filling must be removed to relieve structural overloading, hence extending the life of the structure.

3. Timber Rafters: It has been concluded that as much as possible the timber structure must be maintained, treating them in situ. Damaged rafters will be dealt with depending upon their degree of decay:

- 80% Damage: Rafters must be replaced with new Deodar, treated with anti termite
 - 50% Damage: Rafters must not be removed or replaced, except the decayed or damaged section. This segment must be strengthened by attaching new timber (deodar) pieces. The additions must be jointed with a special Wooden joint known as 'Qalam'

- 30% or less: All those found in reasonable condition must be cleaned and left in position

All rafters must be treated with anti termite 'Biflex' of German origin.
4. Date Palm Matting: Remains of date palm matting must be removed as it is in a highly damaged condition and is fulfilling none of its intended use

5. Bricks used to fill gaps between rafters, while deodar wood planks to be used in areas which are worse off and along the walls
6. Anti-Termite: All structural woodwork must be treated with 2-3 coats of anti-termite, BILFEX, of German origin.

7. Bitumen: In order to avoid a fire hazard, the process of cold application of bitumen must be undertaken. The rate of application must be 7 lbs/ft² on all timber planks

8. Polyethylene layer: for protection against rain, a layer of polyethylene minimum of 5mm must be placed. The sheet must be larger than the area of the room it is being placed in so that it can be turned.

9. Insulation: A minimum 8mm layer of Jumbolon must be placed on the entire surface for protection against water and moisture.
10. The entire surface must be covered with a 2" minimum layer of lime-kankar mix. This must be laid in order to provide slop according to the rainwater disposal plan

11. Water-proofing layer of bitumen and polyethylene sheet to be taken up to parapet walls in order to form a fillet hence providing protection to the joint of parapet and roof.

12. Brick and Mortar: The entire surface must be laid with 6"x12"x2" and 8"x4"x2" bricks. It is essential that the original bricks removed from original roof. These must be laid with 1:3 mortar, where 1 part is lime water also known as Kalie and 3 parts is file lime. The bricks must be used on a 1" thick base. A final layer of grouting must be applied with a white lime-fine lime1:1 mix.

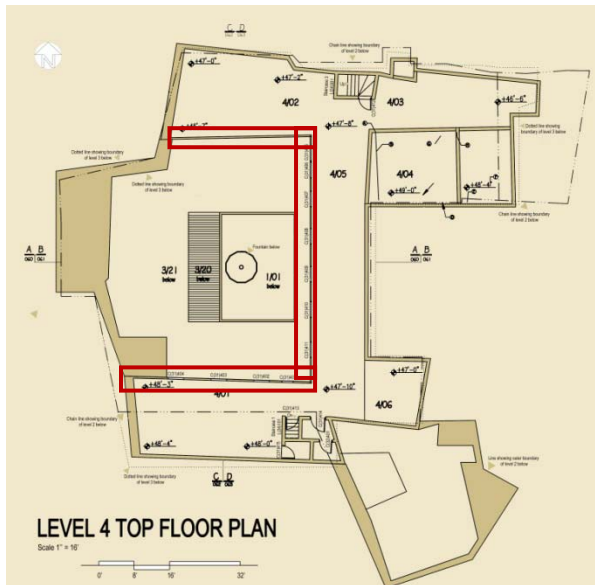
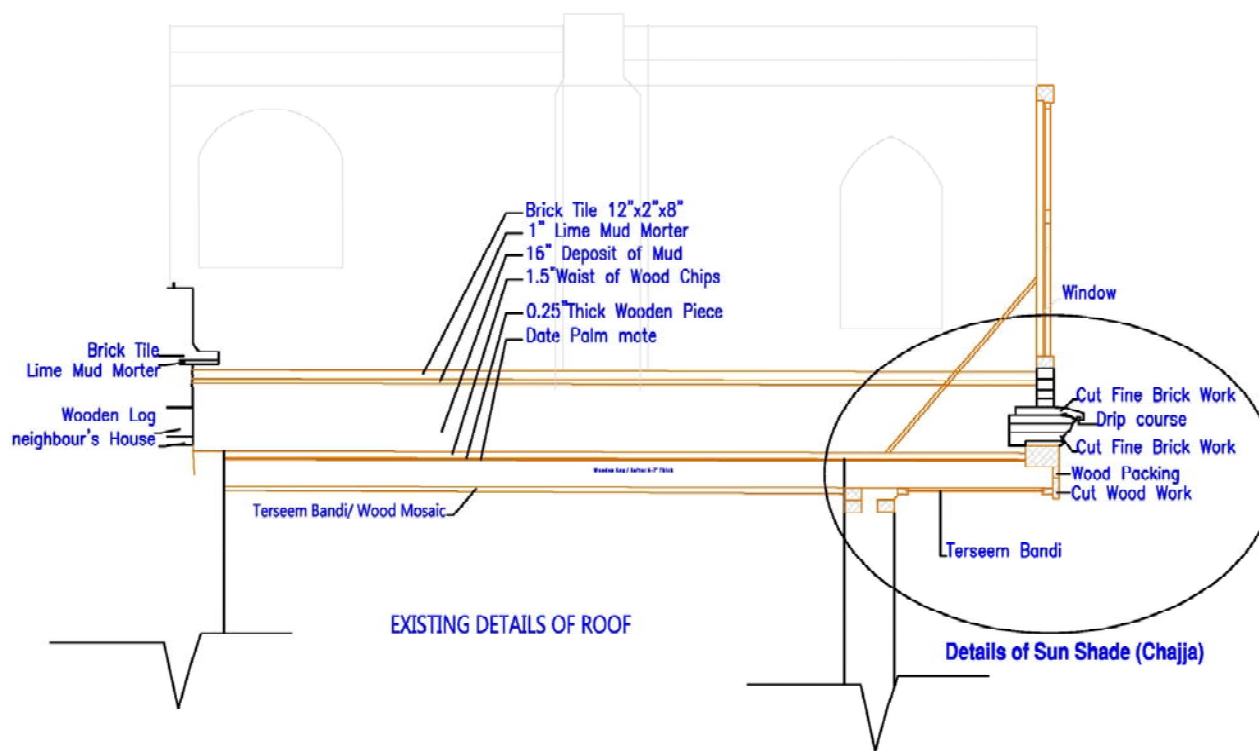
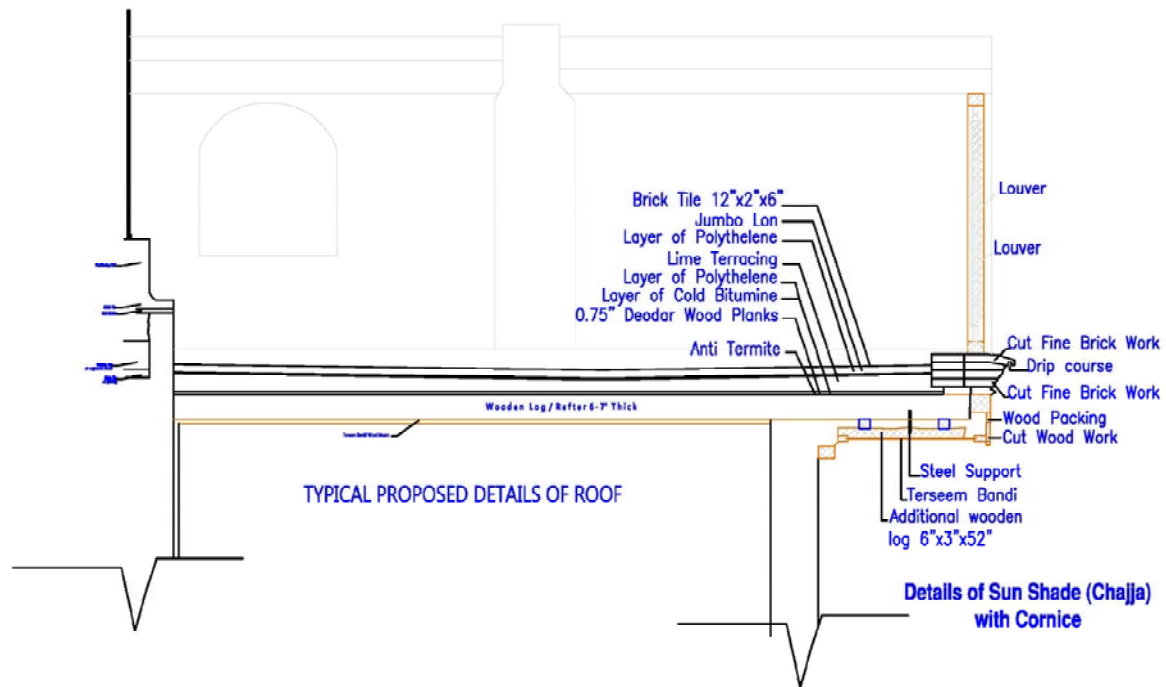
10.2 LEVEL 3

1. Upon the beginning of the work of fixing the highly damaged wooden frames began, the cornice which was also in a damaged condition collapsed along with the wooden Purdah Wall. Due to this collapse both the cornice and the purdah wall had to be reconstructed to not only rectify the above mention problem but also to stabilize the cornice an wood work.
2. The damaged woodwork and also been filled in with brick which required removal.
3. It is imperative that existing bricks found in the cornice be reused to reconstruct it according to sample and design of the original as shown in drawings. At the advent of lack of old brick, new brick may be used but it must be shaped according to the original.

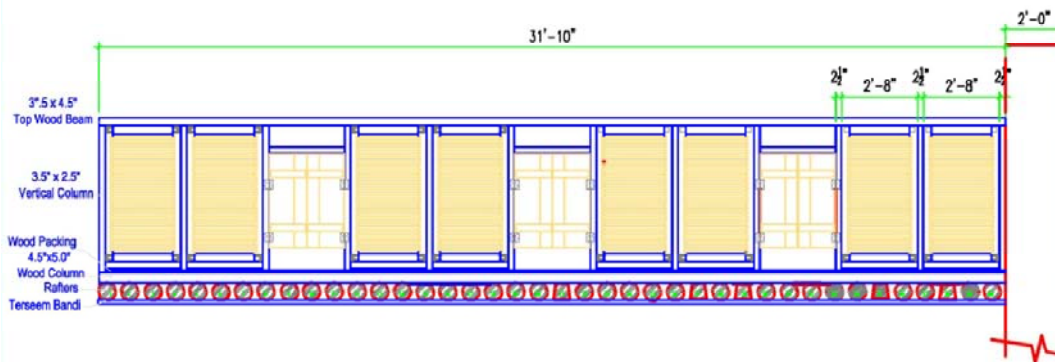
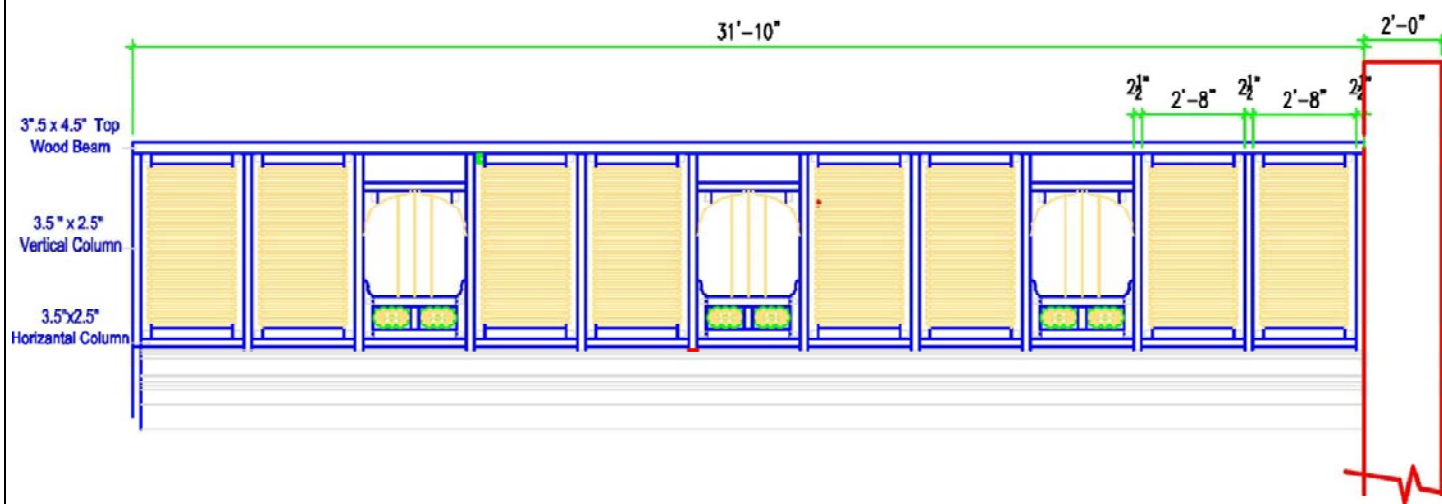
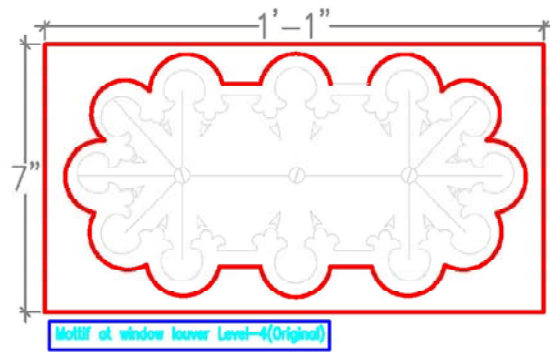
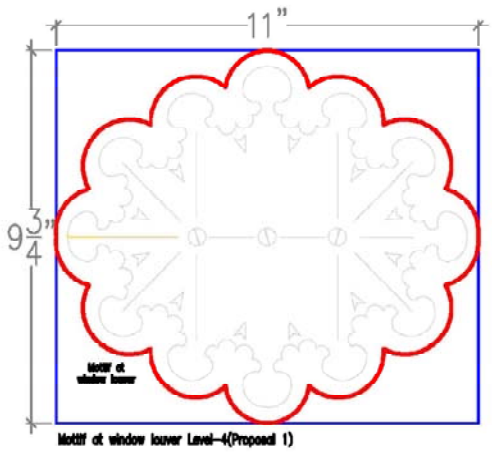
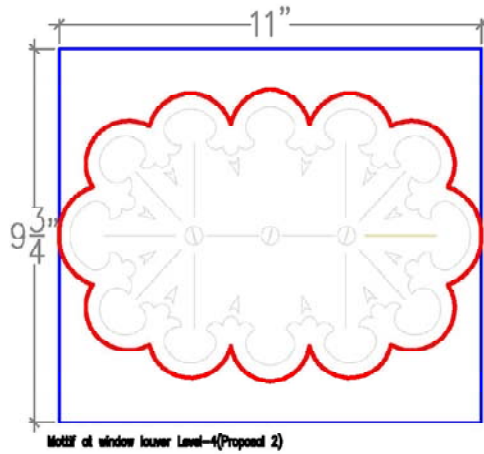
10.2 LEVEL 3

1. Due to excessive damage over the past years the wooden purdah wall along the level 4 roof required stabilization. Upon repair, due to the damaged cornice the entire wooden structure collapsed. Hence entire purdah wall required reconstruction

2. Damaged wood to be reused after planing and fixed according to the original design. It must be secured to avoid further mishap.
3. Although damaged shutter were found in some of the openings but no evidence indicated the treatment of other panels.

4. For filling of the other panels, a survey was conducted of architectural language of surrounding buildings. Eventually a design was decided upon based on a louvered ventilator found inside the Sethi House itself.

5. Sample of exact profile of proposed panels must be prepared. These louvered panels must be placed according to the drawing prepared for this purpose.

6. No treatment to the wood shall be made until decision has been taken
7. Ensure that the entire structure has been fixed so that the wooden purdah wall will not destabilize again.

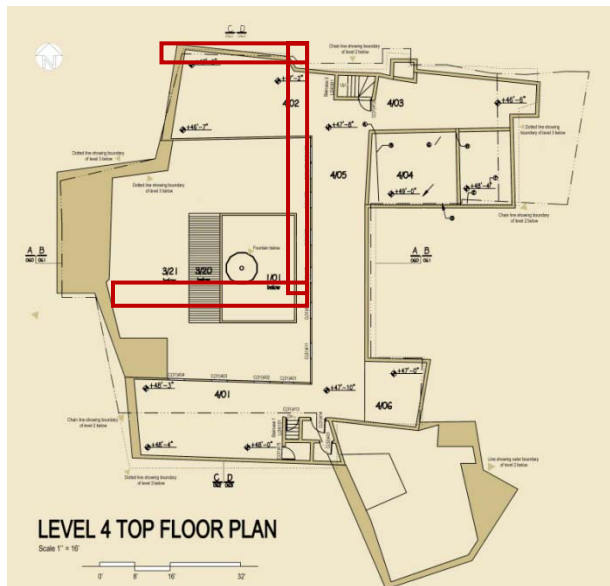
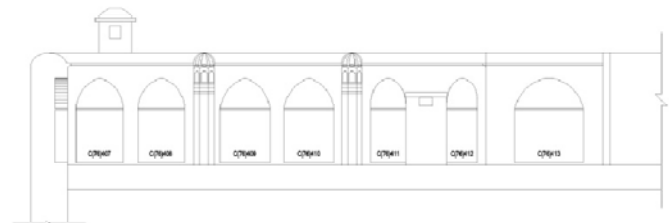
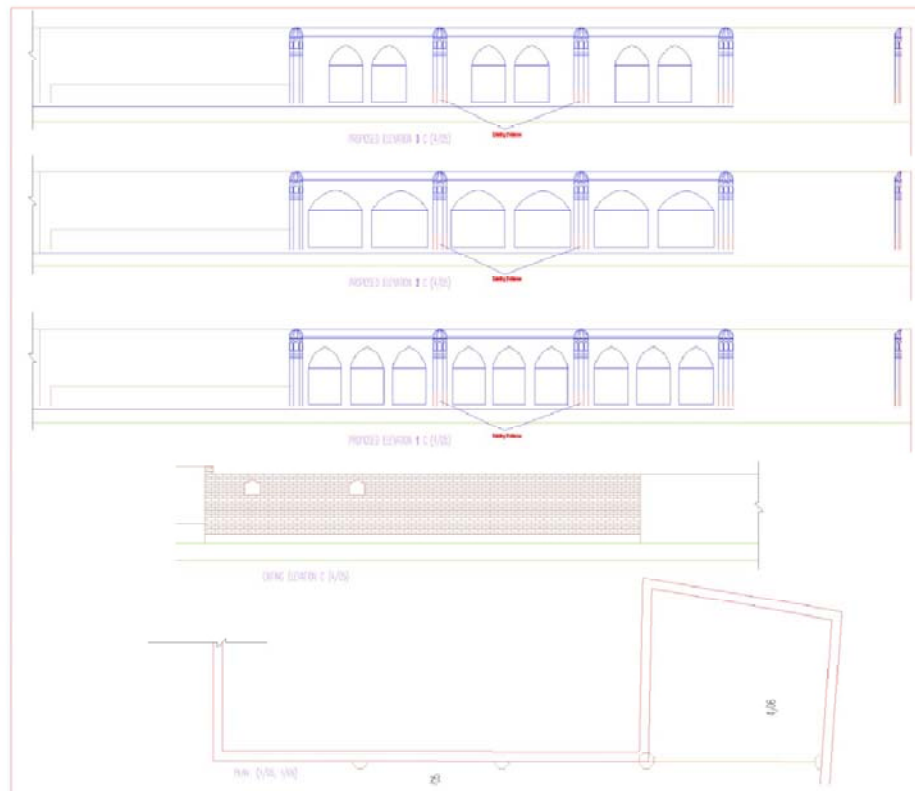
ELEVATION A (4/02)

1. North Purdah wall found to be in original conditions where as remaining masonry purdah walls have suffered alteration.
 - 4/06: New Wall, no decorative features, uneven masonry
 - 4/05: New Wall, roots of tree piercing through, cracks and titling
 - 4/01: Wall partitioning Nisar Sethi's house is a new construction constructed of G.I sheet with steel framing.
 - 4/02: Only remaining evidence of Original Purdah wall
2. New additions to be removed and replaced with new construction based on evidence of original purdah wall along North 4/02
3. Design elements using North Purdah Wall spacing and attached pilasters
4. 8" wall to be constructed. Reuse Bricks from other areas to minimize the use of new bricks
5. Bases and crowns of new pilasters to mock original
6. Use white lime-lime powder (1:3) mix for mortar.

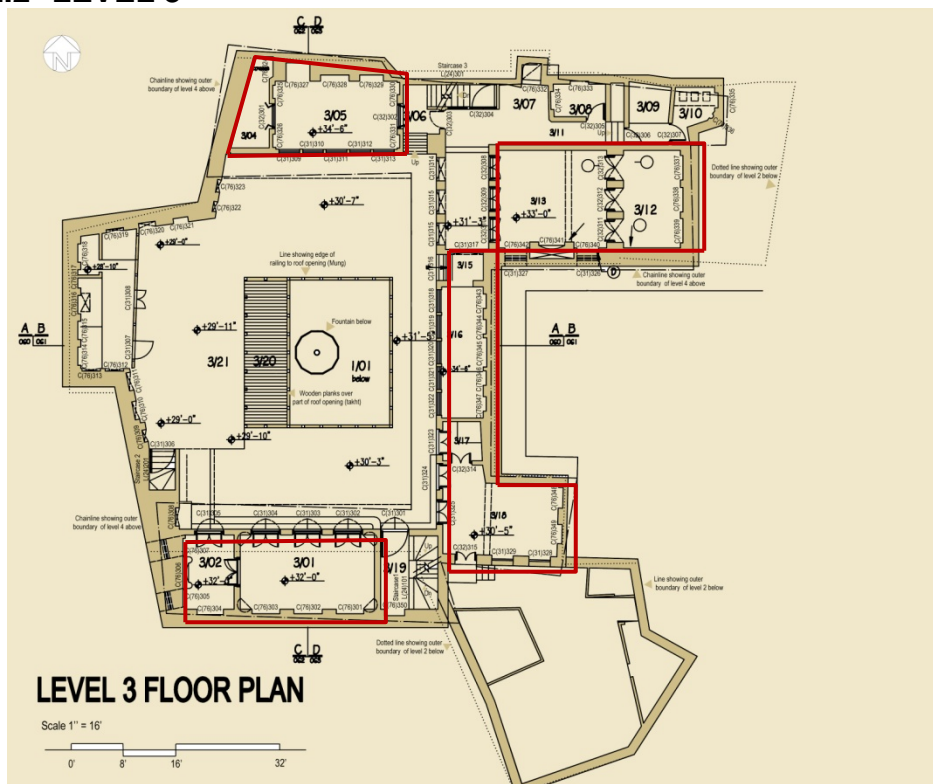
2.2 LEVEL 3

- Reasons for Dismantling Flooring
 - Flooring was uneven
 - Investigation carried out showed that brickwork on floor employed new bricks. Originally lime terracing was used.

- Due to fears that flooring may be in a similar condition as roof level 4 where the timber structure was badly damaged. Further evidence of water retention was visible in the tarseem bandi of roofs on level two rooms.

- Floor level: Investigation led to further understanding of actual floor levels. It was found that the level of timber works such as doors and cupboards was below the existing floor level.

- Removal: All tile flooring and lime terracing to be removed
- Timber: Treat all wooden joists and rafters as in ROOF level 3, 4 to stabilize structure and make serviceable.

- Fill gaps with tiles of timber fillers to even surface
- Anti-Termite: All structural woodwork must be treated with 2-3 coats of anti-termite, BILFEX, of German origin.

- Fill with lime terrace to level of original floor as per investigation
- Do not apply final lime terracing or brick flooring till decision in this regards has been taken

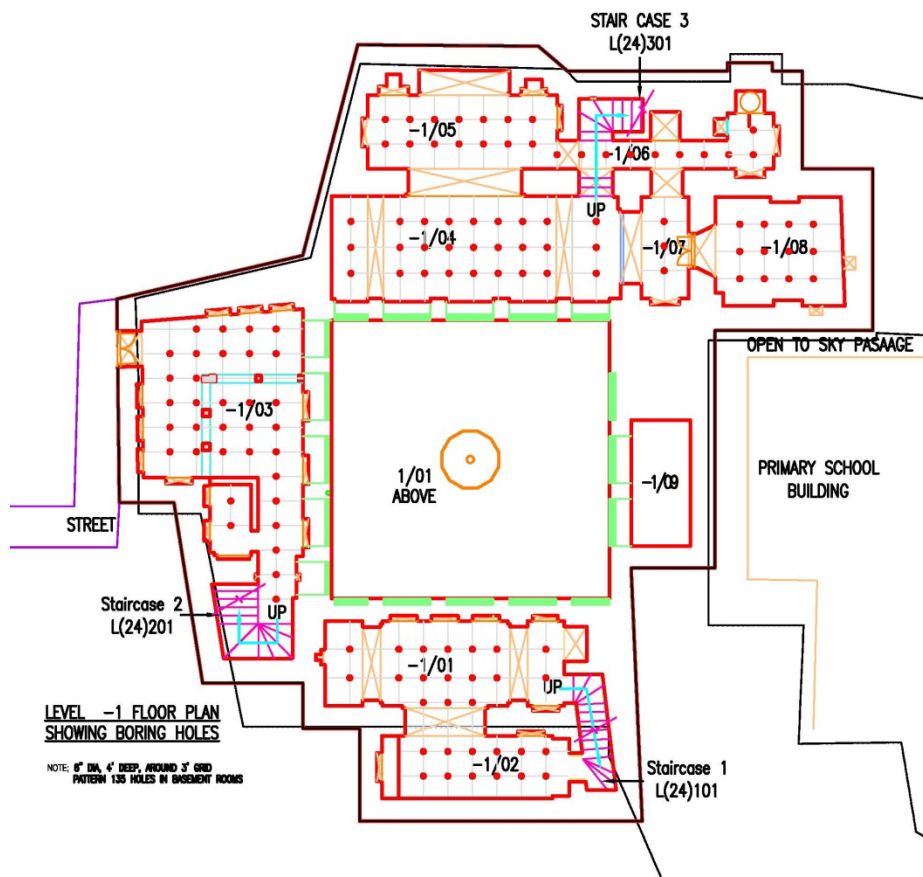
Plan Showing holes that are needed to be made in basement floor

1. Investigation: Geotechnical survey was conducted to investigate the reason for inordinate bulge in basement flooring. Geotechnical Engineer, MR. Ejaz Shahid advised the work that had to be undertaken in order to remove the dampness in the basement causing the damage.
2. Removal: Original brick removed
3. Removal: Earth filling up to 1 foot
4. 6"x6" holes to be dug 4 feet deep into the ground along centres marked on the drawings
5. All holes to be filled with pebbles with 1" – 2" diameter
6. Entire surface to be filled with 6"-7" sand
7. Finish with 3" lime terracing 1" below original floor level as determined on site.

NOTE: Remaining 1" left to be later filled with 1"th brick tile or 1"th lime terracing, depending upon decision.

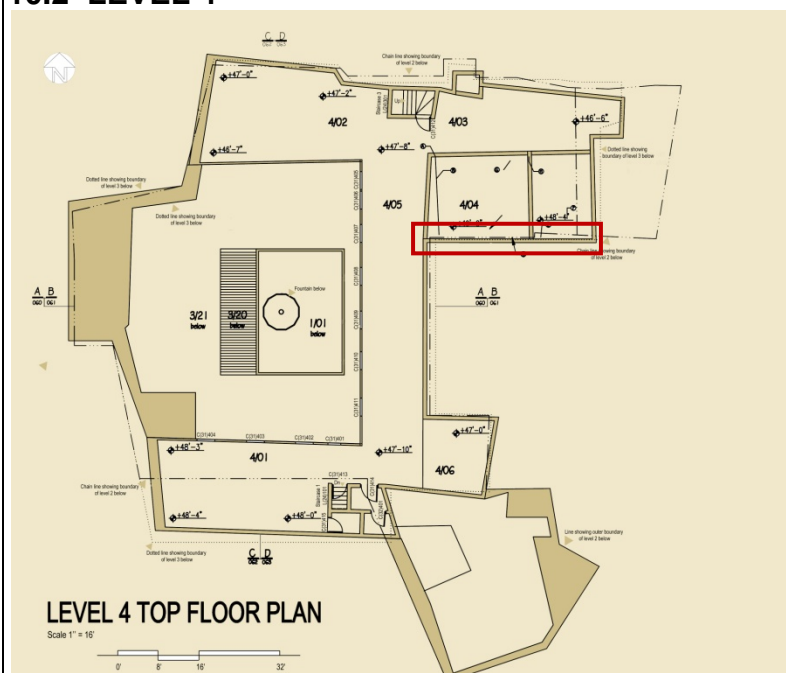
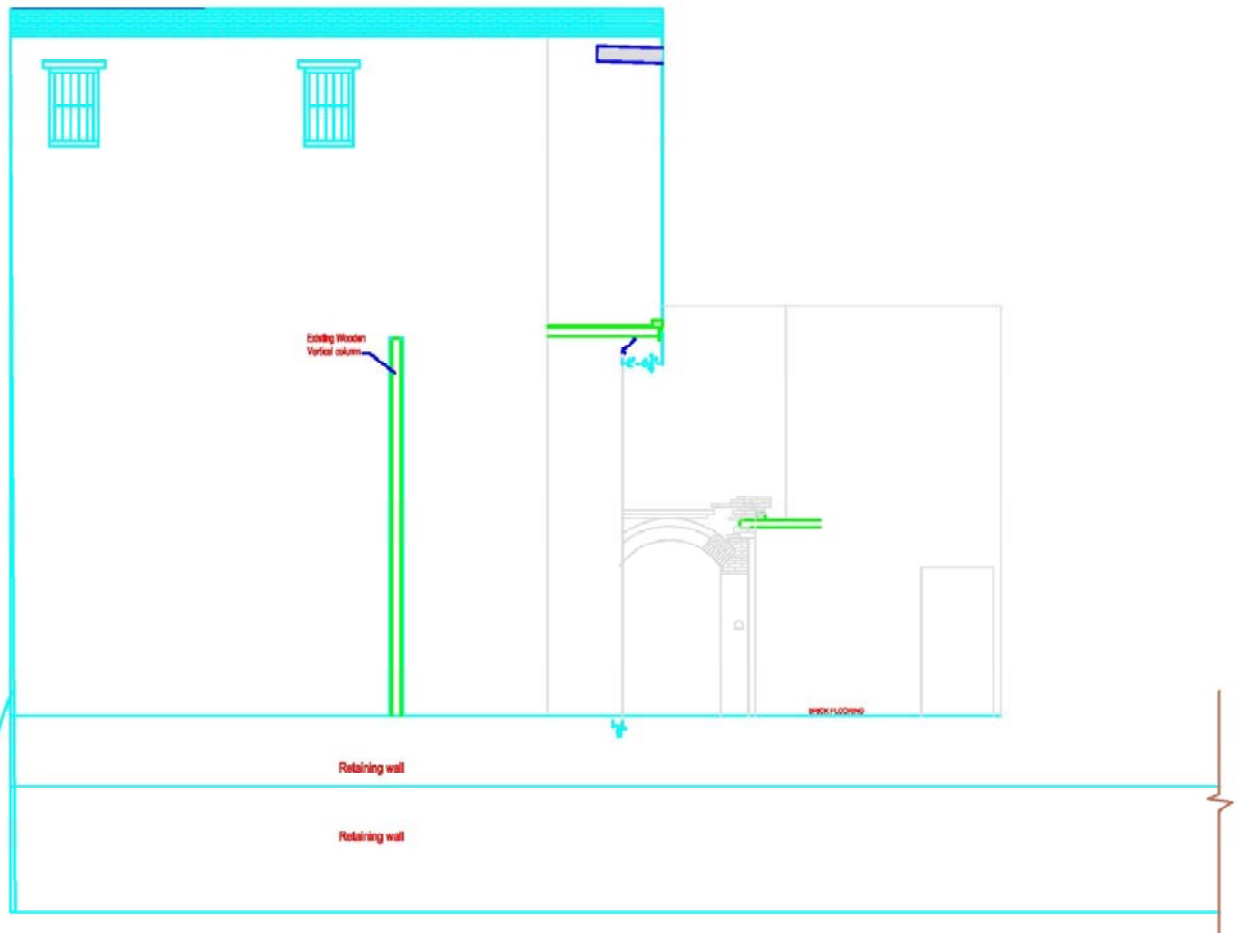
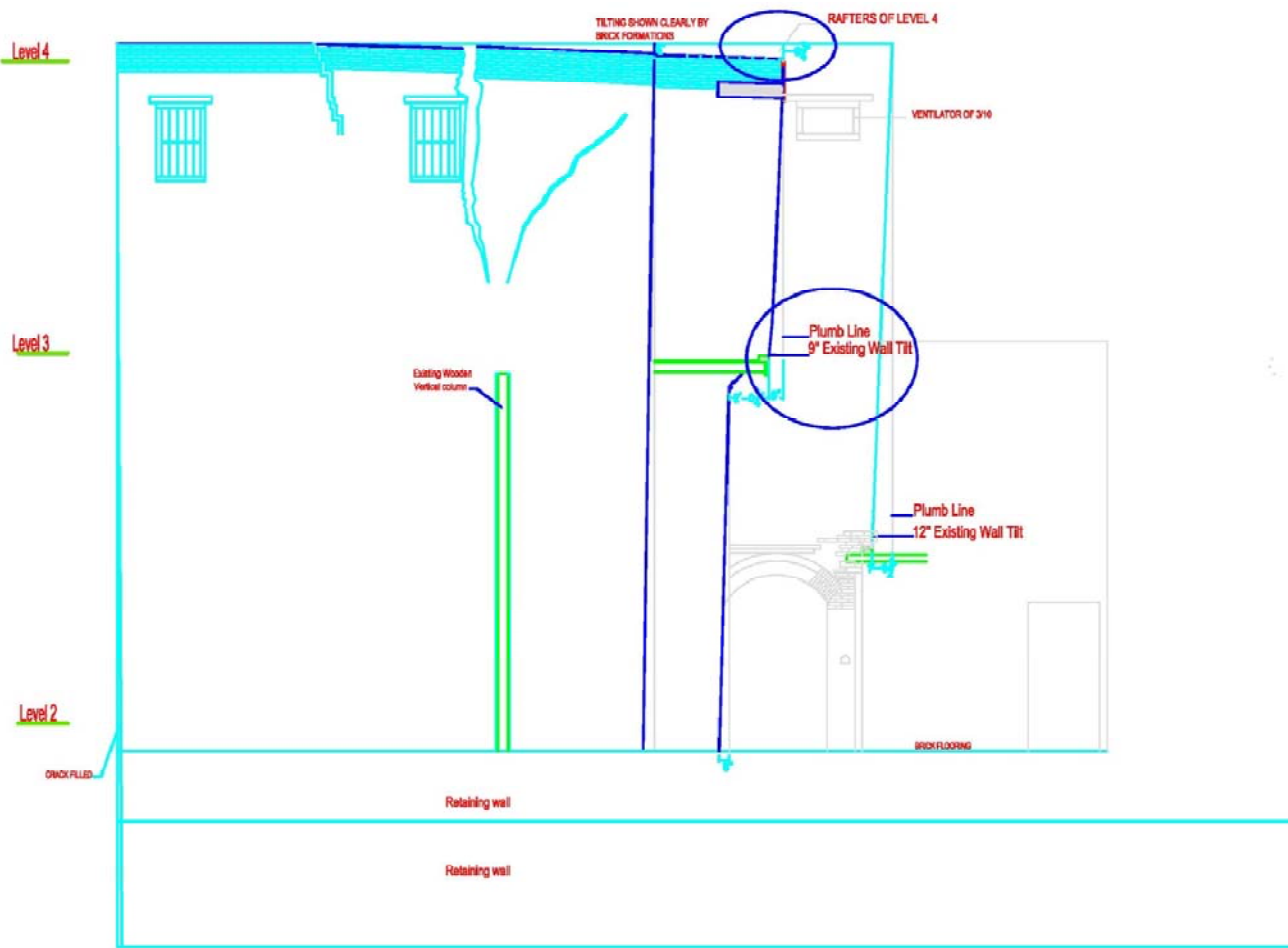
10.2 LEVEL 4

1. Mid historic portion interspaced with cracks. Investigations confirm tilt of wall and emphasis the danger and seriousness of crack along wall that is attached to school. Wall is 32" in width which extends to 34" as it approaches the south east corner
2. Crack to be filled in 2' wide
3. The wall in question is 20" in height, however in view of the examination, it has been found that the deformity is only one brick wide. It has been decided that the only portion where the masonry has been extremely damages must be taken down.
4. The crack should be filled with gypsum-lime water mix
5. The thickness of the fillings must be recorded
6. The actual filling (3"thick and 2" width) must reach the brick work.
7. Additional bricks may be laid to replace the ones removed, but keeping in with the course and bonding as the original. The use of lime Mortar is advised.

NOTE: The bricks that have been taken down must be cleaned and reused.

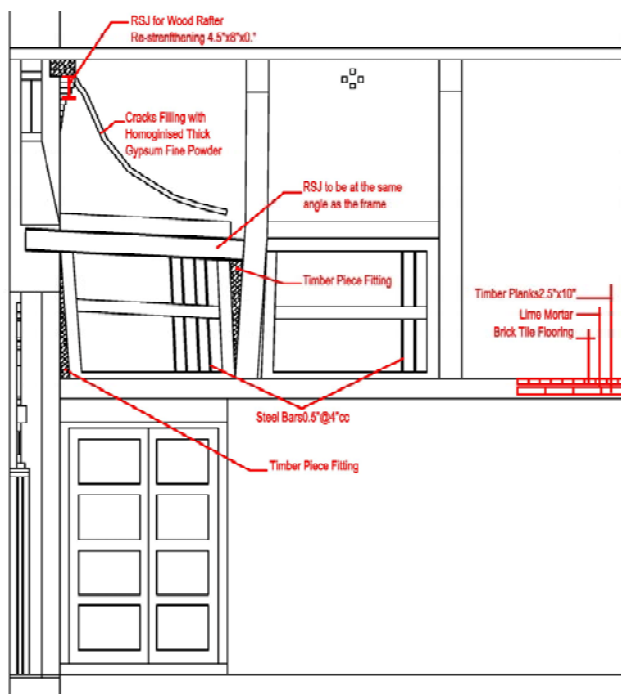
10.2 LEVEL 3

1. Preamble: Fracture on beam has caused a depression in the roof causing a huge hole. As a result, rainwater has been pouring in with no drainage. This has caused extreme damage to the floor as well as the unique tarseem bandi. Since extreme caution was required in order that the structure may not be altered, the roof couldn't be dismantled and work needed to be undertaken with extreme caution.

2. Removal: Existing brick flooring, earth and other filters to be removed hence exposing the location of the fractured wooden ceiling. Checking of other timber element is also required.

3. Scaffolding to be erected to support fragile and dangerous portion. Ceiling supported with special provision of sponge to avoid harming tarseem bandi.

4. RSJ to be placed on top of the fractured beam. Hole to be drilled into wooden beam and bolted to the RSJ. The bolts should be gradually tightened to lift the wooden beam and hence change its position to maintain the required level. Excise extra caution

5. Plates to be placed on the top and bottom and bolted into place
6. Plates to be secured to support fractured portion.

1. Damaged beam to be replaced with new deodar anti-termite treated beam

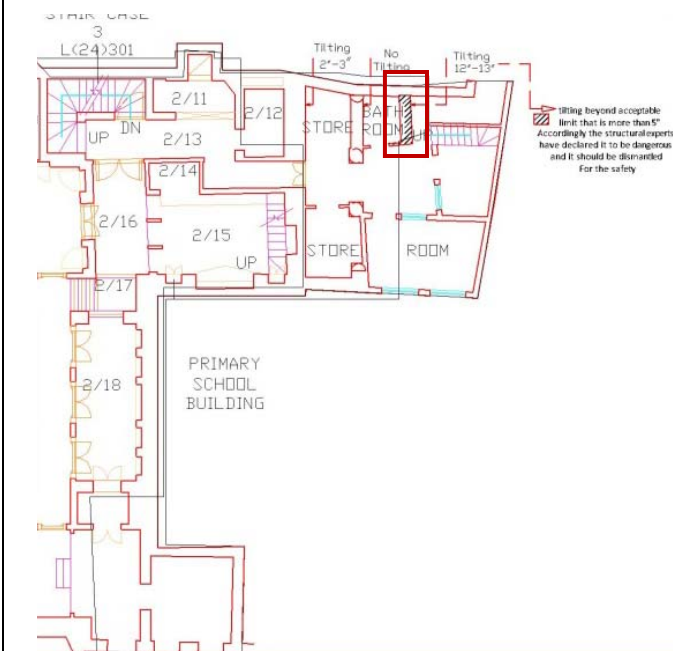
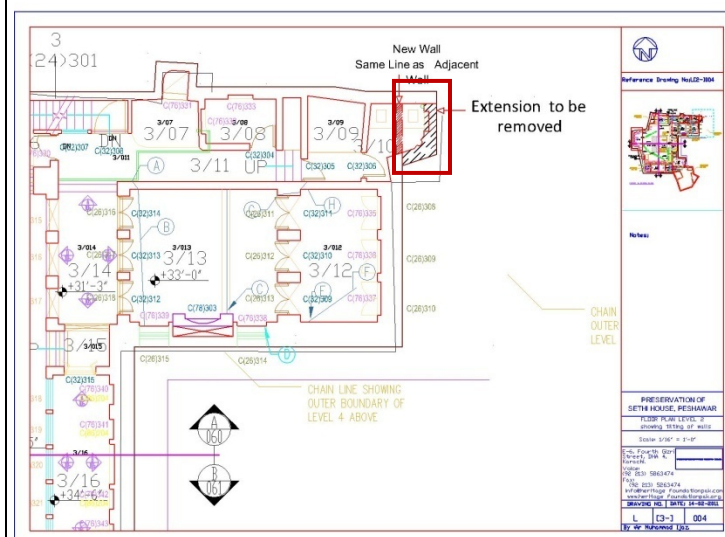
10.2 LEVEL 2

- On checking of the east wall was found to be tilting beyond acceptable limit that is more than 5 inch in fact the tilting is 12inch – 13inch.

Accordingly the structural experts have declared it to be dangerous and it should be dismantled
 For the sake of safety

- It is clear that it is a later period construction for the following reasons
 - There is no bond between the saying room and the other part.
 - It is blocking the arch of the eastern façade. Shown in attached drawings.
 - It is than that the upper portion of the wall was demolished to make place for the new bathroom.

For the above reasons and for the sake of public safety as well as a stabilization of original structure It has been decided to dismantle the wall of the bathroom as shown in attached drawing.
