HERITAGE FOUNDATION'S DRR - COMPLIANT SUSTAINABLE CONSTRUCTION

BUILD BACK SAFER WITH VERNACULAR METHODOLOGIES

Final Narrative Report

22nd June, 2013

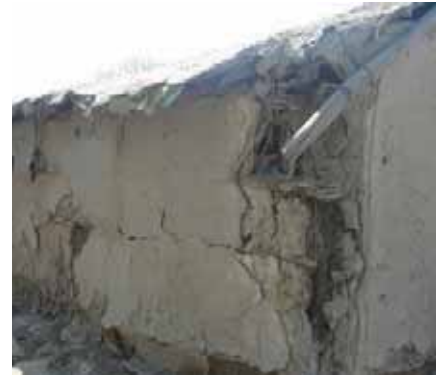
Vernacular construction damaged by standing water.

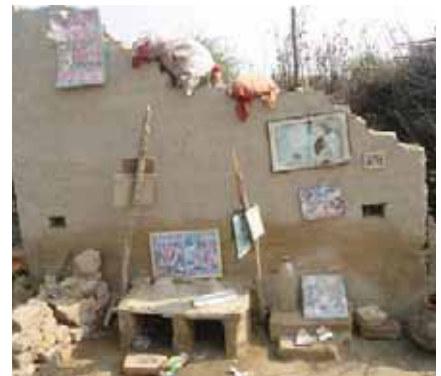
Partially collapsed mud structure selected by Heritage Foundation for rehabilitation.

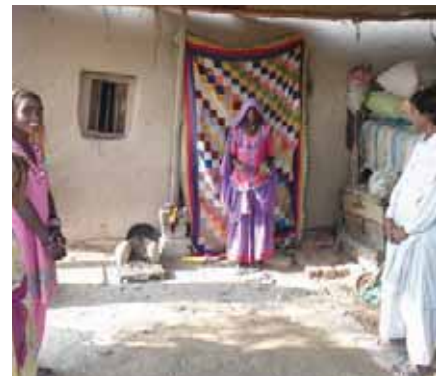
Rehabilitated Demo/Model Unit completed during Stakeholders' Workshop.

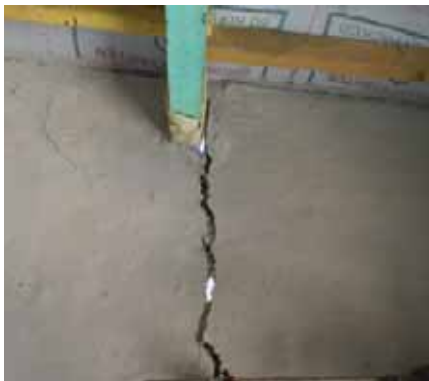
Above. Major crack in the supporting mud wall due to the point load of a steel girder.

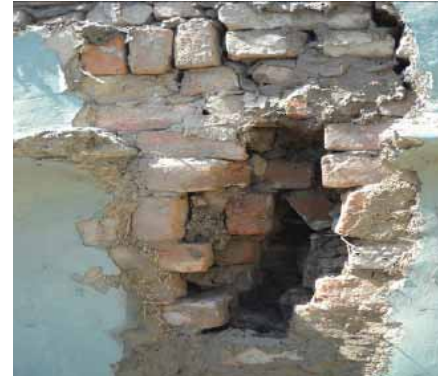
Procedure for rehabilitating a highly damaged wall.

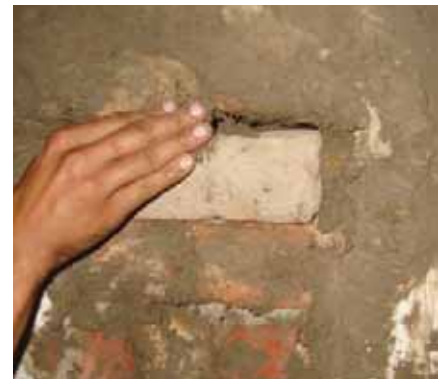
Crack repairing procedure using bamboo lattice being demonstrated.

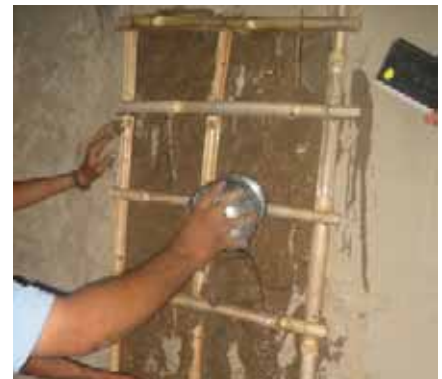
Fixing of bamboo lattice on the damaged area of the wall.

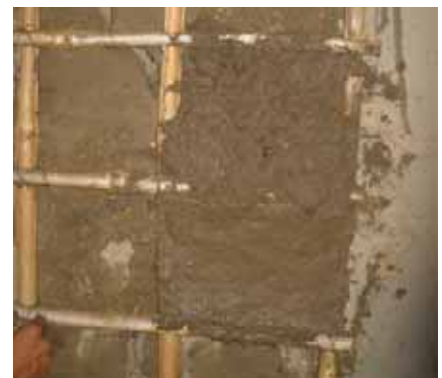
Mud plaster being applied over bamboo lattice, thus saving a damaged wall.

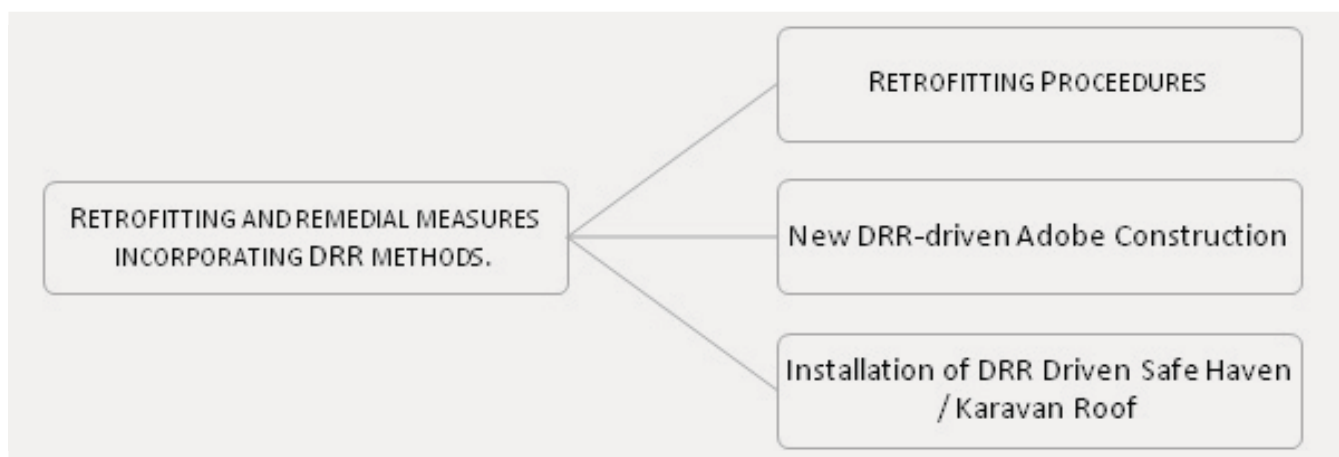
Below. Process of DRR-compliant construction using vernacular methodologies.

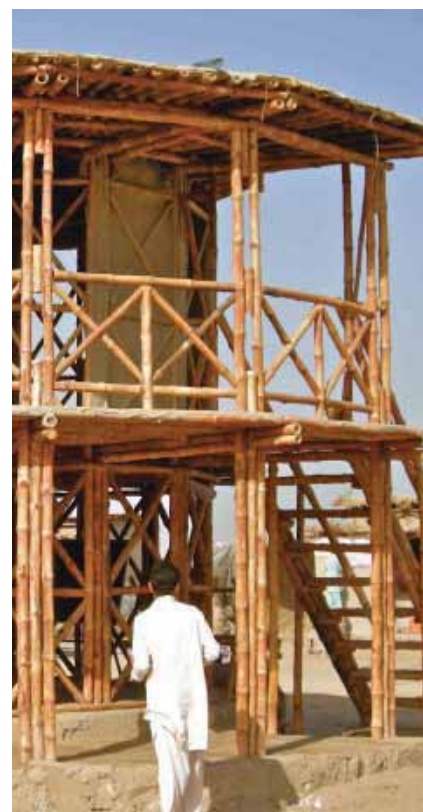
Community building on stilts built by Heritage Foundation in village Darya Khan Shaikh, in katcha area, Khairpur.

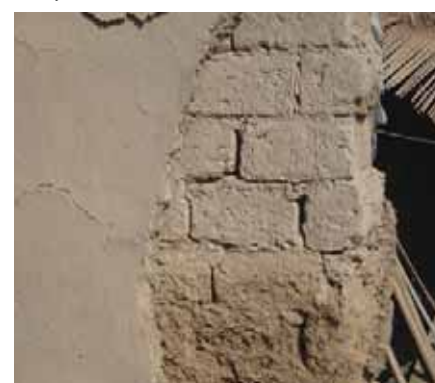
Damaged wall that is structurally stable and can be rehabilitated.

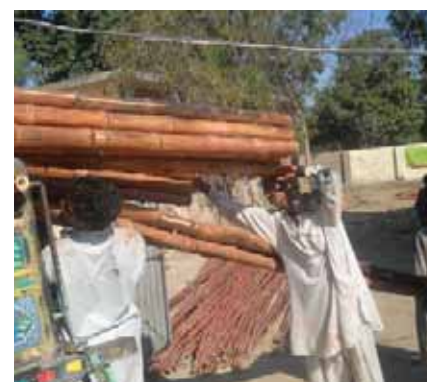
Prefabricated bamboo joists being transported to other locations for use in demo/model units.

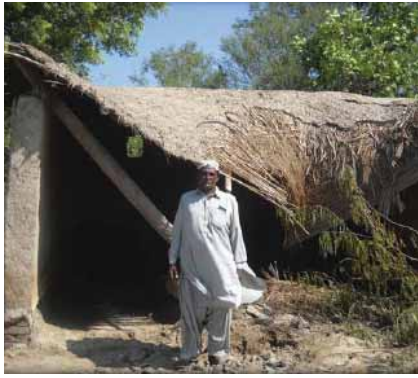
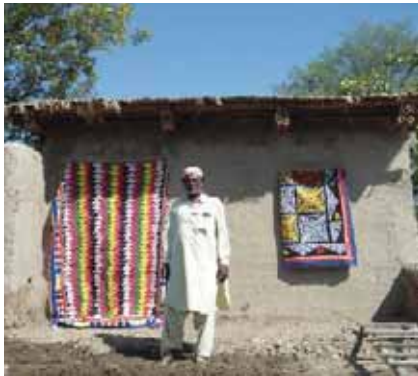
Top. A collapsed structure after floods.
Above. The same house after rehabilitation through DRR-driven interventions by Heritage Foundation.

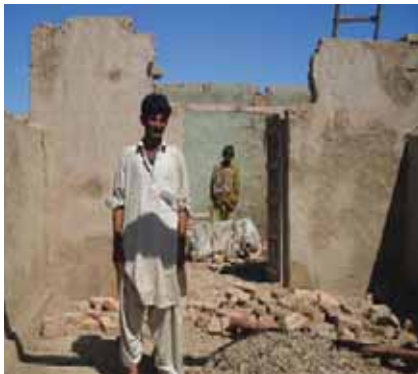
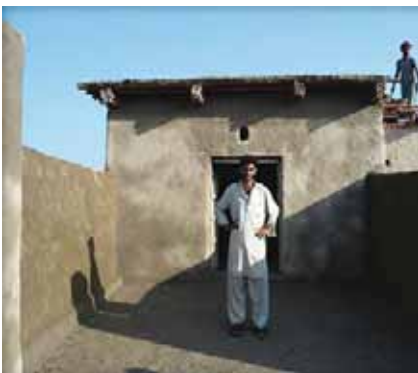
Below. A highly damaged structure.
Bottom. The same house after rehabilitation.

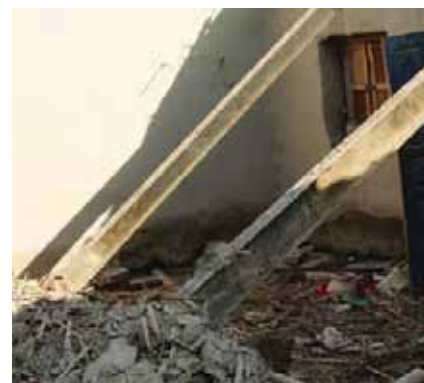
Collapsed wall and roof due to use of heavy steel girders.

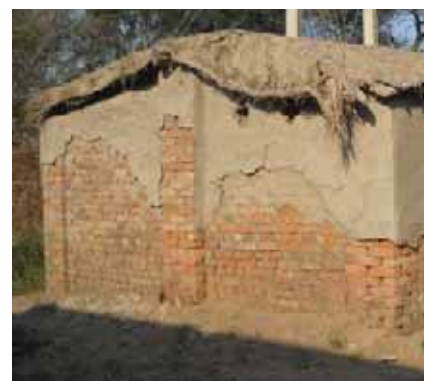
Usual pitched roof construction supported by poorly laid burnt brick walls.

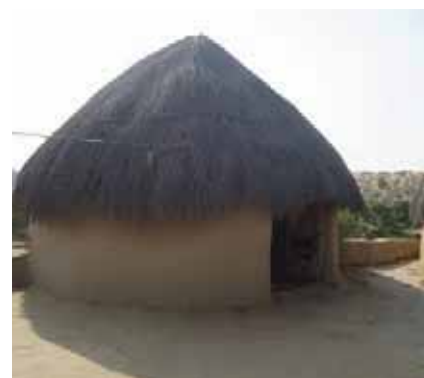
Well finished conical roof construction.

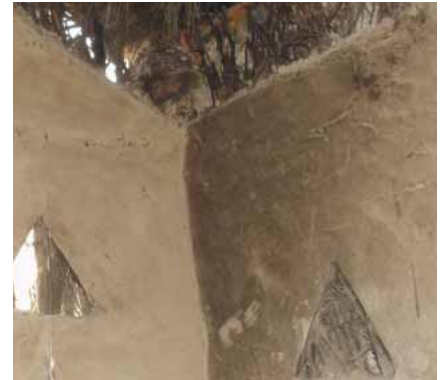
Seepage of water through badly constructed roof making the structure vulnerable.

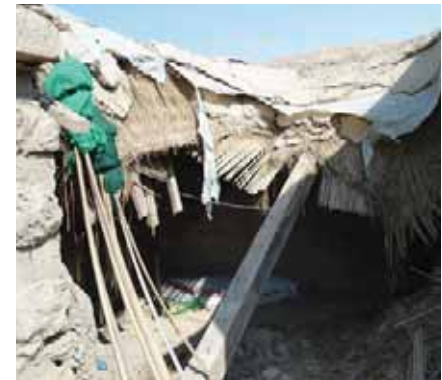
Extra dead weight on a roof causes the collapse of the entire structure.

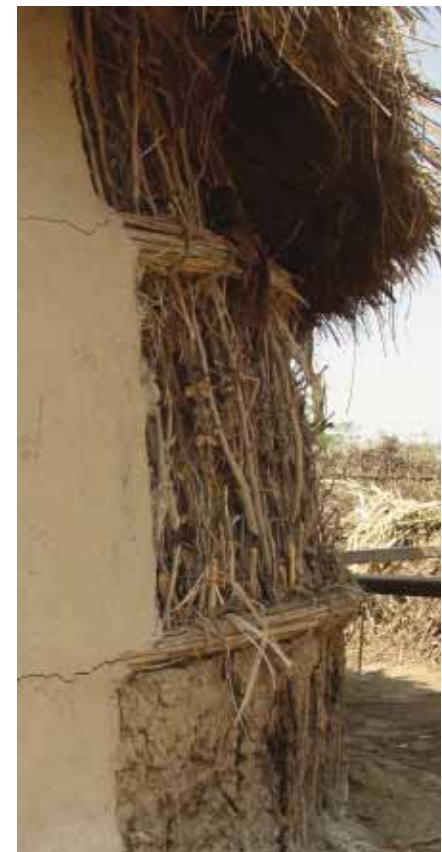
Reed wall construction. Eroded mud plaster render and lack of protection at the base.

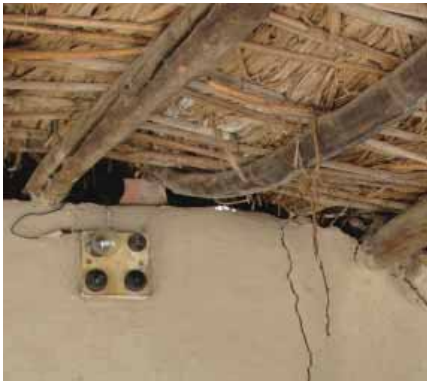
Local soft wood joists prone to termite damage, and unable to carry extra load.

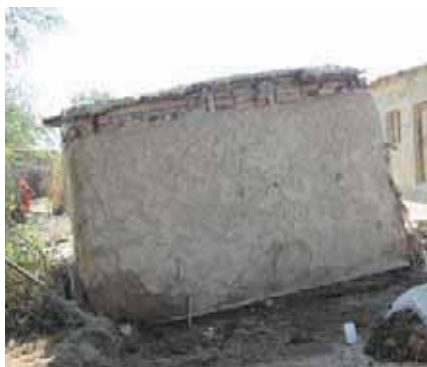
Structure displaced due to a highly damaged base.

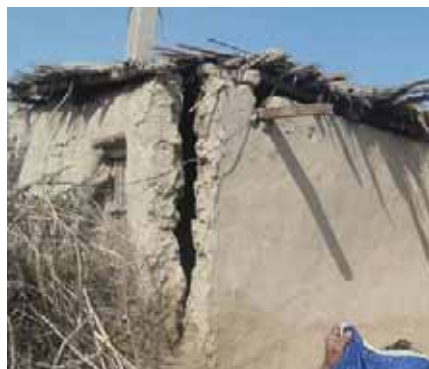
Incorrect construction techniques lead to cracks in walls.

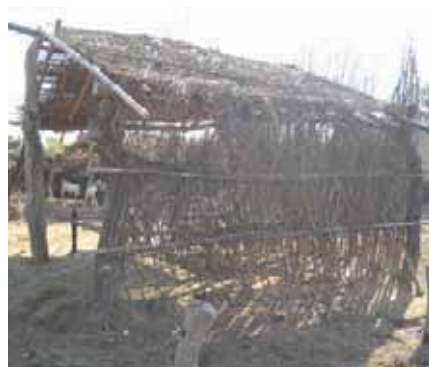
Badly constructed Loh-Khat walls suffer damage

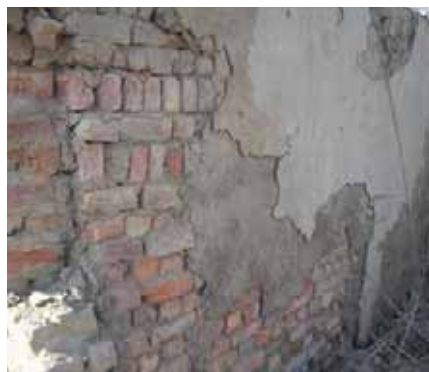
Fired brick walls built without proper bonding or mortar

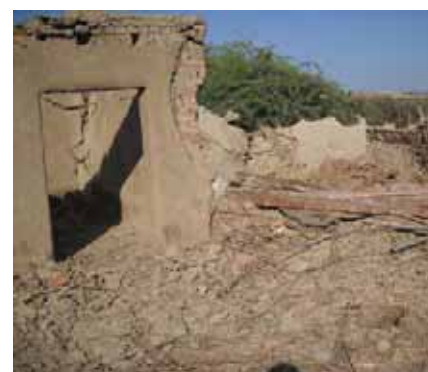
Collapsed roof due to poor construction

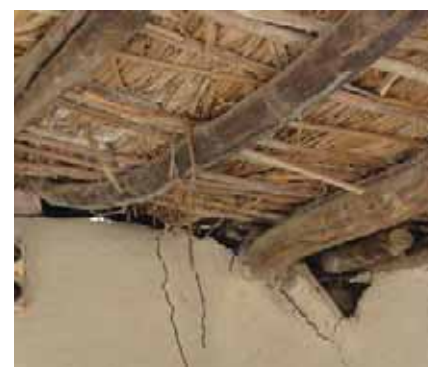
Heavy logs and bamboo used for roof construction damage walls

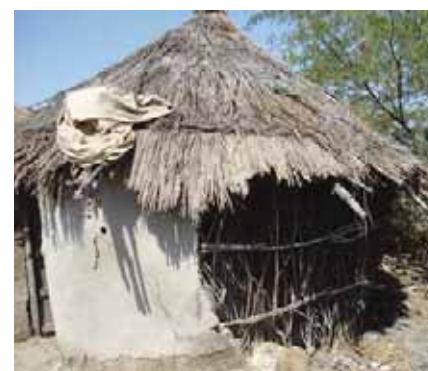
Conical Chaura construction with disintegrated plaster

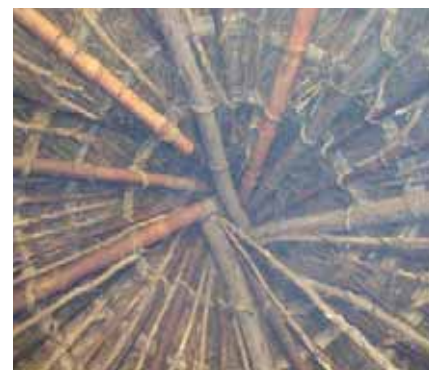
Conical roof structure - skilfully built.

The continued construction of the conical Chaura roof is strongly recommended, however, it is worthwhile to replace the usual wooden joists with bamboo joists and purlins, as shown in accompanying drawings.

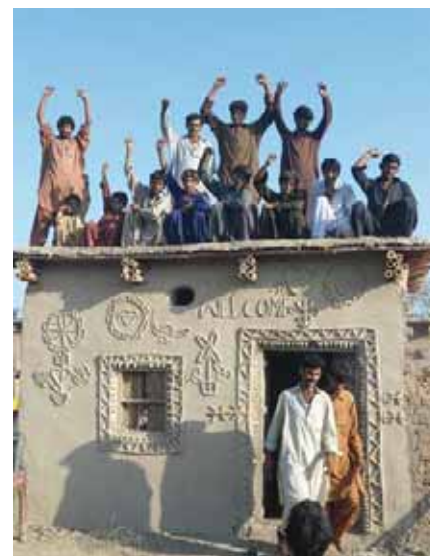
Community members testing Karavan Roof

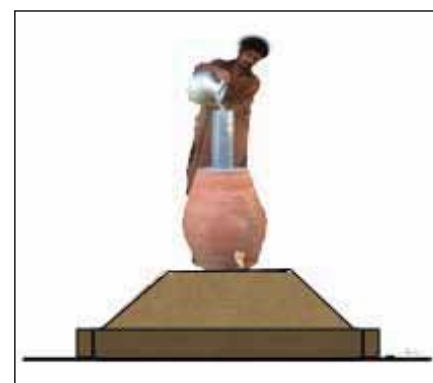
HF-SPS Clay water filter on earth platform

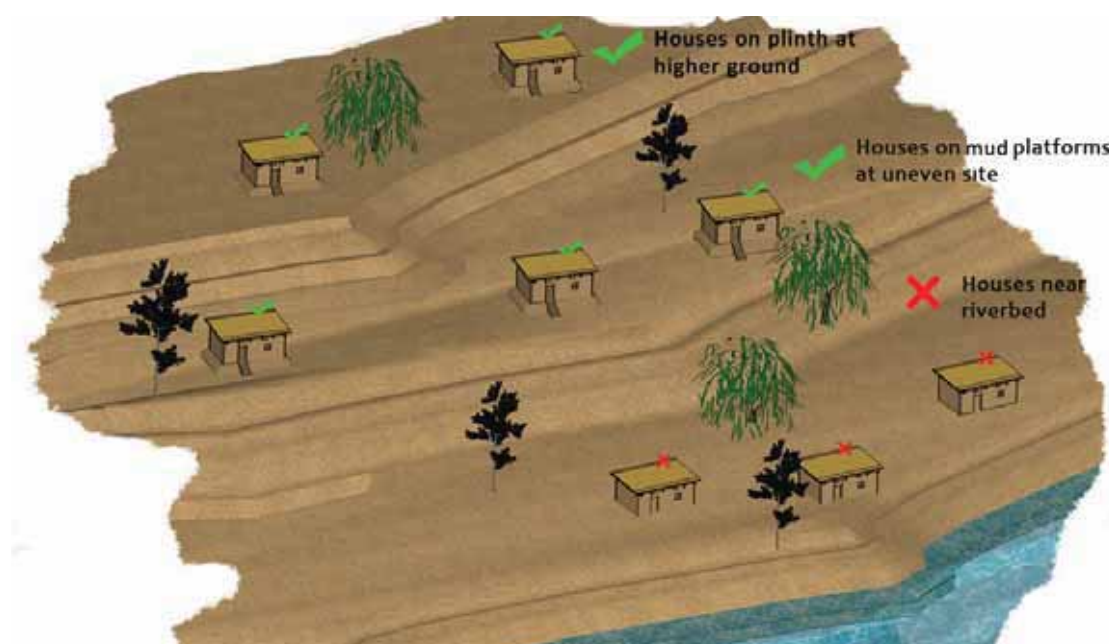
Site Selection

- i. Assessment of risk of ponding or flooding;
- ii. Requirement of drainage or erosion control measures depending upon site gradient;
- iii. Check site for natural rainwater drainage (minimum one per cent gradient is required);

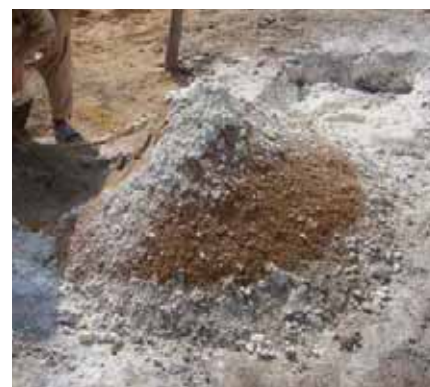
Mixing lime with soil to prepare mortar

- i. The use of lime is essential in making the walls weather resistant.
- ii. A mixture of lime, mud as well as bhoosa (straw) well mixed and fermented for 24 hours, provides a layer that will make the internal core of muds wall safe from rain and flooding.
- iii. Damaged brick is recycled by mixing brick dust in the mud and lime mortar and provides additional weather resistance.

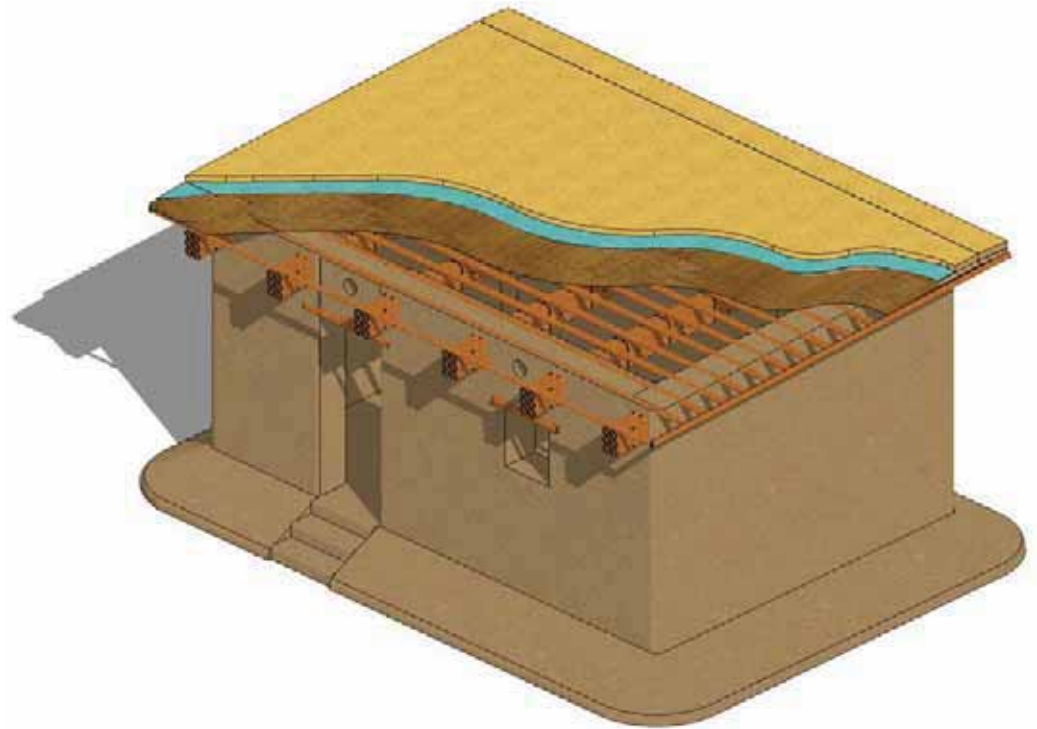
Roof: KaravanRoof

This is considered among the most appropriate types, which has also gained popularity among various villages where Heritage Foundation has carried out shelter construction after 2011 floods. While it will provide refuge in case of a disaster, under normal circumstances it is being used as extension of the house, for example, for sleeping at night or for drying vegetables etc.

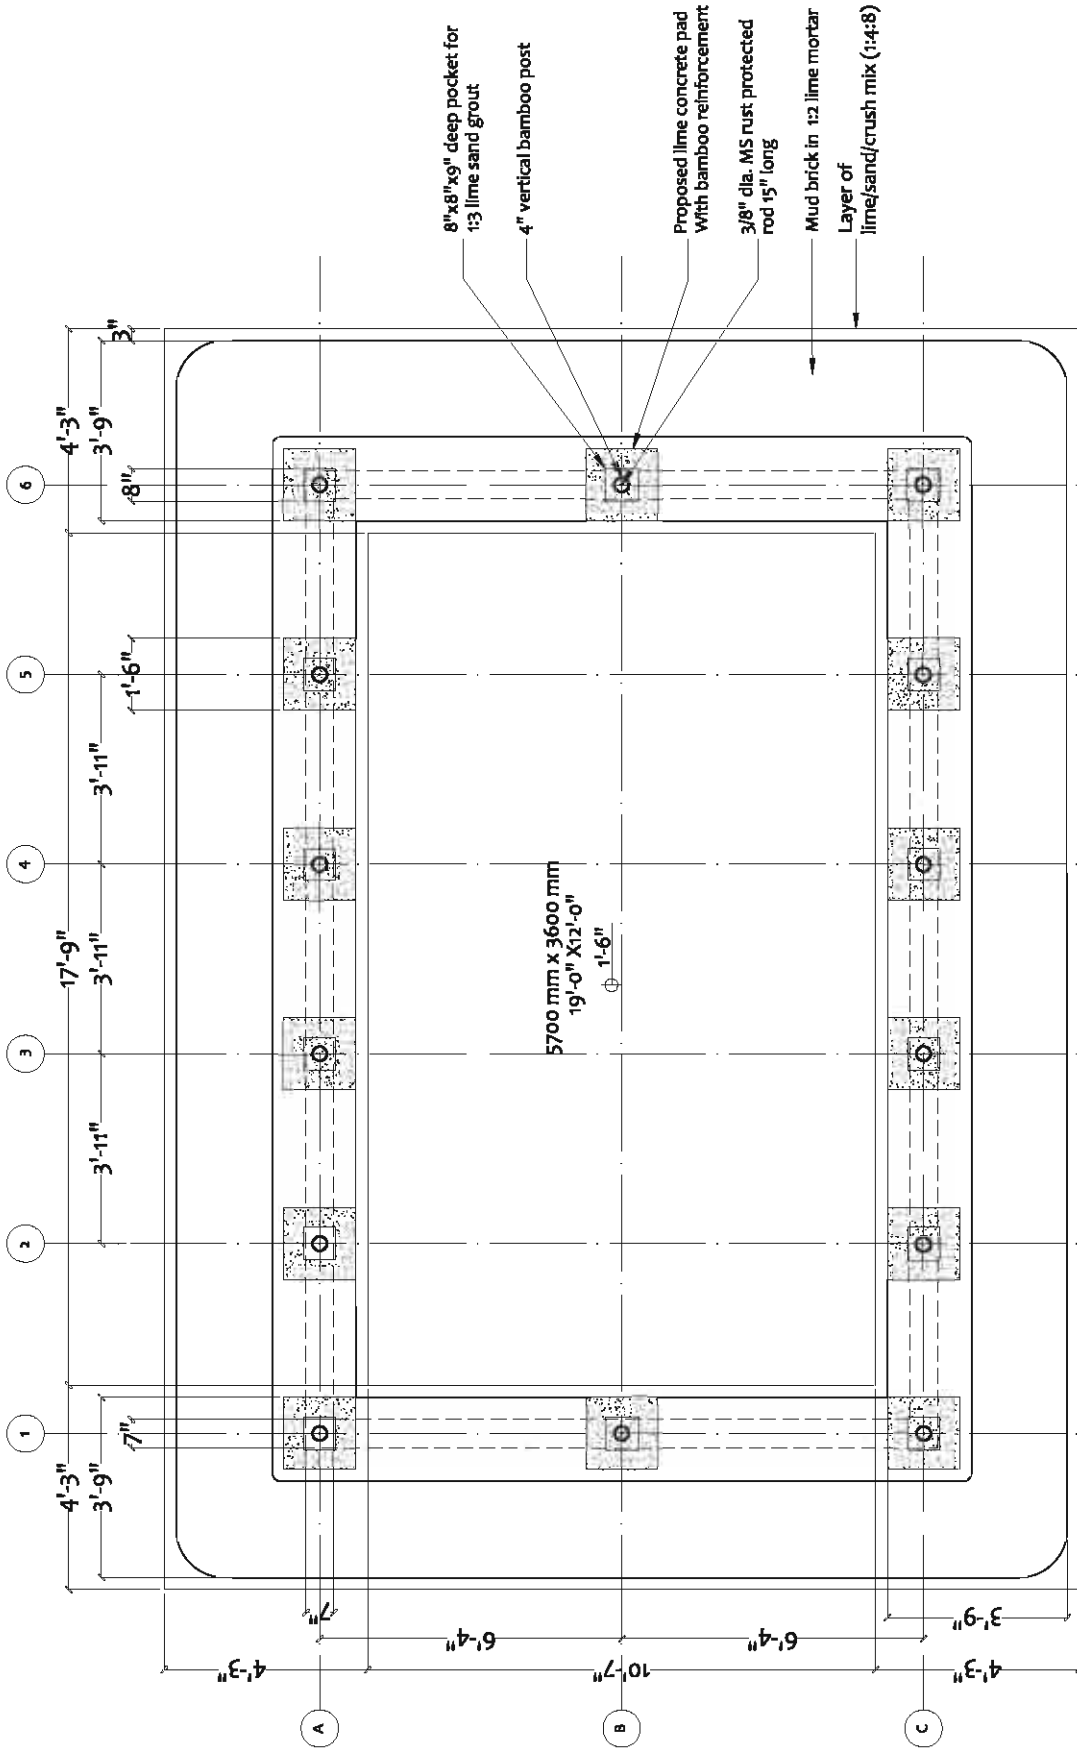
TYPE B1

- 8"x8"x9" deep pocket for 1:3 lime sand grout
- 4" vertical bamboo post
- Proposed lime concrete pad with bamboo reinforcement
- 3/8" dia. MS rust protected rod 15" long
- Mud brick in 1:2 lime mortar
- Layer of lime/sand/crush mix (1:4:8)

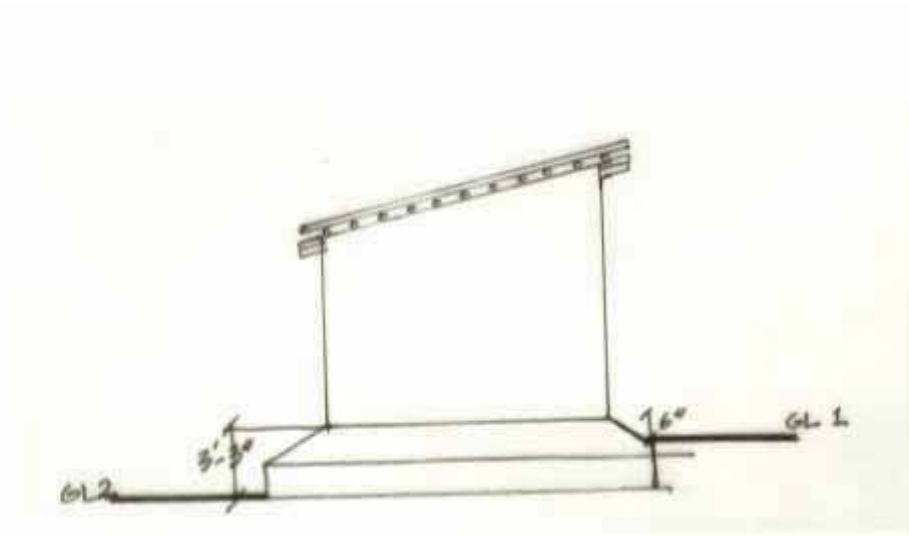
SKETCH 1: If foundations have been constructed on firm soil, and flood water drains from site, this may be allowed.

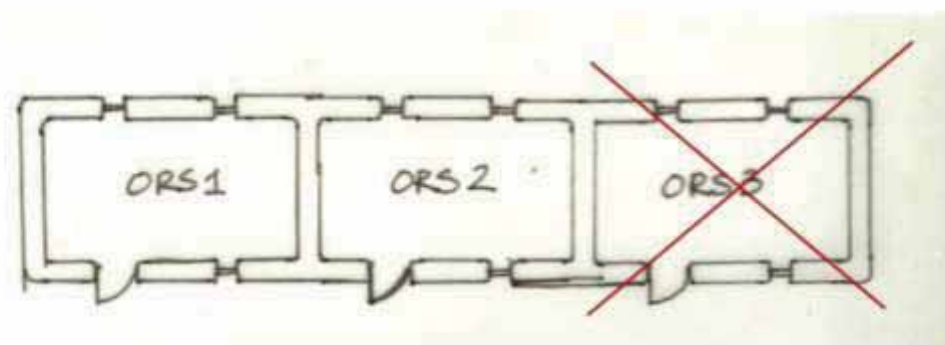
SKETCH: More than 2 shelters with common walls are not recommended.

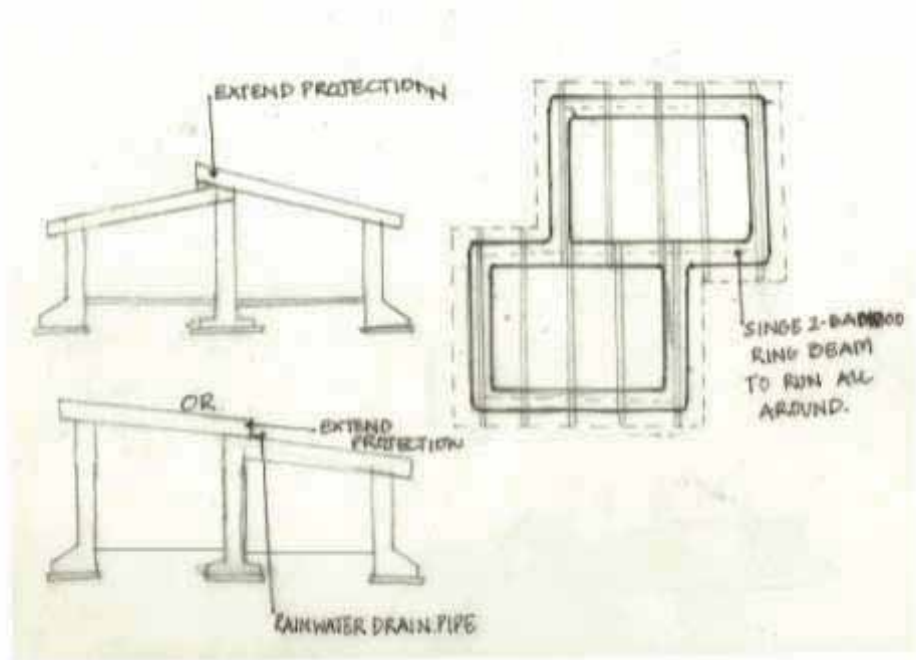
SKETCH 3: ORS shelters sharing long wall

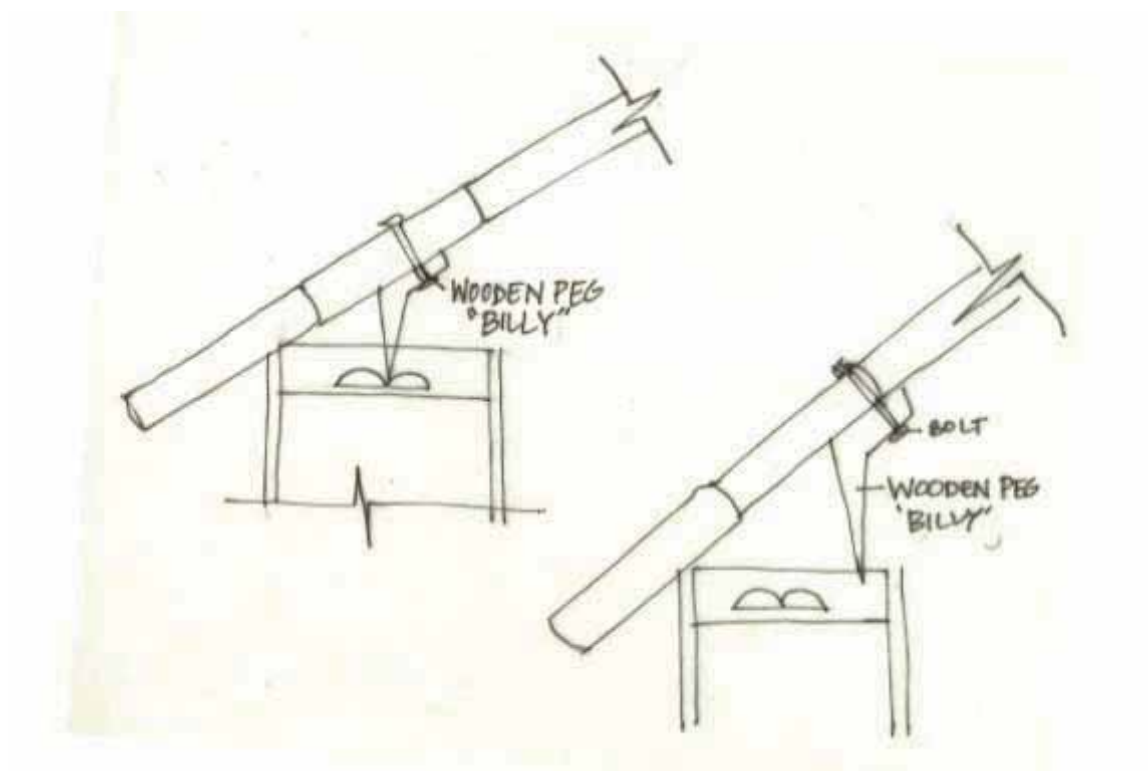
SKETCH 6: Use of Wooden peg NOT RECOMMENDED

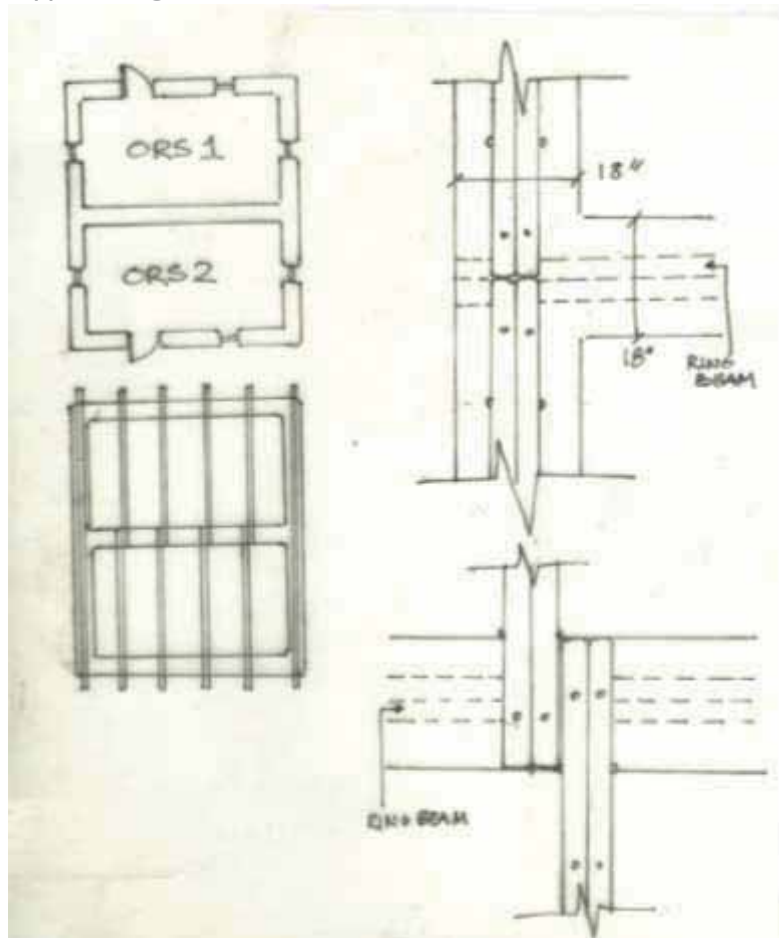
SKETCH 7: 2 ORS sharing common long wall
