# PRESERVATION OF TOMBS OF SULTAN IBRAHIM & AMIR SULTAN MUHAMMAD, WHS MAKLI

## 1<sup>ST</sup> CONSULTATIVE COMMITTEE MEETING

*Folio X– Condition Survey, Guiding Notes and  
Damage Assessment*

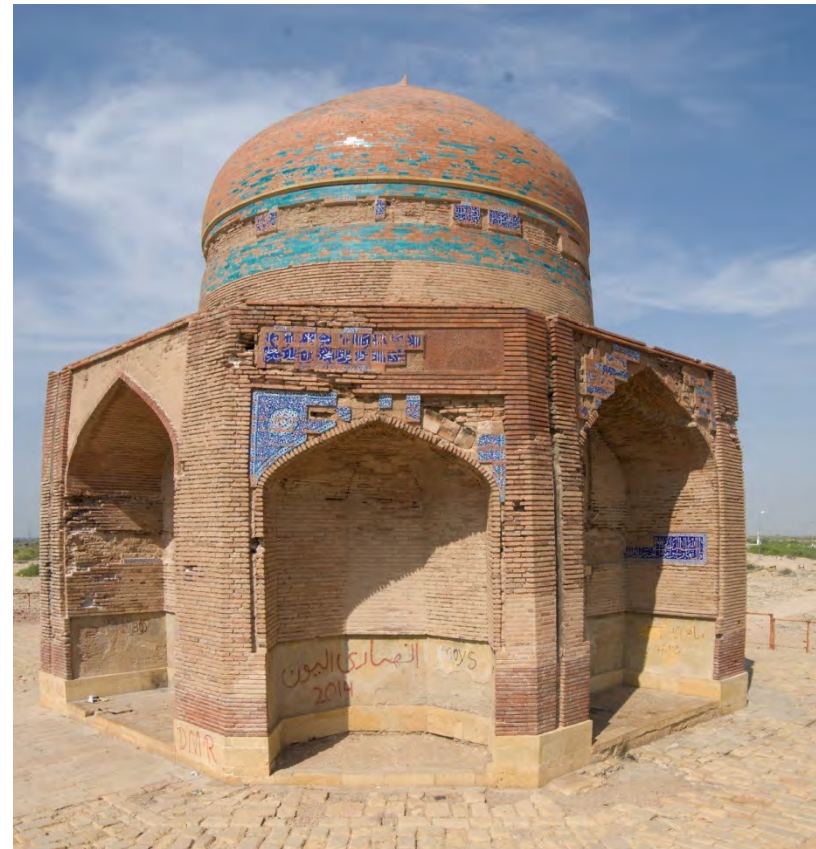
## COMPONENT 01: TOMB OF SULTAN IBRAHIM

- **Octagonal Plan Form with deep alcoves (4.521m x2.235m)**
- **Burnt Brick structure carrying double domes raised on a drum, using squinches in phase of transition, rising to a height of 15.375m**
- **Embellished with glazed tiles (*kashi*) externally and internally, and stucco linings (*manabbat kari*) internally.**
- **4 graves encased in dressed stone sarcophagus incorporating elegantly carved Quranic verses.**

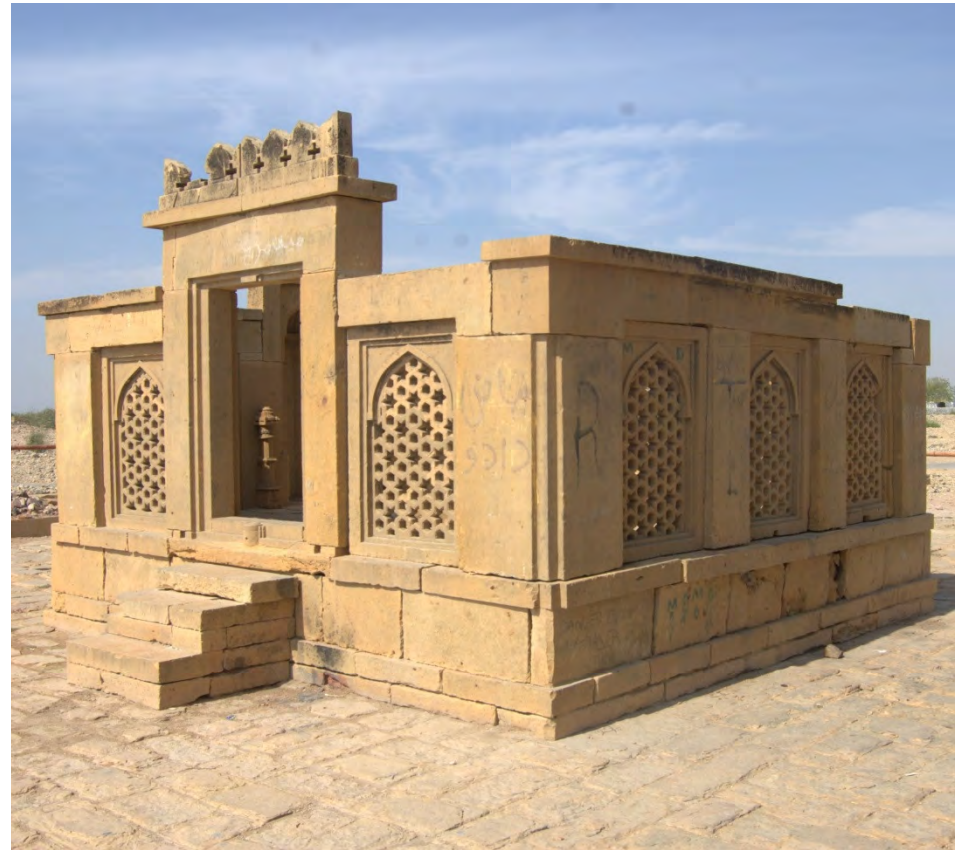
## COMPONENT 02: TOMB OF AMIR SULTAN MOHAMMAD

- **Square Plan Form with stone enclosure size 4.362m x 4.390m**
- **Dressed stone enclosure walls 3.094m High terminated with stone kanguras.**
- **Use of panels of finely carved stone jali (lattice or perforated screen).**
- **1 grave encased in dressed stone sarcophagus incorporating elegantly carved Quranic verses.**

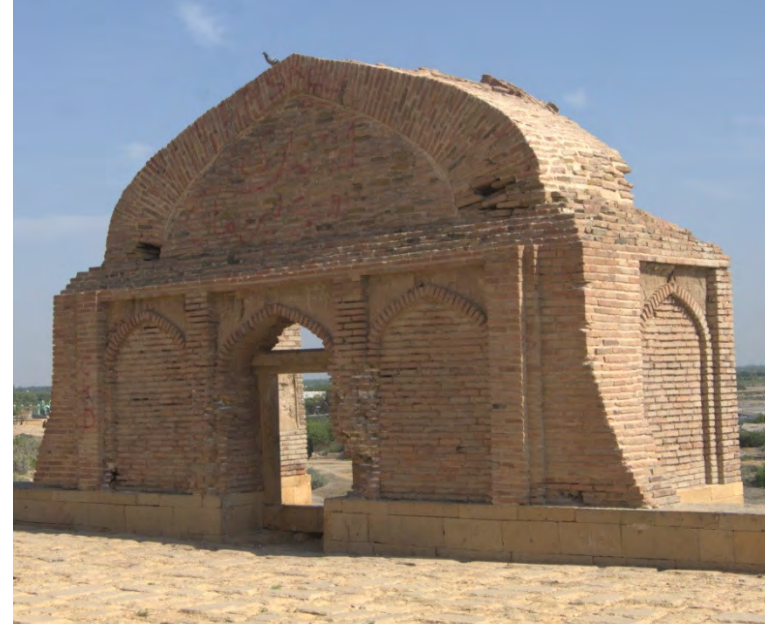
## COMPONENT 03: GATEWAY ARCH

- **Rectangular Plan Form with lofty archway size 2.992m x 8.160m**
- **Burnt brick vaulted structure on dressed stone plinth rising to a height of 5.899m.**
- **Embellished with glazed tiles (kashi).**

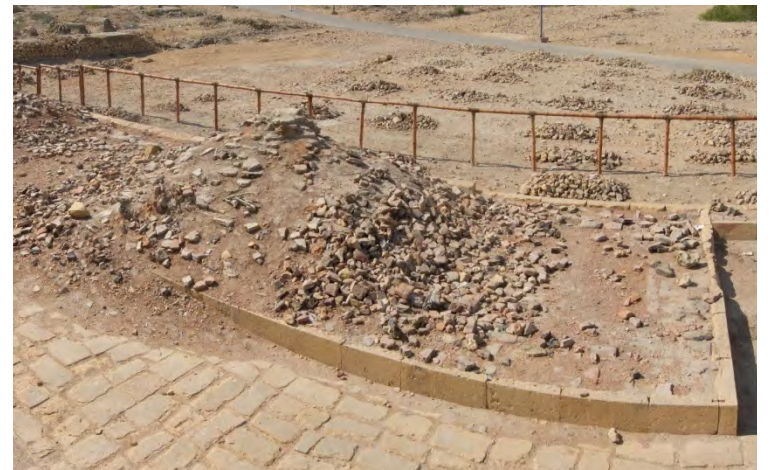
## COMPONENT 04: COLLAPSED STRUCTURE

- **Rectangular Plan Form with size 20.141m x 4.420m**
- **Debris showing low dressed stone plinth.**
- **Debris mostly consisting of burnt brick.**

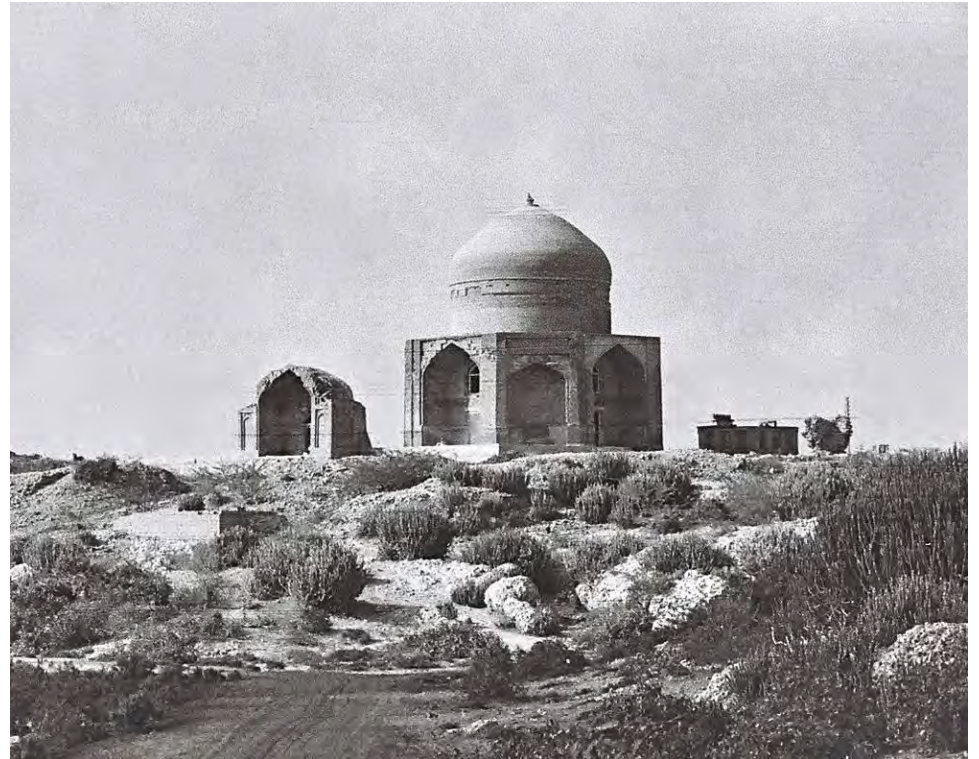
# MASONRY ANALYSIS - TOMB OF SULTAN IBRAHIM

**Study shows interventions carried out over different periods on brick masonry resulting in different types of bricks, mortar colour and surface treatments**

## **PHASE I:**

**Original construction**

## **PHASE II:**

**British Period Restoration**

## **PHASE III:**

**1953 and Later Interventions -  
Pakistan Period**

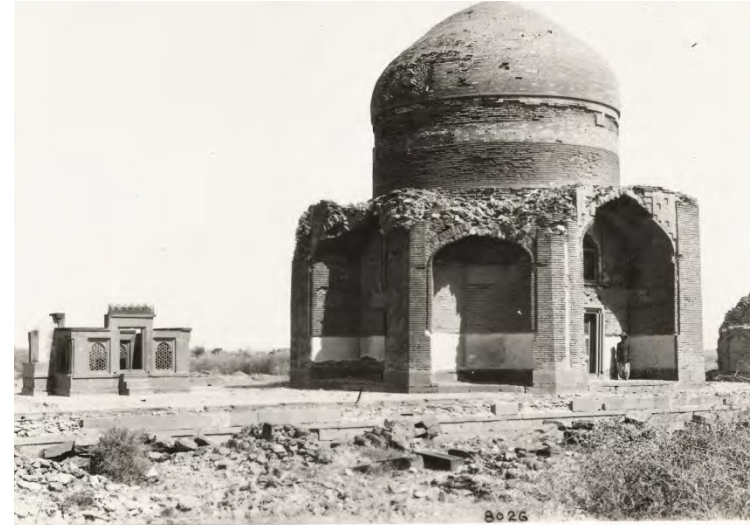
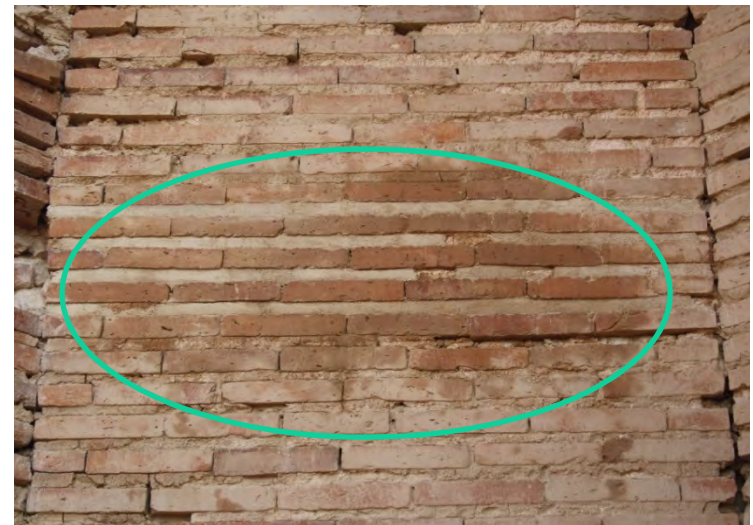
# MASONRY CHARACTERISTICS – PHASE I

**East Elevation alcove deteriorated portion is considered to be the original portion and used to identify original brick work.**

- **Soft ochre colour with marks of wooden mould visible on the surface**
- **Straight edges (rather than rounded as in the case of later bricks), as brick is likely to have been left in mould to dry.**
- **Vertical joints show butt jointing with no mortar.**
- **Horizontal joints 1" wide square pointing recessed slightly from the face.**

**General colour: ochre-pinkish white**

**Use of fine gravel aggregate resulting from the type of sand used.**

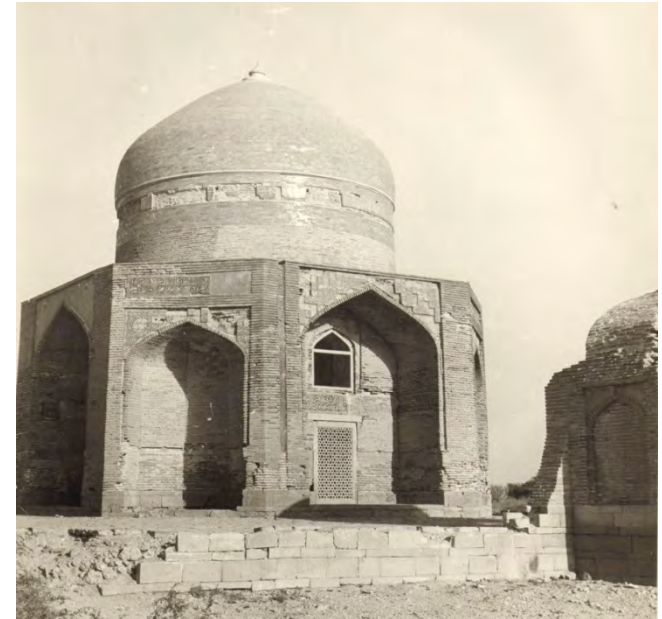
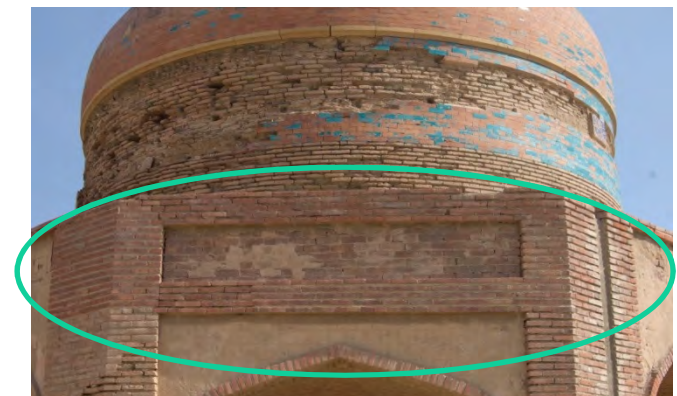
# MASONRY CHARACTERISTICS – PHASE II

Identified due to standard of brick masonry and mortar pointing - consist of 6-8 brick courses above stone skirting and. top 5-8 courses including 2 parapet courses.

- Maroon colour bricks
- Edges of bricks not as straight as bricks identified as original and does not carry wooden mould impression.
- At some places vertical joints have mortar, likely to have been due to spillage.
- Joints of same thickness as original but struck pointing with mortar recessed 1" from the face of brickwork.

- Colour varies from off white to white. Use of surkhi (brick dust) found on outermost façade and parapet masonry.
- Use of fine aggregate noticed.
- Use of cement found in some places notably rainwater drainage channels

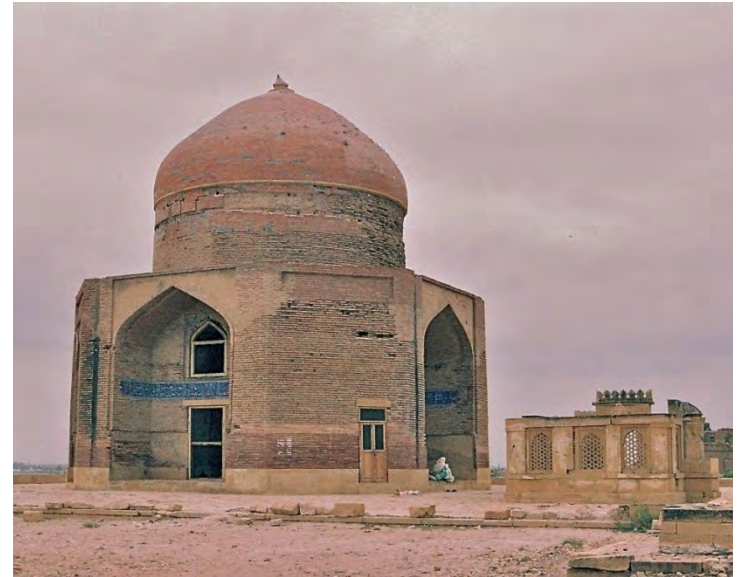
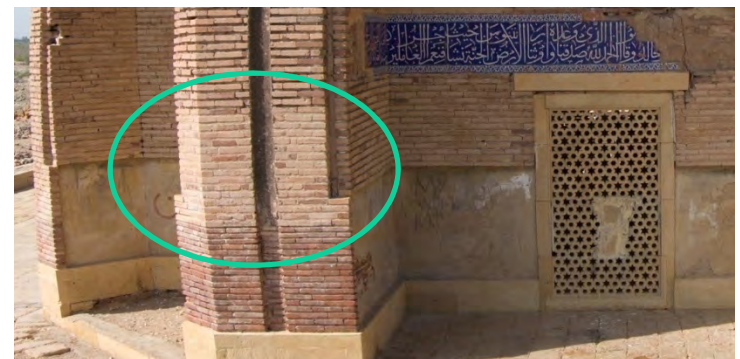
# MASONRY CHARACTERISTICS – PHASE III

Restoration mostly in outer vaulting, niches and façade identified due to brick and mortar treatment. Date recorded on some bricks.

- Red with yellowish tint; darker than original but lighter than British brick.
- High quality brick with straight edges; plain outer face with no wooden mould impression.
- Mortar present in vertical joints, contrary to original and British procedure.
- Joint size the same as original and British, but use of flushed pointing with no recess, making the masonry prominent compared to earlier periods

- Pinkish white to white
- Fine white mortar used between original bricks, when underpinning done.
- Use of cement found in mortar used in drainage channels.

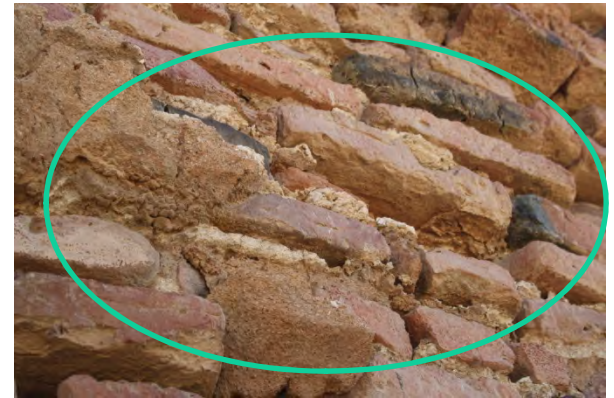
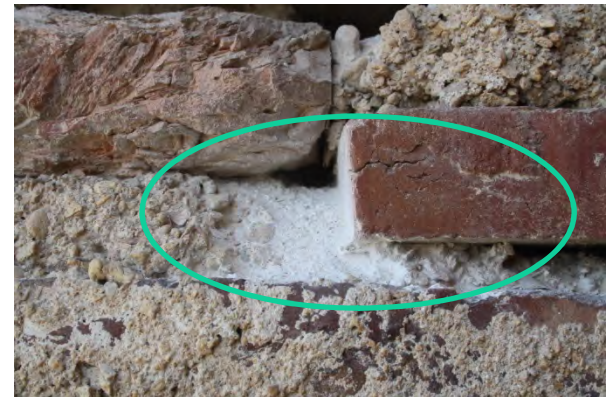
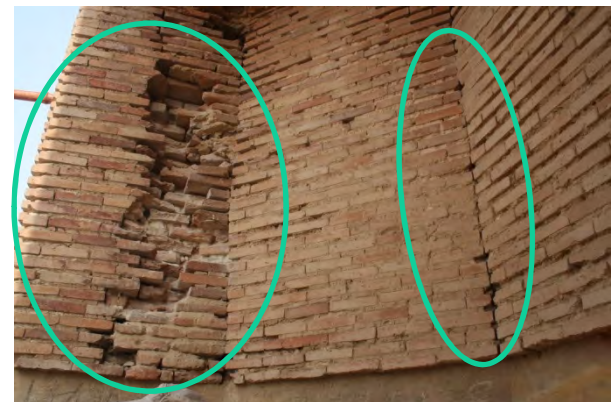
## DAMAGES IDENTIFICATION - I

**Masonry Damage:** Various kind of damage have been identified due to varying kind of brick and pointing.

**Efflorescence:** Damage through surface salts leading to loss of brick surface.

**Sub-florescence:** White powder like fine dust on mortar surface, where fallen brick has exposed the inner layer of masonry.

**Pitting:** Dislodged bricks leaving a void for water ingress, thus damaging the integrity of the load bearing wall. Birds' nests and cobwebs have also caused damage.

**Spalling:** Found to be most prominent in the corner edges of external arches and vaults and around door and ventilator frames. Caused largely due to loss of glazed tiles, leaving edges of bricks vulnerable. Cavities aggravated due to nesting of squirrels and their burrows.

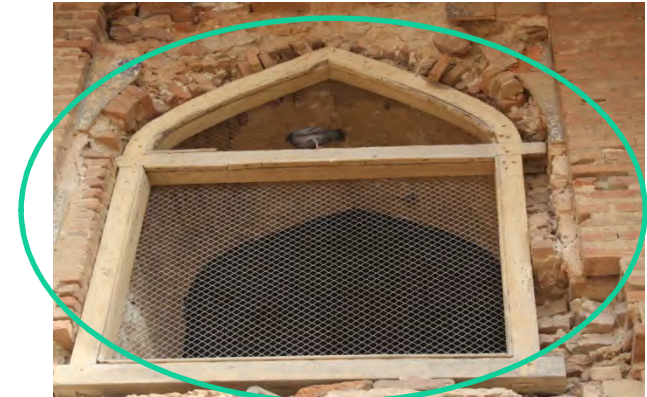
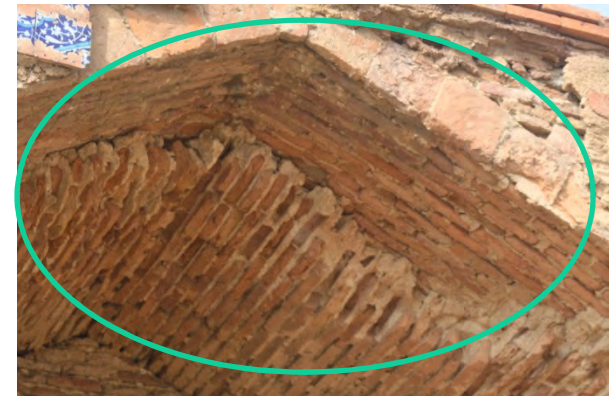
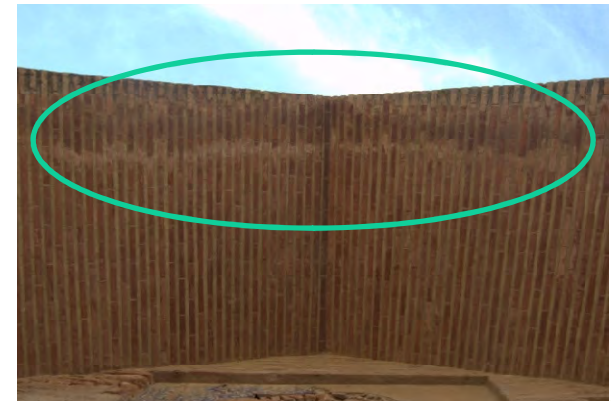
## DAMAGES IDENTIFICATION - II

**Weakened Masonry:** Found to be in areas above lintols and arches, due to settlement and weathering.

**Erosion:** Some bricks have been found to have lost the outer layer due to decades of weathering, the dry core turning into dust and leaving empty pockets of mortar.

**Moisture:** Water penetrating through mortar joints and cracks leading to discolouration of brick along outer edges of arches and openings. Lack of protective layer at parapet allows seepage of water from the top.

**Damage to Terracotta Tiles:** The internal floor tiles have suffered from loss of glazed surface.

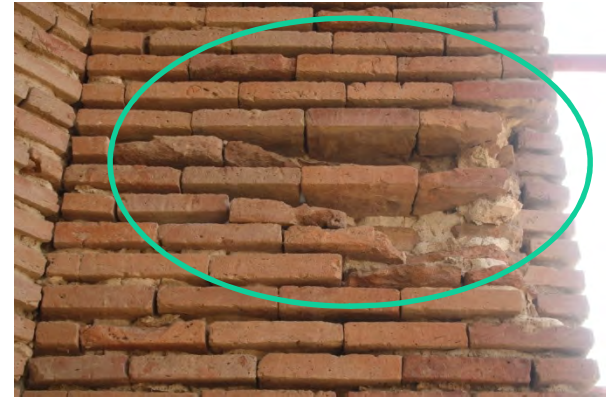
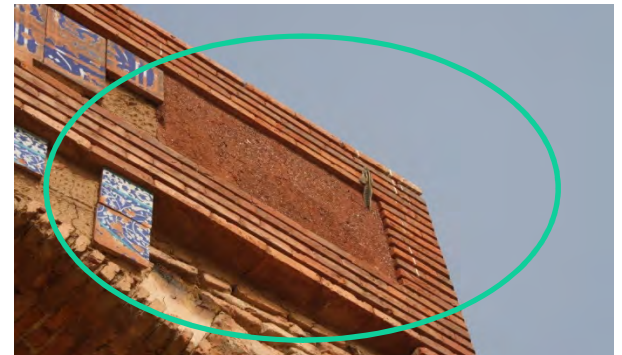
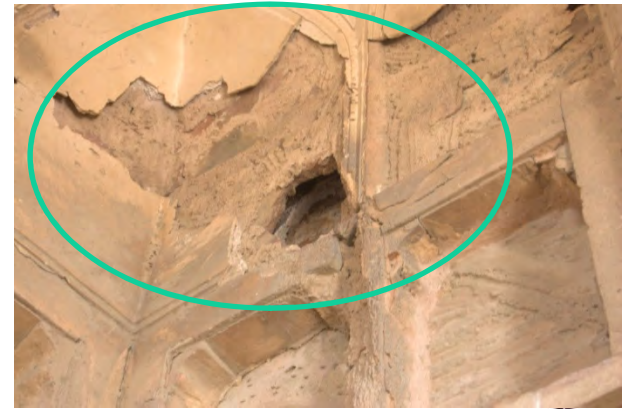
## DAMAGES IDENTIFICATION - III

**Loss and Recess of Mortar:** Due to varying levels of restoration at varying times, special care and treatment are required for conservation of masonry.

The mortar is found generally to be in a damaged condition, with loss of cushion and binding factor leads to loss of bricks; partial or complete disintegrated of mortar at the joints of brick and stone masonry, leaving crack-like spaces which harbour dampness, dust, spiders and ants, damaging the core.

**Loss of glazed tiles:** A major loss that impacts the visual character of the tomb, requiring careful consideration for its treatment.

**Deteriorated Stucco Work:** Detachment of stucco treatment and its loss is clearly visible. The treatment requires careful consideration due to implication to the presentation of interior space.

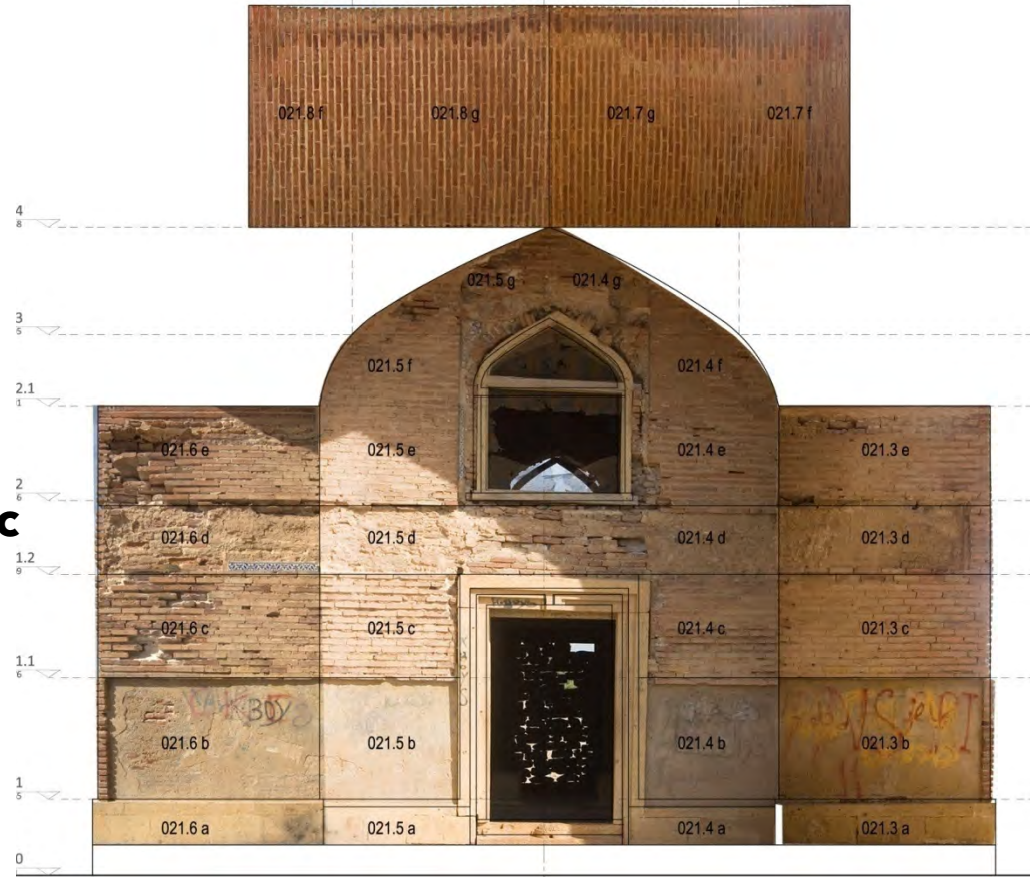
## SOUTH ELEVATION 021 – TOMB OF SULTAN IBRAHIM

- This entire level is of Tile Mosaic Work and now the base mortar for the tiles is visible. The treatment needs to be identified.

- The brick border needs to be cleaned and repaired.  
Underpinning required.
- Retrofitting of the wooden frame, placement of new *jali*

- Surface Cleaning
- Underpinning

- Cleaning
- May be re-plastering / adding of sacrificial layer

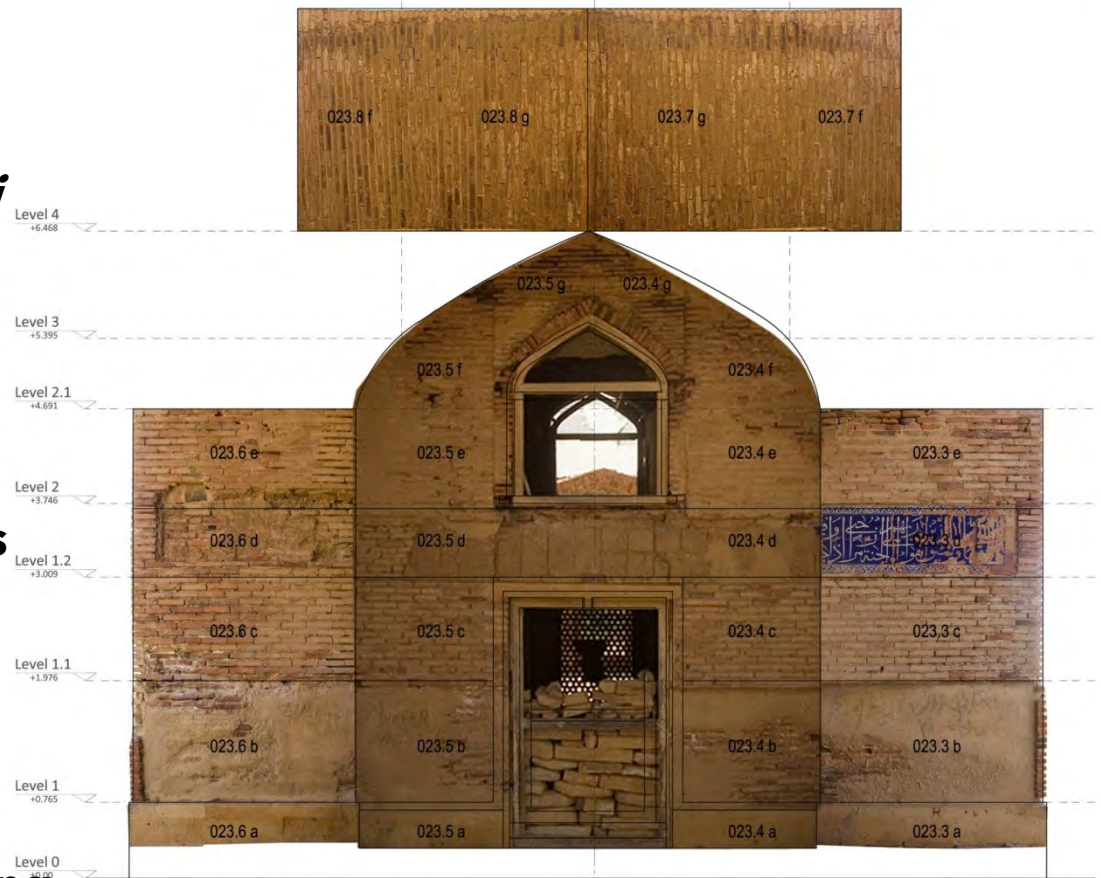
# WEST ELEVATION 023 – TOMB OF SULTAN IBRAHIM

- This entire level is of Tile Mosaic Work and now the base mortar for the tiles is visible. The treatment needs to be identified.
- Underpinning & Brick repairing

- The brick border needs to be cleaned and repaired. Underpinning required.
- Retrofitting of the wooden frame, placement of new *jali*

- Cleaning, maybe re-plastering / adding of sacrificial layer
- Opening the access of the door by removing the stored stone slabs

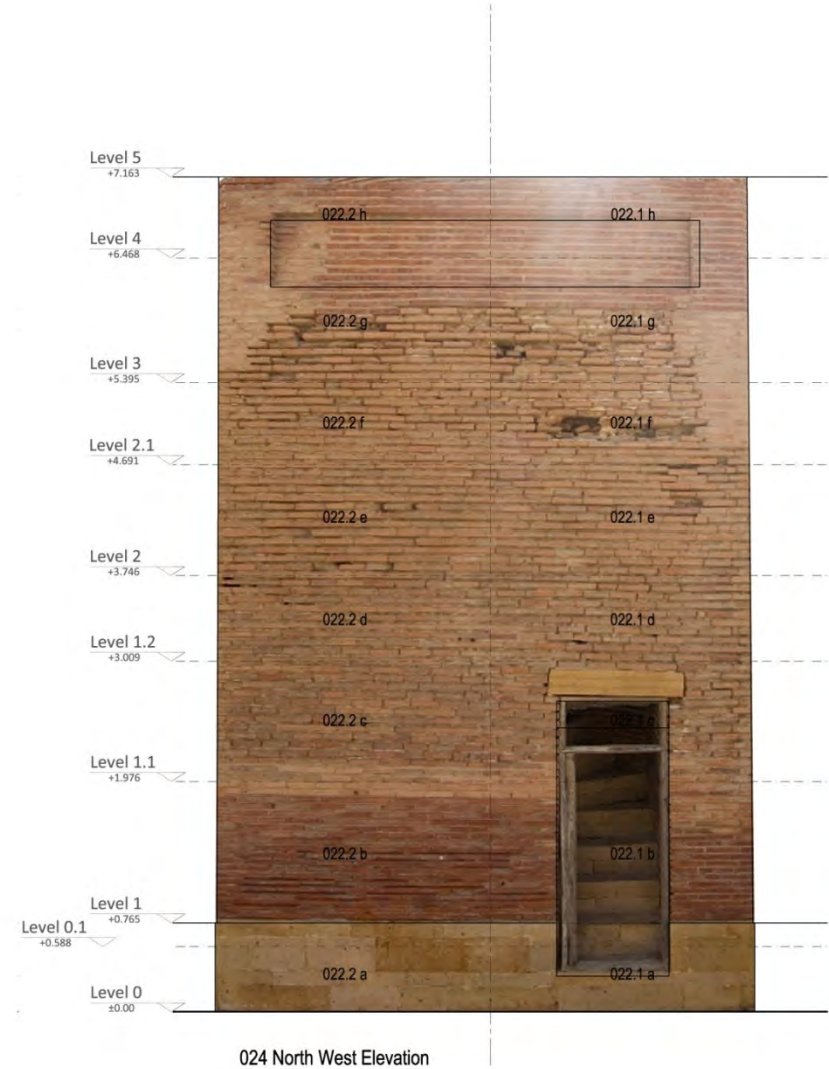
# NORTH WEST ELEVATION 024 – TOMB OF SULTAN IBRAHIM

- This entire level is of Tile Mosaic Work and now the base mortar for the tiles is visible. The treatment needs to be identified.
- Underpinning & Brick repairing
- Door needs to be retrofitted with new reinforcing joints and hinges. Wooden frame needs to be termite proofed / painted.
- The interior wall behind the staircase needs to be examined to assess the soundness of the staircase.

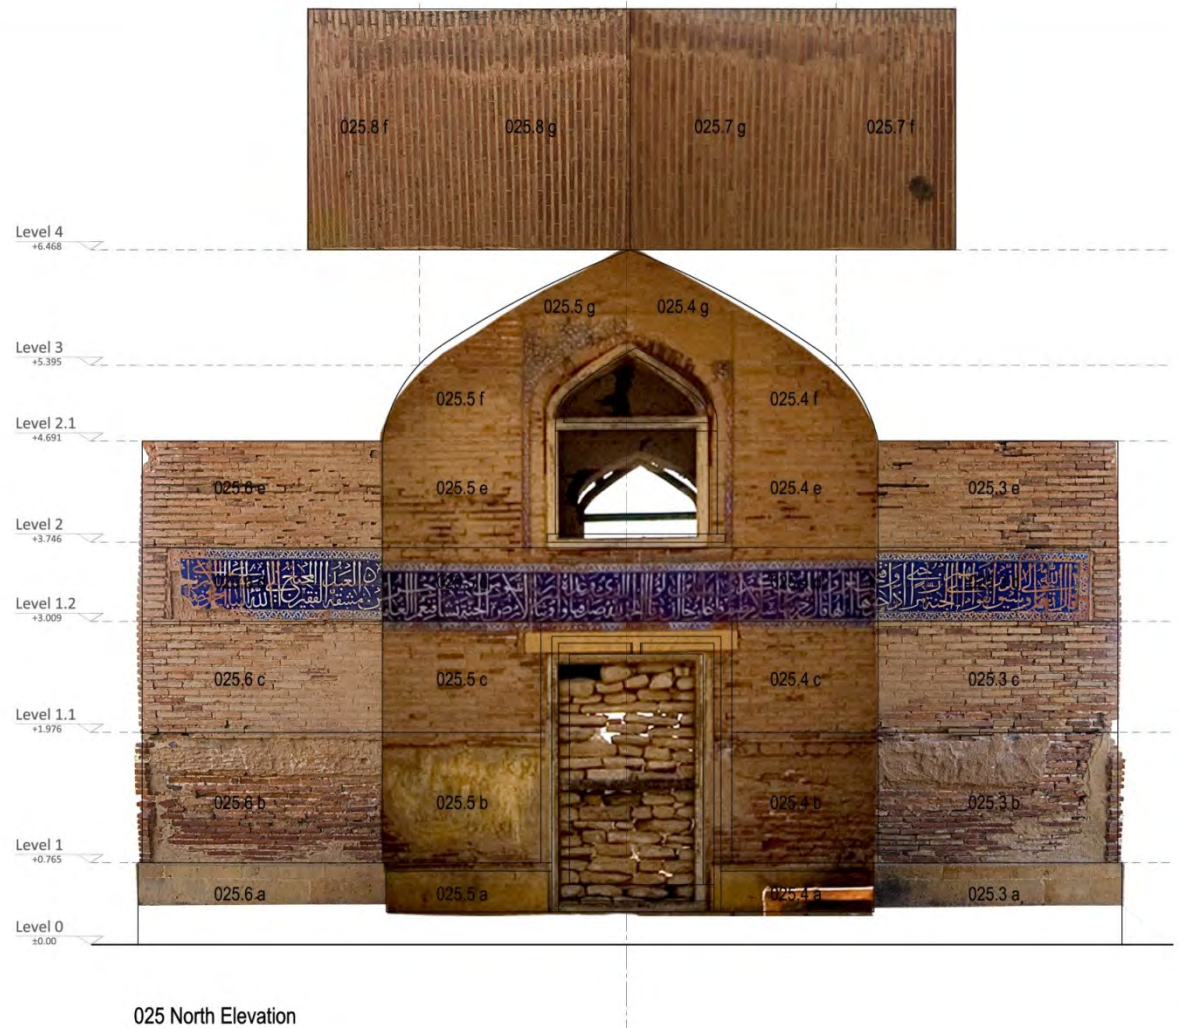
## NORTH ELEVATION 025 – TOMB OF SULTAN IBRAHIM

**This elevation has the most intact of the Tile Mosaic Work. Cleaning and stabilization of tiles is needed. Somebody needs to identify the verse for proper documentation and the calligraphic style used. I think it is THULUTH script developed in Shiraz, Iran, in the 11<sup>th</sup> Century.**

**The doorframe here is not of stone. The door lintel is also not original as it does not have any central projection like the rest.**

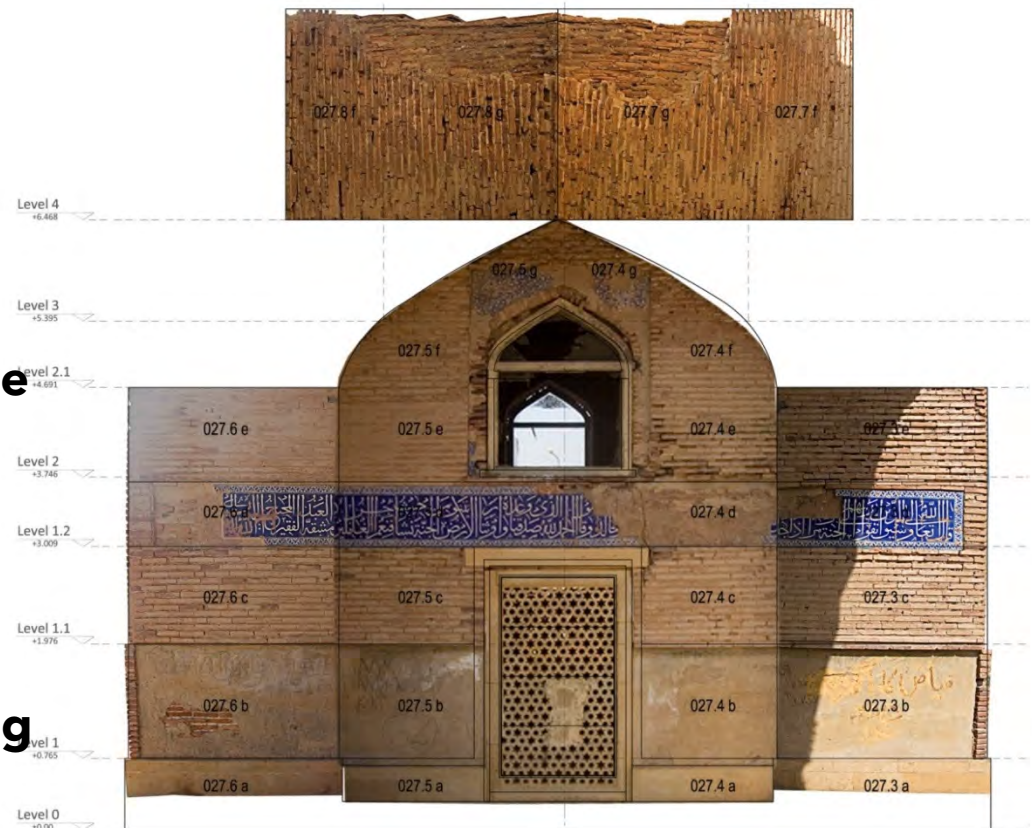
## EAST ELEVATION 027 – TOMB OF SULTAN IBRAHIM

- This entire level is of Tile Mosaic Work and now the base mortar for the tiles is visible. The treatment needs to be identified.
- Tile Mosaic needs to be stabilized.
- Underpinning & Brick repairing  
*Also in 027.7g & 027.8g  
& 027.7f & 027.8f*

- The brick border needs to be cleaned and repaired.  
Underpinning required.
- Retrofitting of the wooden frame, placement of new *jali*

- Cleaning, maybe re-plastering / adding of sacrificial layer
