US Ambassador's Fund for Cultural Preservation Tombs of Sultan Ibrahim & Amir Sultan Muhammad at WHS Makli, Thatta Progress Report First Quarter - 2014/009-012

1st- 30th September, 2014

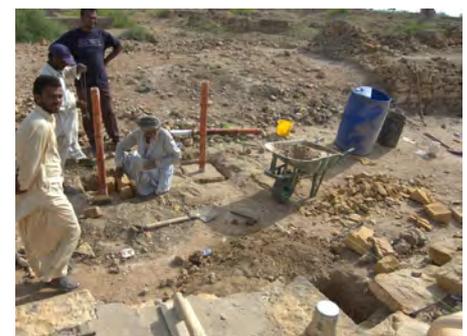
Construction of boundary fencing at Tomb

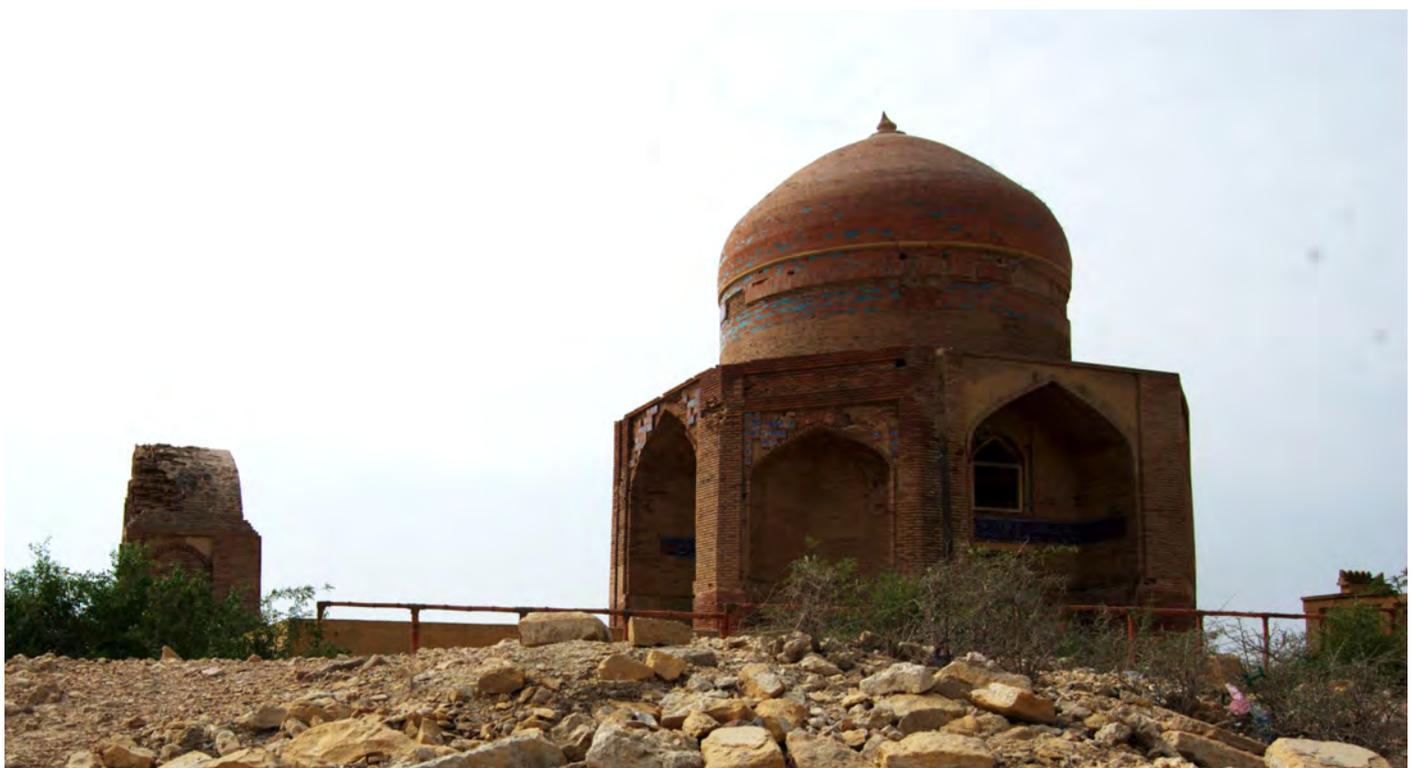
Construction of Boundary fencing at Tombs of Sultan Ibrahim and Amir Sultan Muhammad.

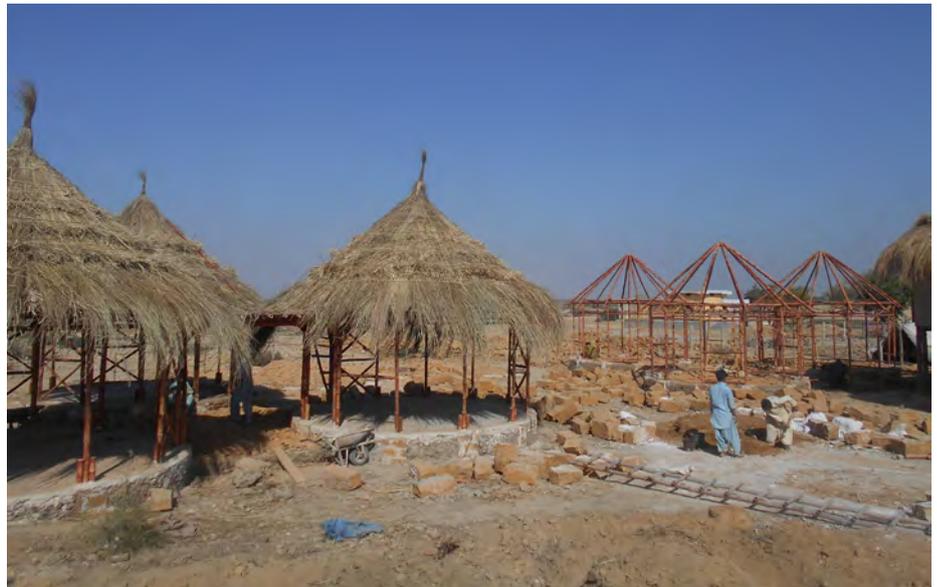
Progress of cluster of artisan's workshops, Buffer Zone, WHS Makli

With a permission received from the Department of Culture for setting up artisan's workshops at the site, and a refreshments corner, work by HF was begun in the designated area in the buffer zone of the site during the first week of November.

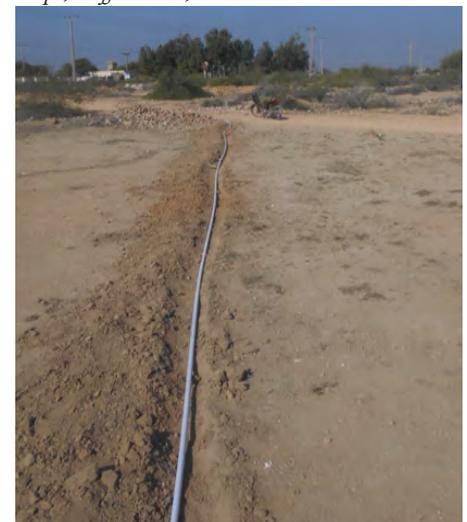
Installation of water supply line at Makli

In view of absence of regular water supply, it was considered essential to arrange for supply of water for work to be undertaken at the site. HF undertook the installation of a supply line to the buffer zone, in the designated area for artisans' workshops. A pipeline was also installed near the Tomb of Sultan Ibrahim for ease of supply once conservation work is undertaken.

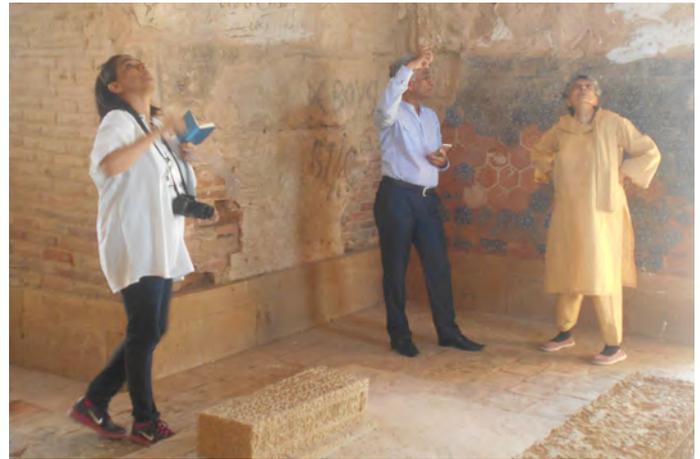
Visit by Amin Tariq for preliminary evaluation of the tombs

It was important for studies on site to be undertaken at the earliest. In this regard, Heritage Conservation Engineer, Engr. Amin Tariq, MD, Amin Tariq Associates undertook an initial visit to assess the damages and make a preliminary report (Annex A-2). The final structural rehabilitation report will be prepared once geo-technical studies have been completed.

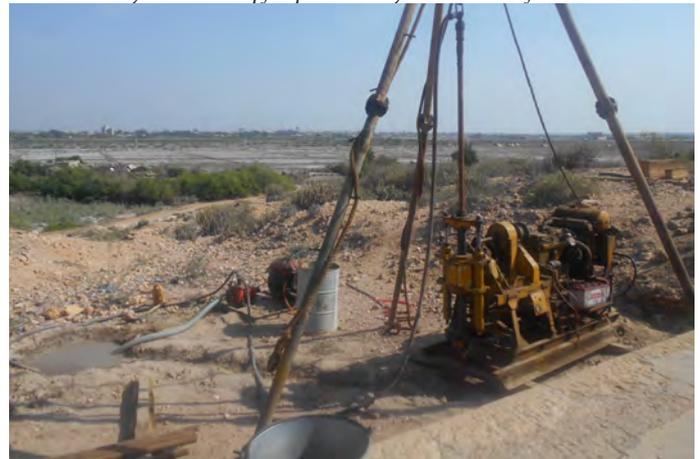
Initial machine brought to the site which was unable to conduct tests

Geo-technical studies were begun by Consolidated Engineering Services led by Engr. Danish. Mobilization to the site was undertaken by the second week of November, with a plan to complete work by the end of the month. The field teams, however encountered various problems: the initial smaller machine was unable to cut through the hard stone along the edge of the ridge, and had to be replaced with a larger drilling machine. The second machine also had several problems as the hard core of the rock made drilling impossible, with drill bits constantly breaking and several boreholes had to be abandoned and restarted at a different position. All four boreholes were completed after three weeks, two weeks beyond the estimated time. The finalized report of the geo-technical studies will be available by mid-December.

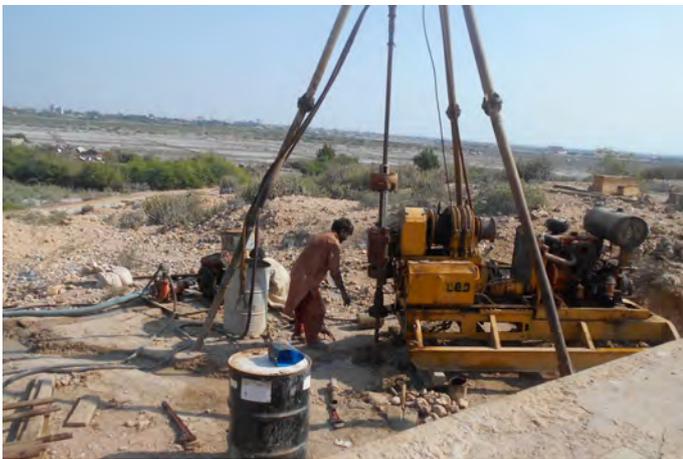
Setting up of the second, much larger machine for soil investigation

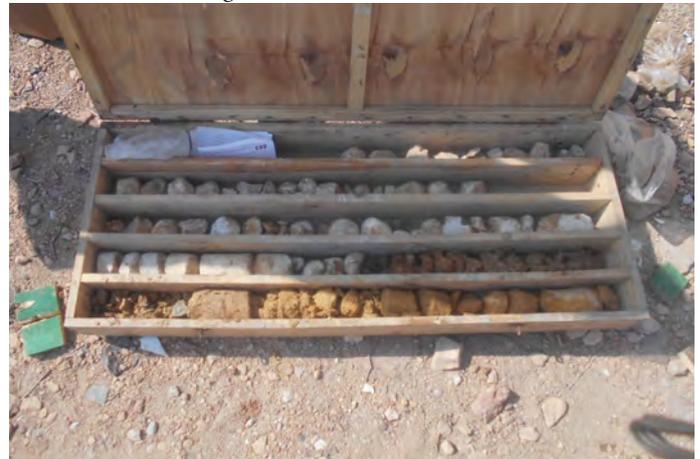
Core samples from geotechnical soil investigation

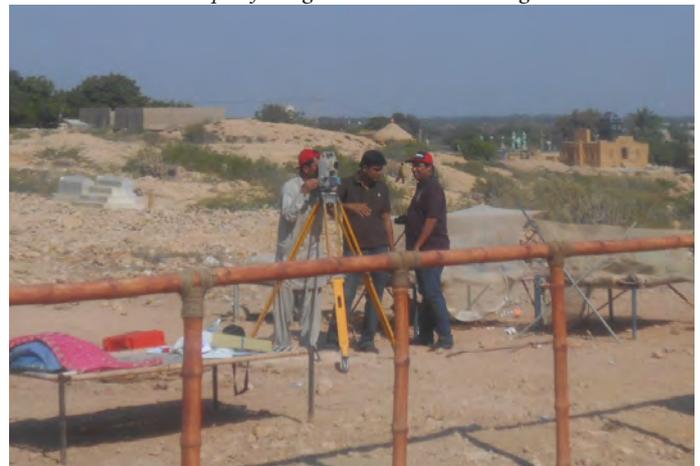
Survey being conducted with total station on site

Physical surveys were undertaken by Osmani & Co, under the guidance of Engr. Atif Osmani. The field teams were deputed to the site during mid-October. Since drawings of the best quality are required for all conservation work to be planned and assessments of the building be accurate, it was decided that another surveyor would also be engaged. The intricacies of the interior of the building and minor damaged to walls required detailed surveying, that would not be possible for one team to complete in time.

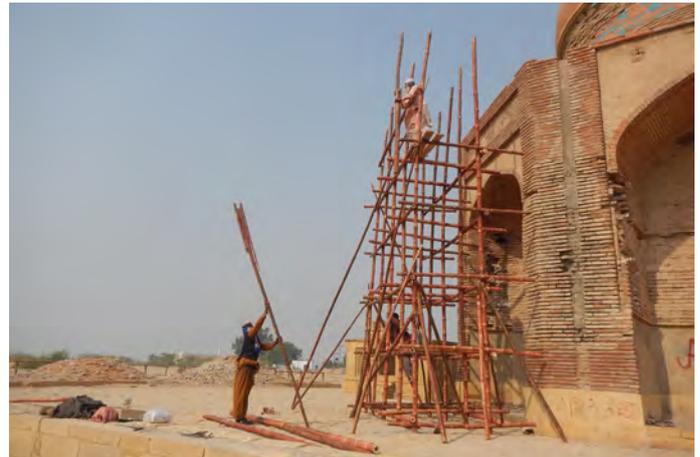
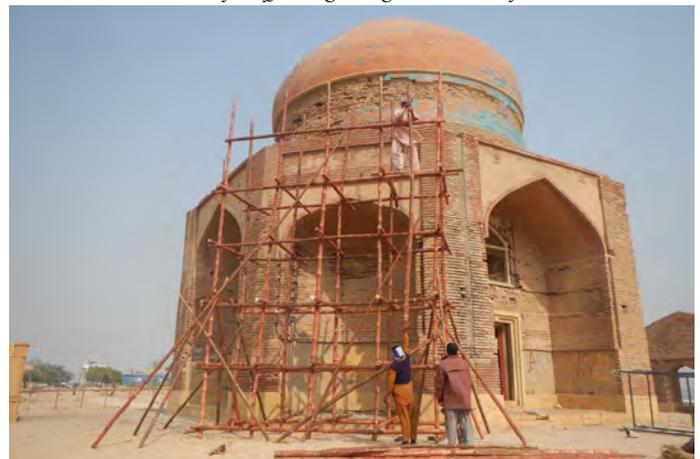
Erection of scaffolding along South-West facade

Erection of Bamboo Scaffolding along South-West Facade

As the month of December began, various activities were begun on site. HF artisans fabricated and installed a module of the external scaffolding made of bamboo. The scaffolding was erected on the South West External Façade and was fabricated to test how workers would be able to reach the highest point of the dome and drum. After fabrication, it was determined that subsequent scaffoldings would be of a shorter span for ease of movement to other façade and elevations. Additionally, measures were undertaken to ensure safety of workers who would be above ground.

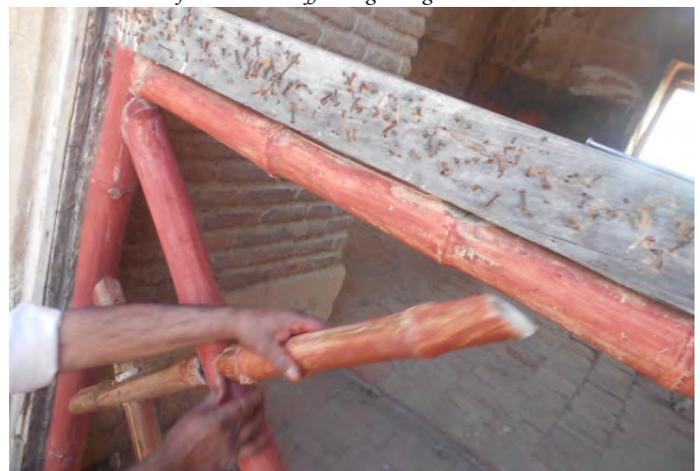
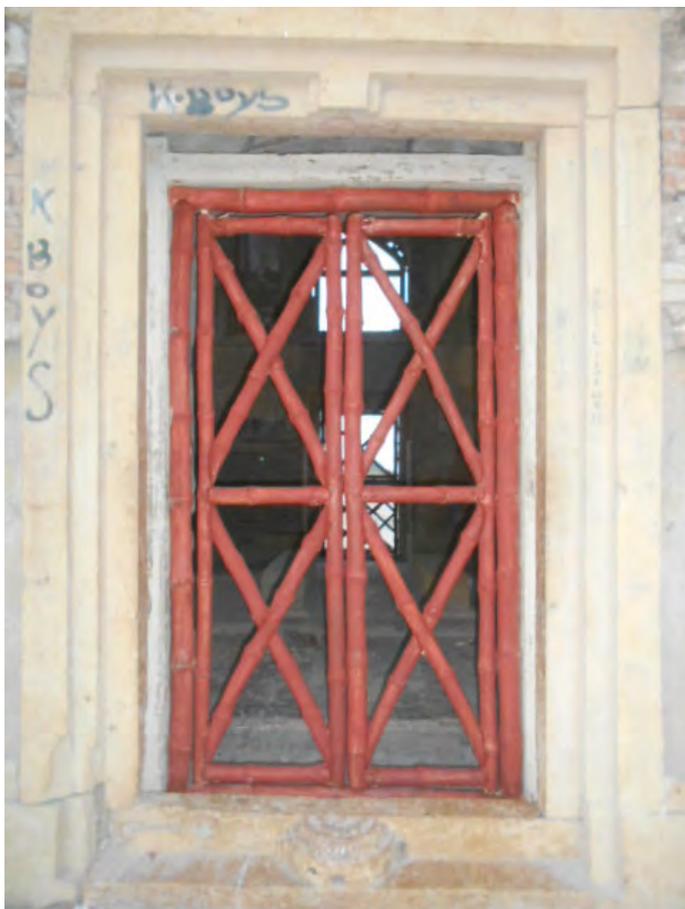
Blocking openings with bamboo doors

Blocked opening with bamboo door

All openings have been blocked to restrict entry to avoid damage by visitors. Since the work is proceeding, it is important that un-authorise persons should not enter which can be cause of dmaage. Additionally, all opening were also closed with a metallic netting to keep out various pests i.e. squirrels and birds that were currently occupying and damaging internal walls of the main tomb. Since there are bird nests which are a cause of pollution as well as dmage to the fragile surfaces carrying stone carved interlacemets, freso decoration and stucco work.

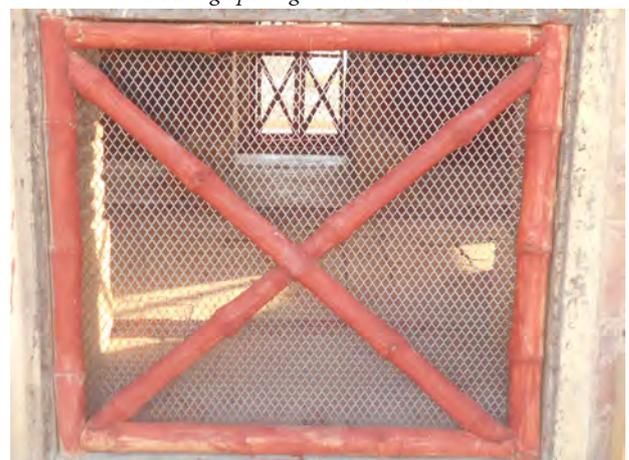
Placement of metallic mesh on all openings

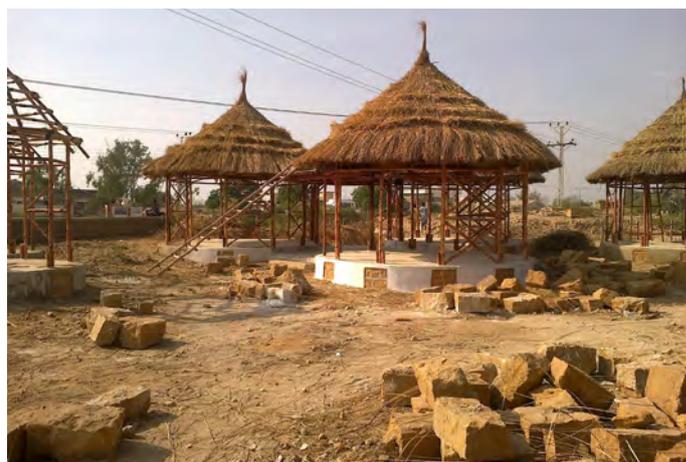
Artisan Clusters nearing completion at Makli

The artisans also reached the completion stage of the artisan's cluster of workshops at the site and the remaining finishing touches including final finished stone flooring. Since the site is now fully mobilized with HF supervisory staff and artisans being trained to learn to handle various delicately executed surfaces, the site is being readied to undertake the test patches and various samples of mortars and investigations that must be completed before the first Consultative Committee meeting scheduled to be held on 6th March. As artisans have been identified and more interviews and investigations taking place, the workshop area is expected to be functional by March 2015.

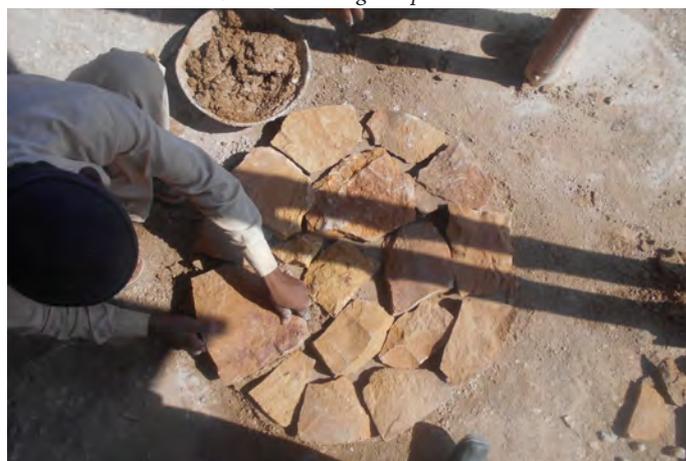
Stone flooring being prepared on Site

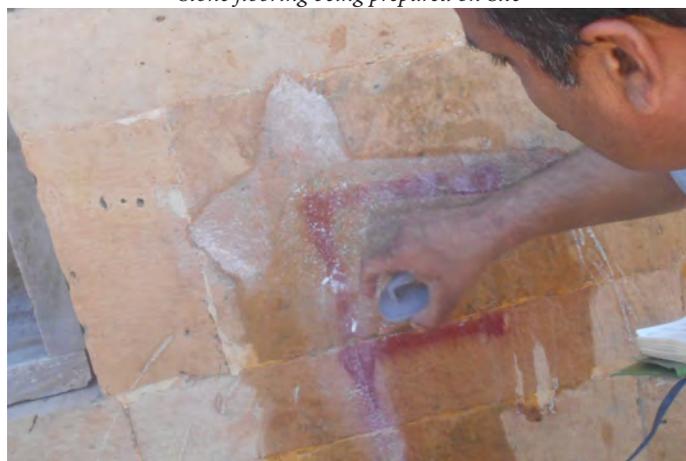
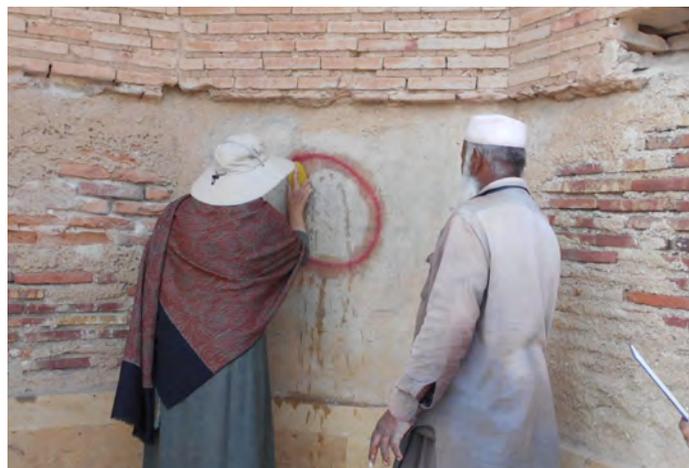
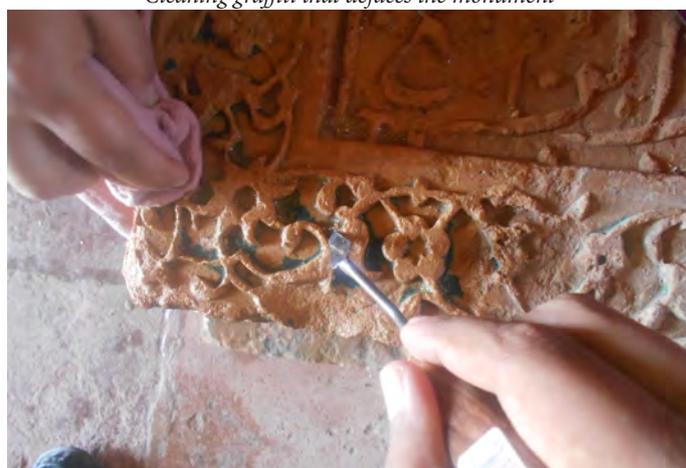
With the monuments being neglected for many years, the tombs have been defaced with various forms of graffiti, i.e.

Cleaning graffiti that defaces the monument

Cleaning being undertaken on Site

Removing tough enamel paint from groves between stone carving

with spray paints, scratched surfaces, charcoal, pens, pencils and markers. A thorough cleaning undertaken over many months with dry soft bristle brushes, gentle organic acid free soap, alkaline powders and other gentle cleaners has been initiated. The cleaning methods were first experimented on small sections of the building to ensure that no further damage would be caused to the monuments and subsequently implemented all along the facades of the tombs.

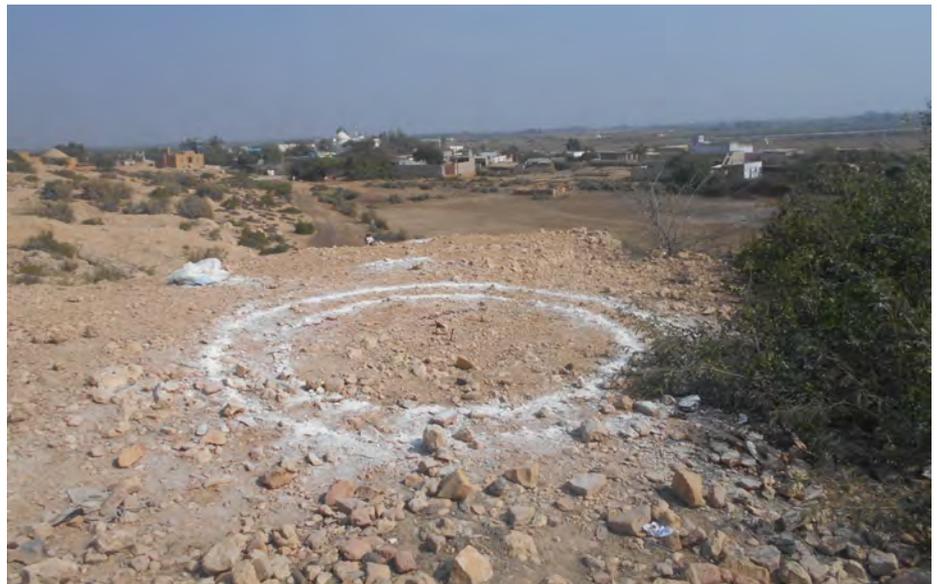
Layout of display area near Sultan Ibrahim

It was decided that since work had begun on site, an information display space would be constructed near the site. This space would hold various panels of information on the details of the project, i.e. a short history of the tomb and prior work of conservation undertaken, project time line and milestones achieved, conservation work being undertaken during the month along with a small sample area. The layout of the display space was undertaken and construction begun. The completion of the unit has been set to the end of February, 2015.

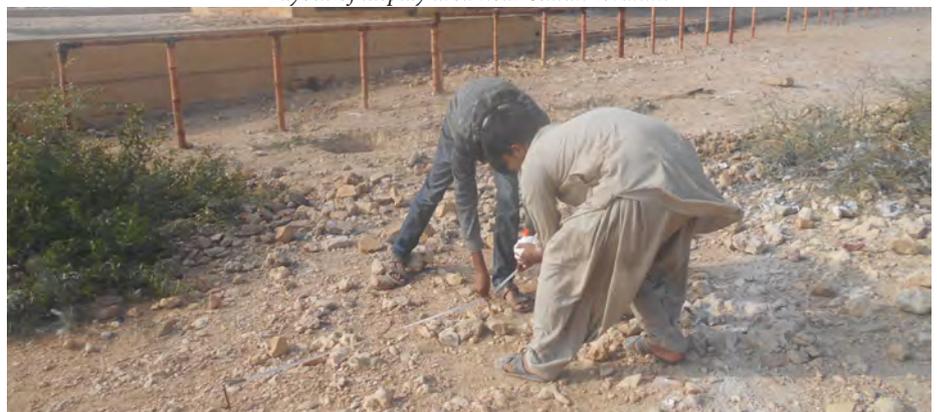
Work being undertaken for construction of display space at Sultan Ibrahim

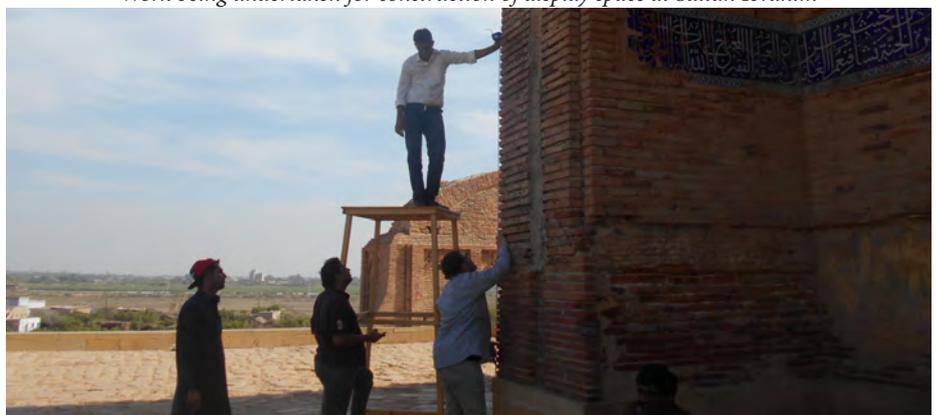
Physical Survey being undertaken at Sultan Ibrahim

Due to the complex nature of the building and its defects, the physical survey of the building has proven to be the most testing activity thus far. Two separate consultants had been engaged, but after various on-site discussions, meetings in Karachi, peri-

odic sharing of information and drawings, the final output of drawings by both consultants was not according to the requirements specified by structural consultants. Defects in the form of bulges, leans of walls, damage to masonry and squinches could not be highlighted by the as-built drawings prepared. Therefore, it was decided in the middle of December, that the physical survey and further details would be completed in-house by HF itself.

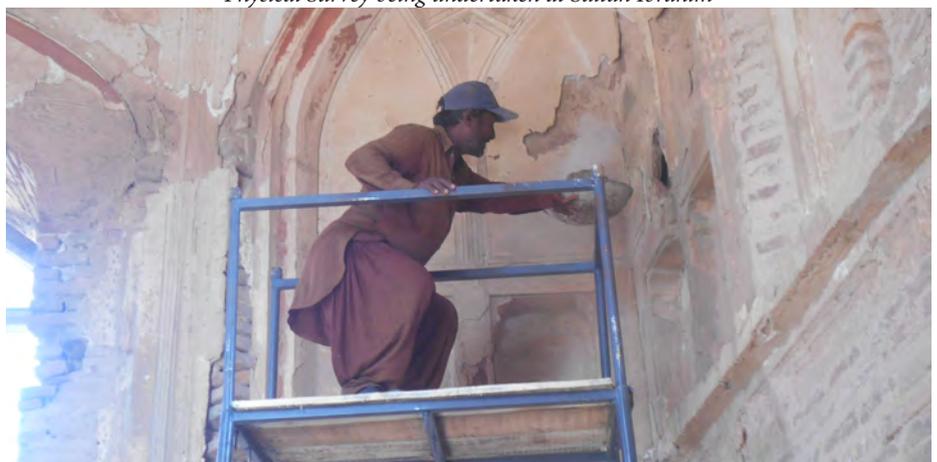
Smoking wasp infestation between walls

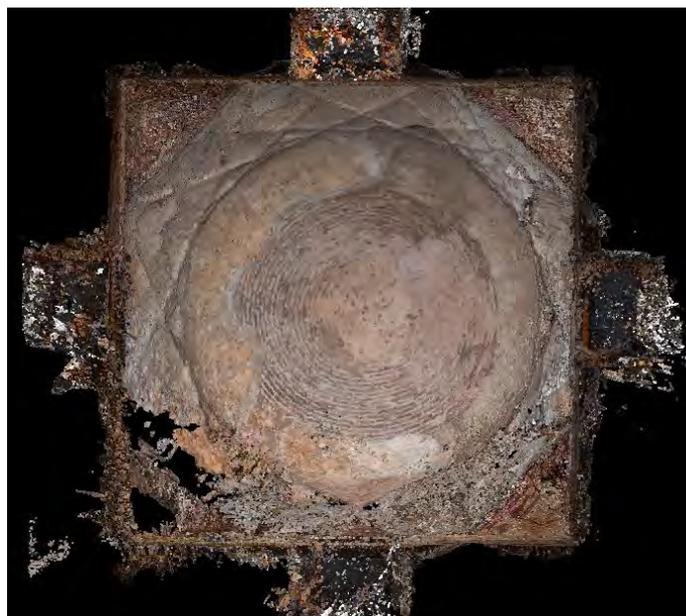
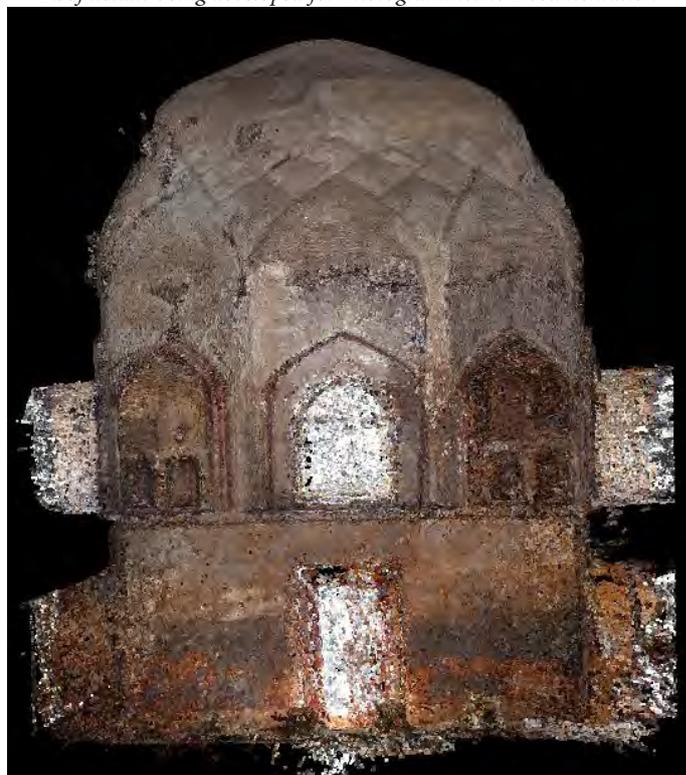
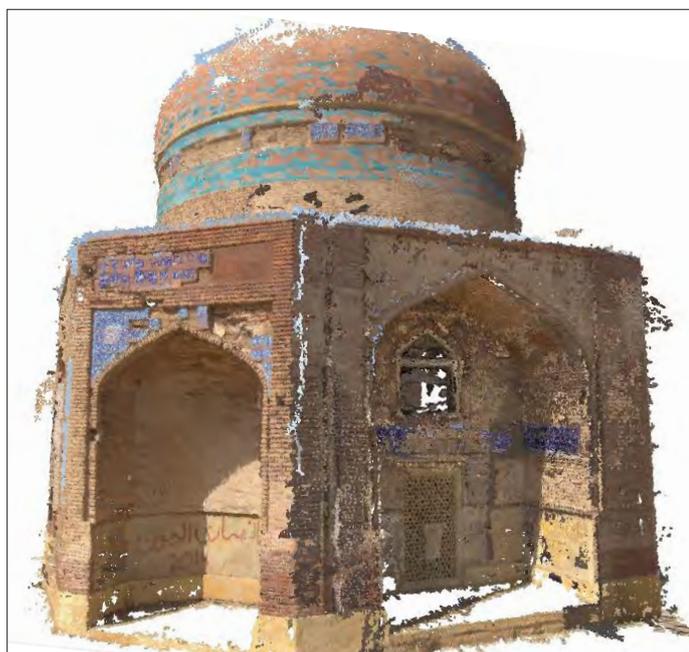
Roof details being developed for Photogrammetric Documentation

Internal view being developed for Photogrammetric Documentation

External views being developed for Photogrammetric Documentation

Alongside completion of physical survey, a photogrammetric documentation was undertaken. This involves the capturing of the built structure with the use of a GPS camera followed by rigorous processes in various software, to prepare a 3d model, which represents the complete condition of the monuments. The 3d model can then be used to prepare as built drawings, complete the conjectural information of the conservation process and highlight the various defects in the structure. Detailed drawings are being prepared in order to record each and every part of the subject structures. As valuable time was spent in preparing drawings, it was decided that Damage Assessments and Condition Surveys would be undertaken in a parallel fashion. Accordingly, condition survey and various treatments are in the process of finalization, for which services of Conservation Specialist, Ms. Saba Samee have been procured for finalization of the report in February 2014.

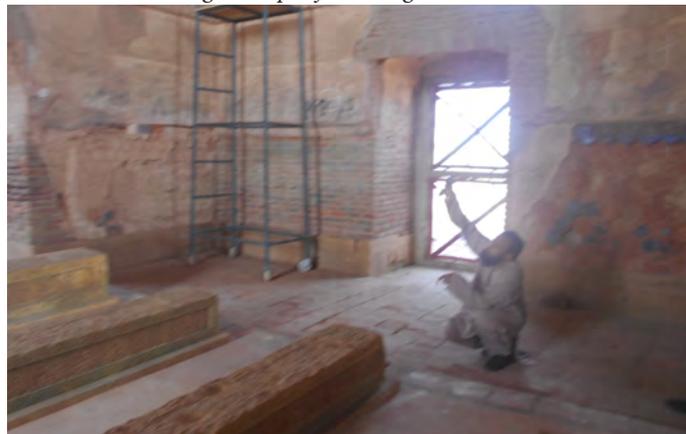
HF personnel undertaking Photogrammetric Documentation
