US Ambassador's Fund for Cultural Preservation Tombs of Sultan Ibrahim & Amir Sultan Muhammad at WHS Makli, Thatta Progress Report No - 2017/7-9 July - Sept 2017

TOMB OF SULTAN IBRAHIM

Progress Report No - 2017/10-12 Oct - Dec 2017

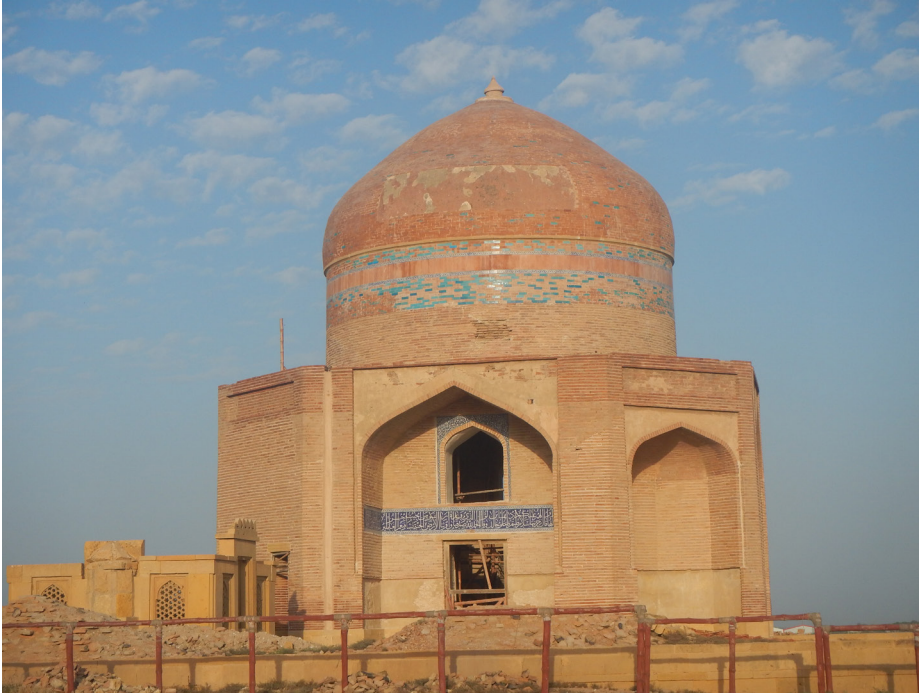
View of monument after removal of scaffolding.

As all the work on the dome had been completed, the bamboo scaffolding that was constructed in 2016 was dismantled and taken down. This was a major operation as the entire scaffolding which had been constructed to withstand the wind pressure and would provide security to workers while conserving the dome area, was dismantled section by section. The entire bamboo pieces had to be carefully brought down ensuring that there was no damage to the conserved walls of the staircase.

The removal of the scaffolding finally made it possible to see the hard work that had been expended on making the dome presentable once again.

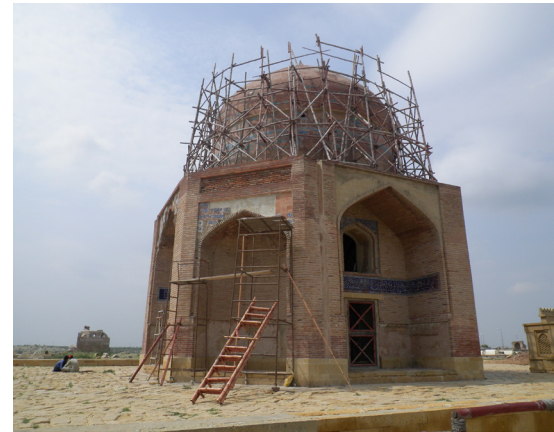
View of monument during removal of scaffolding.

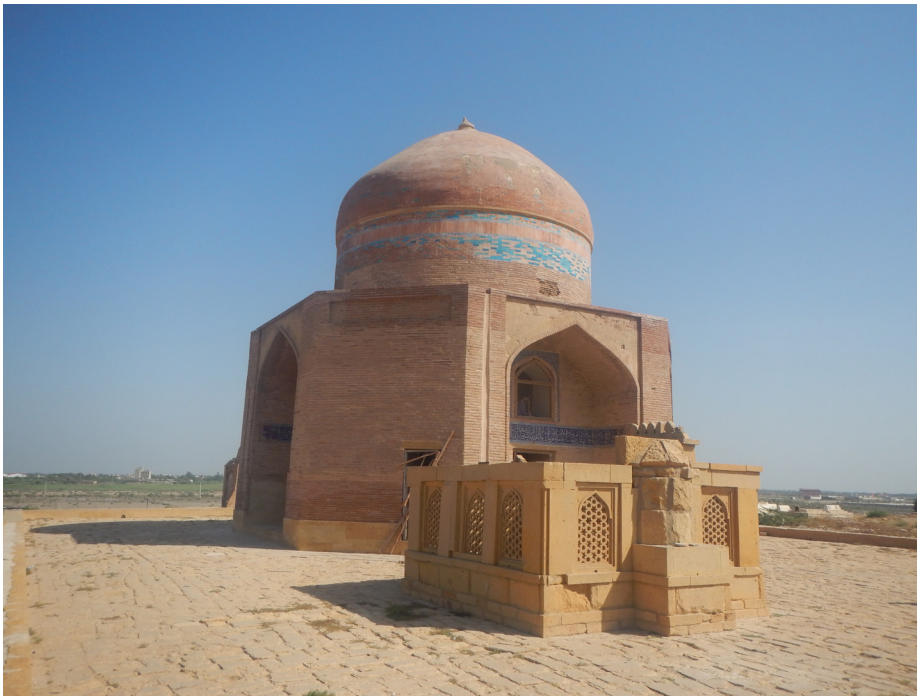
General view of tomb of Sultan Ibrahim and Amir Sultan, podium pavement and the environs after completion of work.

The month of October was utilized to finish off all the works. It was decided to maintain the wooden frames that had been placed at some later time but which were in an excessively bruised condition with many nails and screws. The surface had become highly damaged and required repairs to make place them into a presentable condition. The paint had blistered and was in a highly blemished state. The entire paint was removed, the holes were filled in and the entire surface were provided natural polish.
