Sepulchre of
Mirza Jan Baba
Father of Isa Tarkhan the Second

Yasmeen Lari
2017

© HERITAGE FOUNDATION OF PAKISTAN 2017

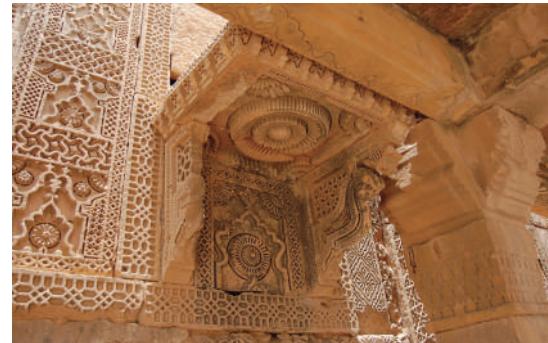
Detail of exquisitely carved jharoka.

main entrance internally and externally. The *jharoka* elements are in a highly damaged state, having lost their projecting sculptural parts. Even though a triple *mihrab* appears as early as the 15thc. tomb of the Samma ruler Jam Nindo or Nizam al Din, here it is a two-*mihrab* treatment. The most profuse ornamentation in the perimeter walls is reserved for the *mihrab* alcove that enunciates the *qibla* direction on the west. The giant wall of the outer *mihrab* rises 17'3" above the ground and 6'8" above the Perimeter Wall, and punctuates the western wall. While the entire wall is treated with elegant carving, it is the inner *mihrab* itself that was selected for the most profuse ornamentation.

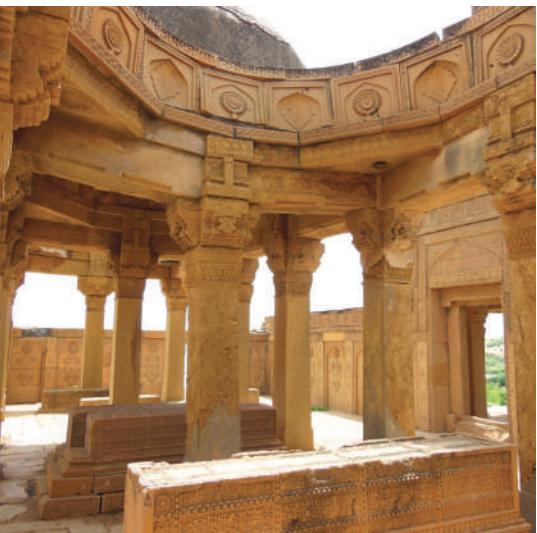
The transition from the square bays of the colonnade into octagons by employing triangular stone pieces at the corner of pillars can be seen in the extant central dome with a diameter of 10'. A unique cupola shape is achieved through the formation of concentric rings, converting the octagon into a 16-sided dome and gradually reducing in size until it reaches the top. The surviving concentric rings laid on the eight-sided base of the two collapsed domes point towards their form being similar to that

Graves Canopy. Voids show arrangement of phase of transition for cupolas.

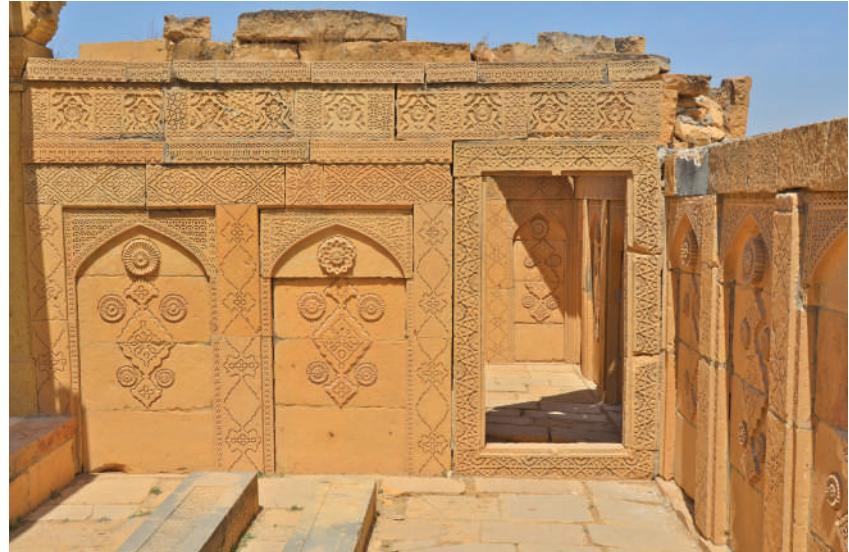
The zenana was delineated within the enclosure. It is a separate chamber of size 11' x 11', and houses the graves of imperial females. This is a secluded chamber that appears to have been topped by a cupola of 9'8" diameter. Its roof having collapsed, the chamber was found in a highly damaged state. The roof void had left the interior features, and indeed the graves themselves, entirely at the mercy of the elements. The extant triangular pieces, laid diagonally in the corners, are similar to the arrangement for the cupolas in the Grave Pavilion. Thus, even though the lower course of stones had been lost or displaced, no doubt

Entrance doorway to Zenana Chamber seen from inside the Enclosure.

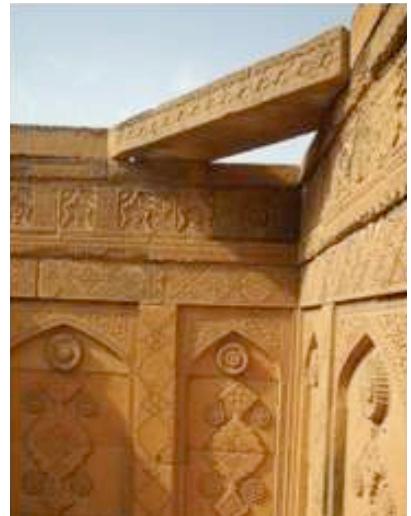
Zenana Chamber. Extant triangular corner stone at the base of collapsed roof.

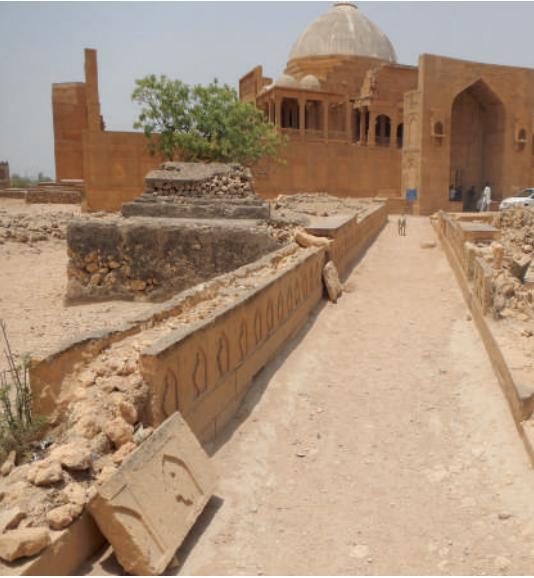
Walkway. Remnants of dwarf wall.

The walkway, which appears to have been constructed at a later date, provides direct access from the tomb of Isa Tarkhan II. It was found in a highly dilapidated condition, most of the carved stones having been lost, exposing the pathway to misuse and pilferage. The walkway is an important element that provides accent and significance to a tomb which was neither as baroquely ornate nor as lofty as the exalted sepulchre of Isa Tarkhan II, a ruler with high-ranking powers bestowed on him by the Mughal emperor. The loss of a major part of the walkway had undermined the value of his father's sensitively built tomb with its classical attributes. The 8' wide path extends to 91' length and once carried 3' high dwarf walls on its northern and southern aspects. An offset at the eastern end, provides a width of 12'9" close to the Entrance Canopy. The dwarf walls were composed of 4.5" thick carved stone slabs carrying simple ornamentation, and topped with 6" thick dressed stone slabs.

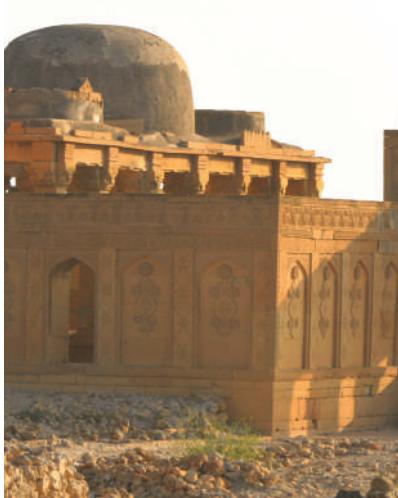
Perimeter Wall from southwest. Extant cupola and base only of the east cupola can be seen.

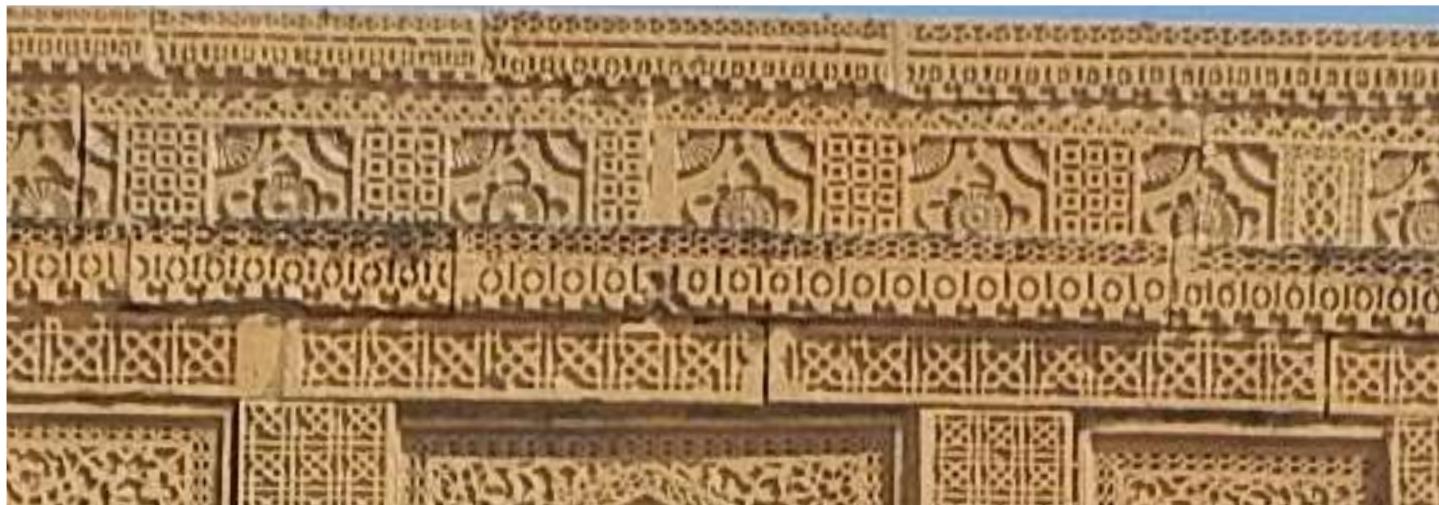
Carved frieze stones above Perimeter Wall.

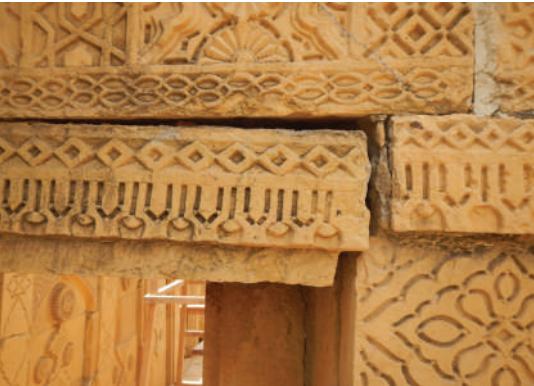
Zenana Chamber. Displaced lintol (above) and view into the chamber (far right).

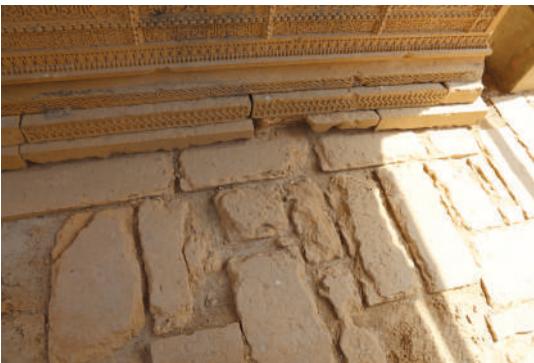
Zenana Chamber. Damaged state of flooring.

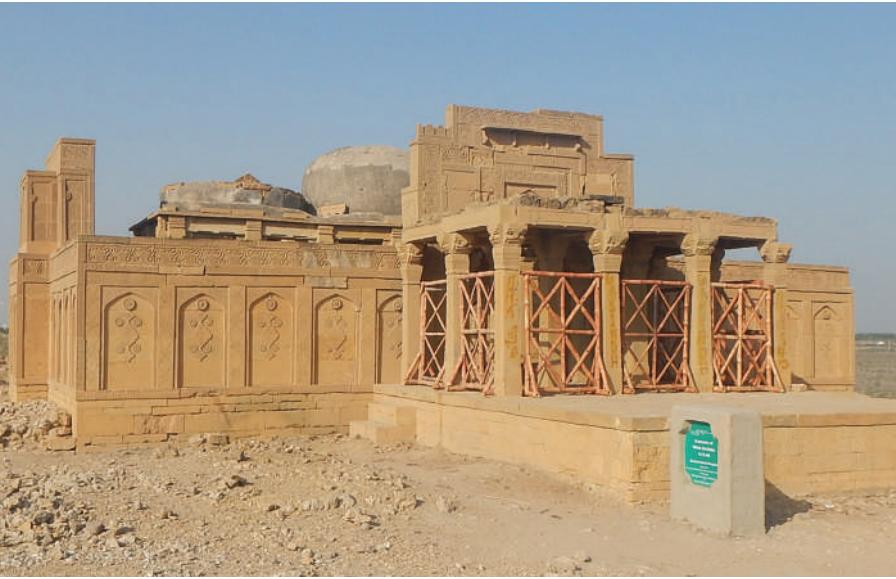
Barricades provided to prevent entry into Entrance Canopy.

As soon as permission from the authorities was received, steps were taken to forestall such damage in the future, and the monument was barricaded from unwanted visitations. Specially designed bamboo barriers were erected in all openings. In view

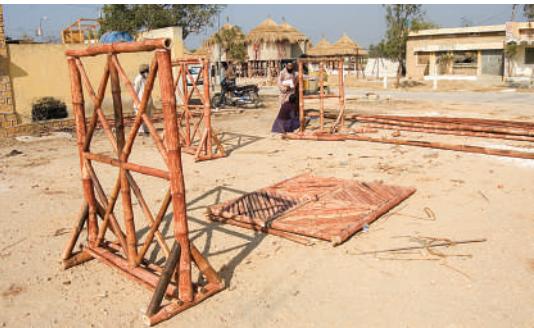
Free-standing bamboo barricades.

of the fragile nature of the monument, the barriers were designed as stands and their bases were fitted with padding to prevent any damage to the flooring.

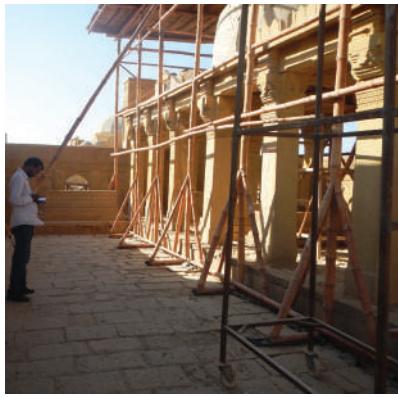
Enclosure. Carefully placed supports for temporary bamboo roof over Graves Canopy.

During the construction of this temporary bamboo roof, the graves and flooring were covered with gunny bags to prevent any inadvertent damage. The erection of the temporary bamboo roof provided the much needed protection to the entire Graves Canopy ensemble and rescued the Graves Platform from further damage. As in the case of the Graves Platform where two cupolas had been lost, the Zenana Chamber's roof had also collapsed several decades ago. Because of the void in the roof, rain water had played havoc with the interior, and the chamber was in

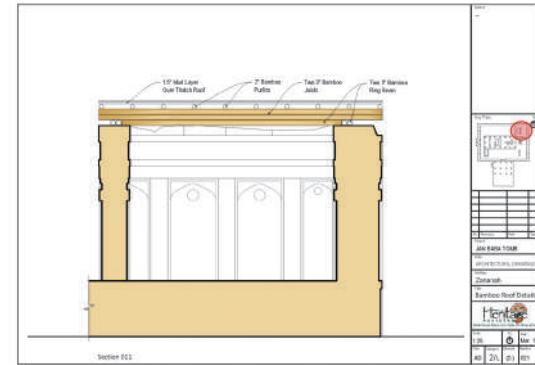
Zenana Chamber. (Left) Flat bamboo roof constructed to provide cover. (Above) Section showing details of construction.

urgent need of cover. The evidence of a cupola was unclear at the time and it was decided to place a flat roof on the chamber. However, once evidence of stone rings for the original cupola was unearthed, the newly built bamboo flat roof was removed and a bamboo cupola constructed instead.

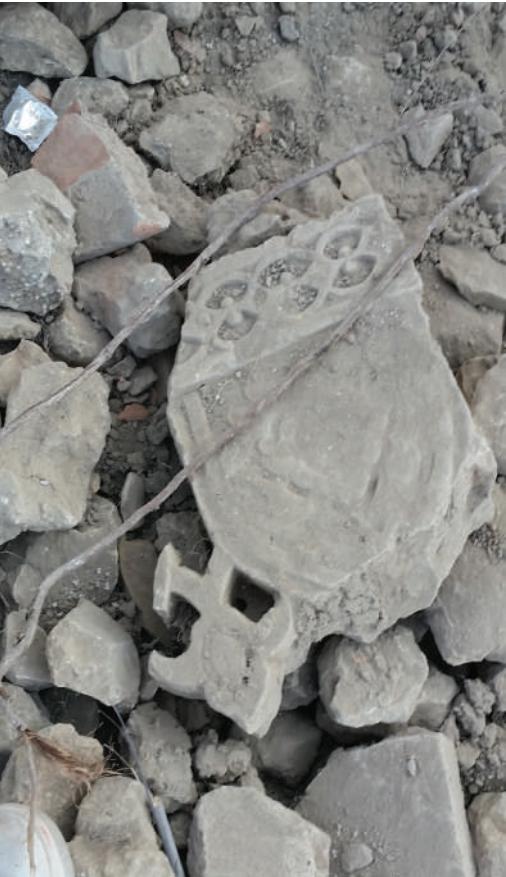
(Above and right). Carved stone pieces strewn around the site.

that were strewn around the tomb periphery were carefully and gently picked up and placed away from the tomb.

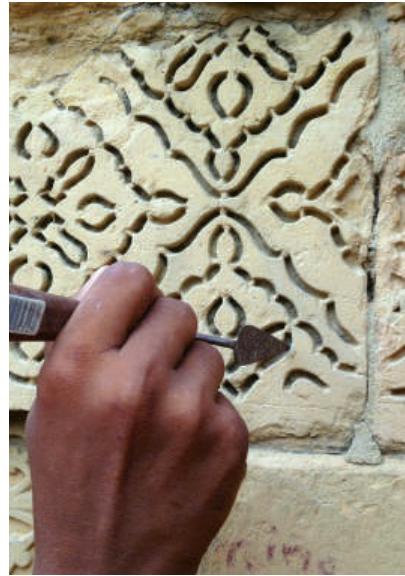
(Left & above). Gentle cleaning using tooth-brushes to remove dirt from crevices.

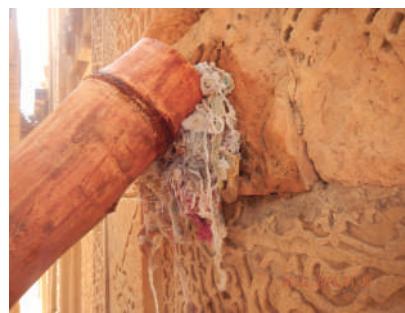
Using poultices to soften dirt.

Poulticing was applied consisting of soft cotton soaked in warm water and left on the surface for at least 2 hours. Once the dirt had become soft, tooth brushes were used to remove the dust deposits, gently and gradually. In some stubborn cases slight scratchings also had to be used to remove the accretions from deeply carved motifs. It was made sure that great care was taken, both in soaking of stone and during the process of removal of dirt residue.

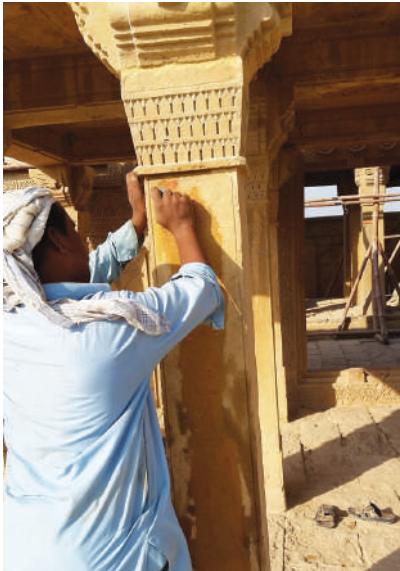
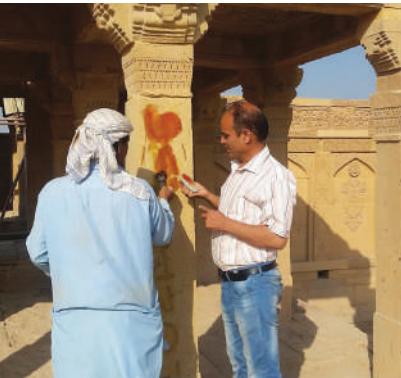
(Above and far right) Removing stubborn graffiti from stone surfaces. Guidance being provided by Nabeem Shah.

to paucity of guards, and unfortunate visitors' behavior, graffiti was seen on many surfaces of the monument. Although normally it is difficult to remove the marks made by markers etc., however, here too a combination of Lizapol and soapnut soap, applied gently but firmly was used, without inflicting any harm to the original surface of the stone. The strategem resulted in finally getting rid of the stubborn graffiti, that had marred the beauty of this remarkable monument. In several places remnants of loose cement plaster were found. Where cement repairs were difficult to remove and there was danger of causing damage to the original stone, these were left in their place. Any cement application that can be seen today in the monument is part of the interventions carried out in the past.

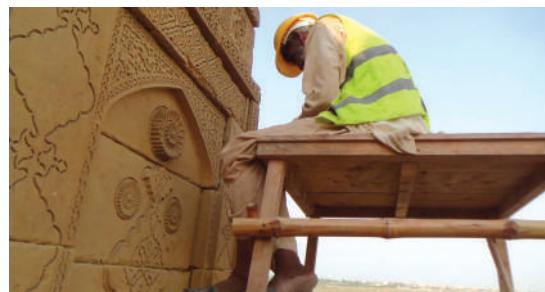
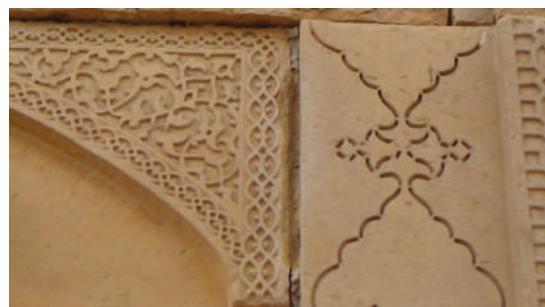
Thorough cleaning and pointing of joints.

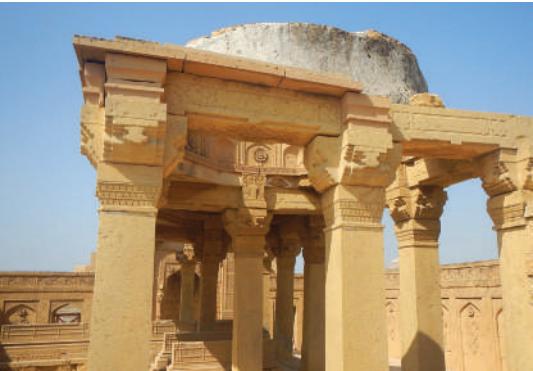
Loss of cupola making structure of Graves Canopy vulnerable.

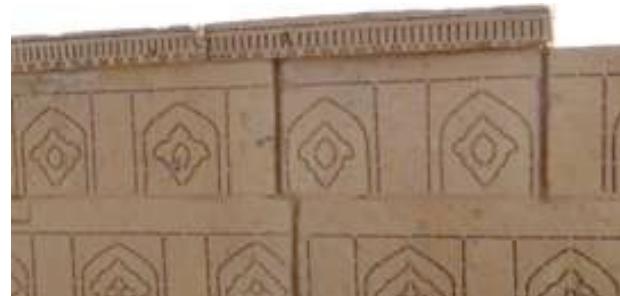
Pointing in progress to seal all joints.

sured that field staff would not miss any areas. Pointing was thus carried out very carefully by specially trained master artisans and in areas that had been identified. All pointing was deep struck and unobtrusive in order that the character of the monument is maintained, at the same time water ingress into the structure is prevented.

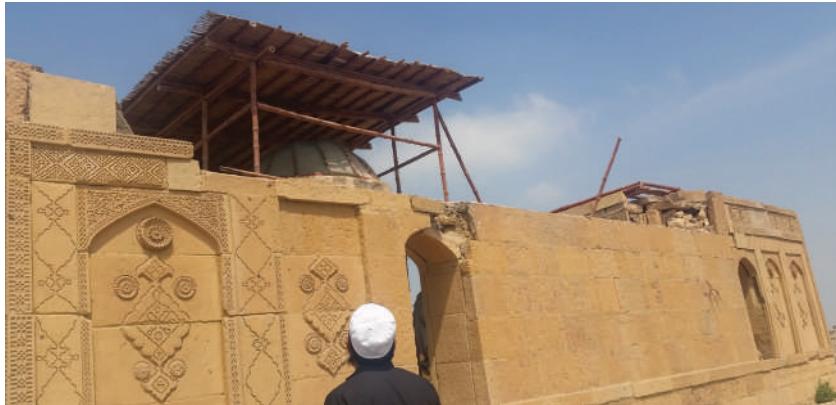
East Perimeter Wall. As part of early 20th c. restoration, rebuilt portion of wall with simple dressed stones between openings can be seen.

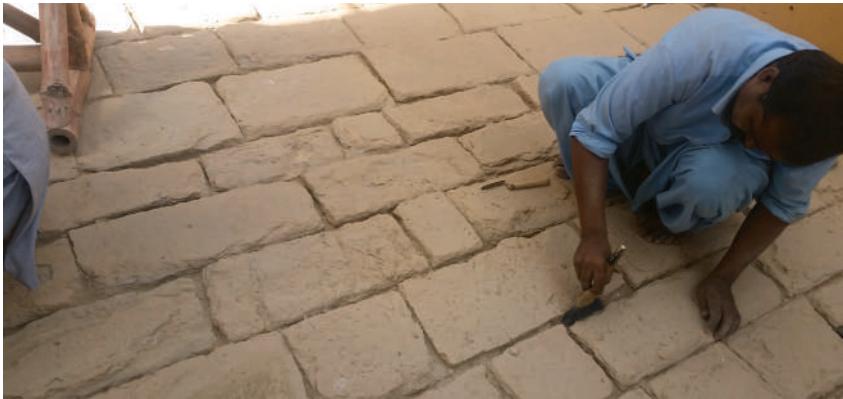
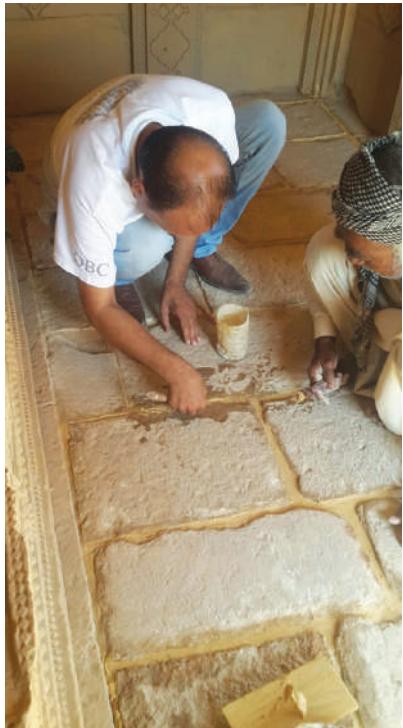
(Right). Thorough cleaning deep joints of flooring to prepare for pointing in two to three layers.
(Below). Naheem Shah supervising application of pointing.

Stone flooring was used on the Graves Platform, inside the main enclosure, in the Zenana Chamber and in the Entrance Canopy. In all areas it was in a highly damaged state. Most of the joints had opened up which had exposed the flooring to constant water seepage. Although a drain existed in the enclosure and punctured it at floor level on the southern perimeter wall, it seems to have been blocked for several decades. The lack of drainage was among the causes that aggravated the dilapidated condition of flooring inside the enclosure.

It was thus important to ensure the sealing of all joints. Drainage of the flooring in the main enclosure was worked out and it was ensured that the floor was fully drained. Although initially it was thought that part of the flooring would have to be re-laid, it was later found that, after repointing, the paving could be maintained in its present condition.

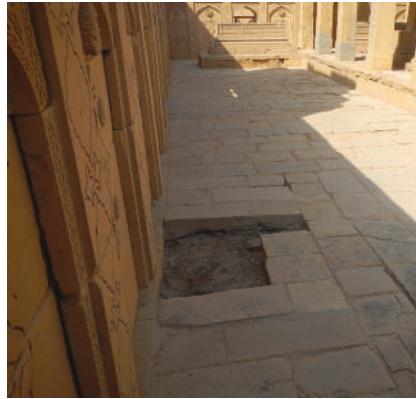
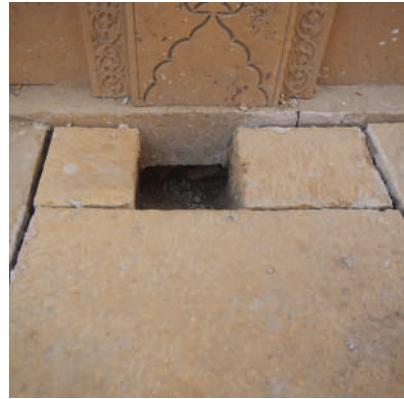
(Far left and left). 'Before' and 'During' images of making up lost stones near drain in the enclosure.

Accordingly, where considered necessary new dressed stones were placed. The new stone pieces were kept at a minimum.

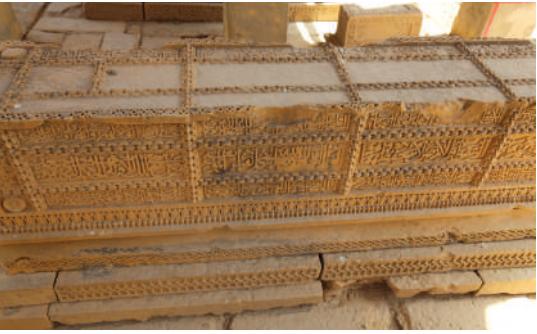
Grave with damaged base stones.

An element of concern was the misalignment of one of the graves where the base stones had been damaged. The entire sarcophagus was hoisted up with great care, and new stone slabs were inserted to stabilize it. This was a challenging activity as in case of any mis-step, the damage could be irretrievable.

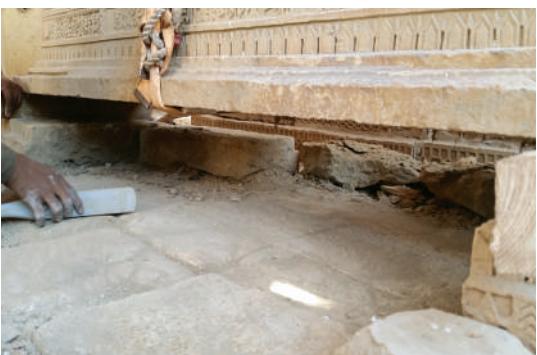
Lifting the sarcophagus to reset eroded stones.

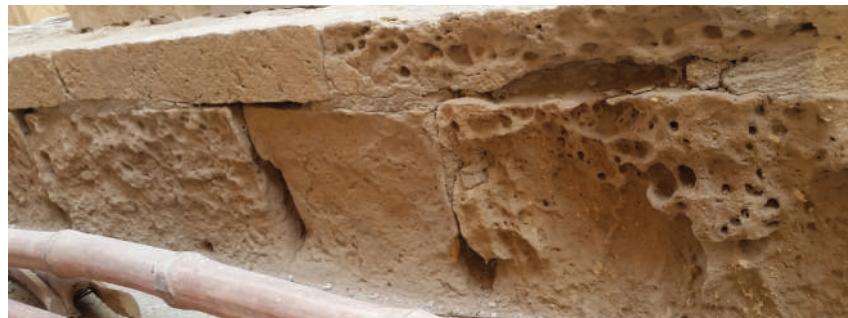
Level of erosion in Graves Platform stones.

A time-consuming procedure was devised. The susceptible points consisting of a net of cavities and holes were injected with a syringe carrying a mix of lime/sand/stone dust mortar to prevent further degradation, without altering the character of the marred stone.

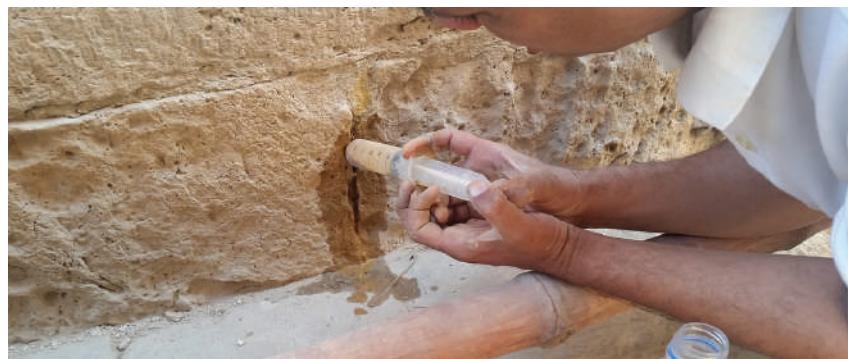
Injecting mortar in voids with sacrificial layer of lime and stone dust.

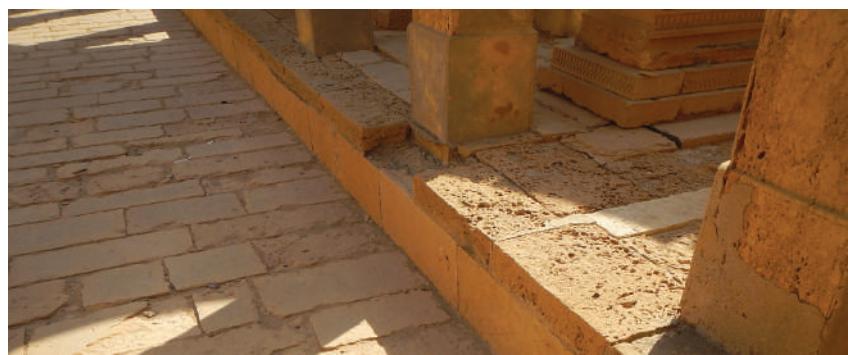
View of stone slabs after injection of mortar.

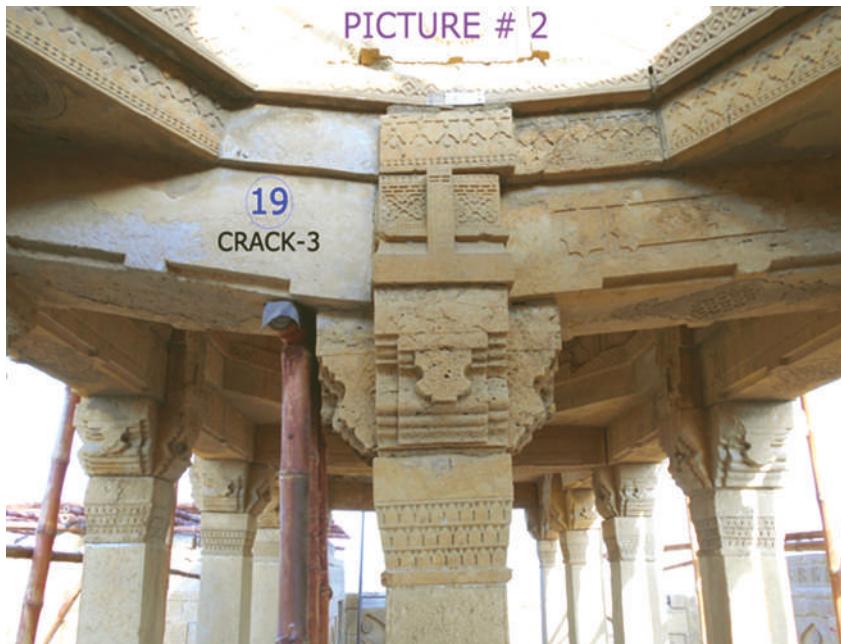
The settlement was evident in the tilt in the columns located on the west of the central bay, and in the deflection and misalignment of the stone beams and slight deformation of the cupola's profile. It is likely that the structural defect was caused by placement of one of the graves at a later date which might have

been filled with loose earth. To determine conclusively regarding any movement in the structure, arrangements were made for regular scientific readings through Total Station measurements and placement of crack monitors. The appraisal enabled monitoring for movement in north-south and east-west directions, and a separate log, along with pictorial evidence, was maintained for the data. After carrying out the study for 10 months, it was concluded that there was no longer any movement in the structure, as the deformities appear to have stabilized over several decades. Accordingly, filling of open joints in the cupola would suffice for providing protection from the weather.

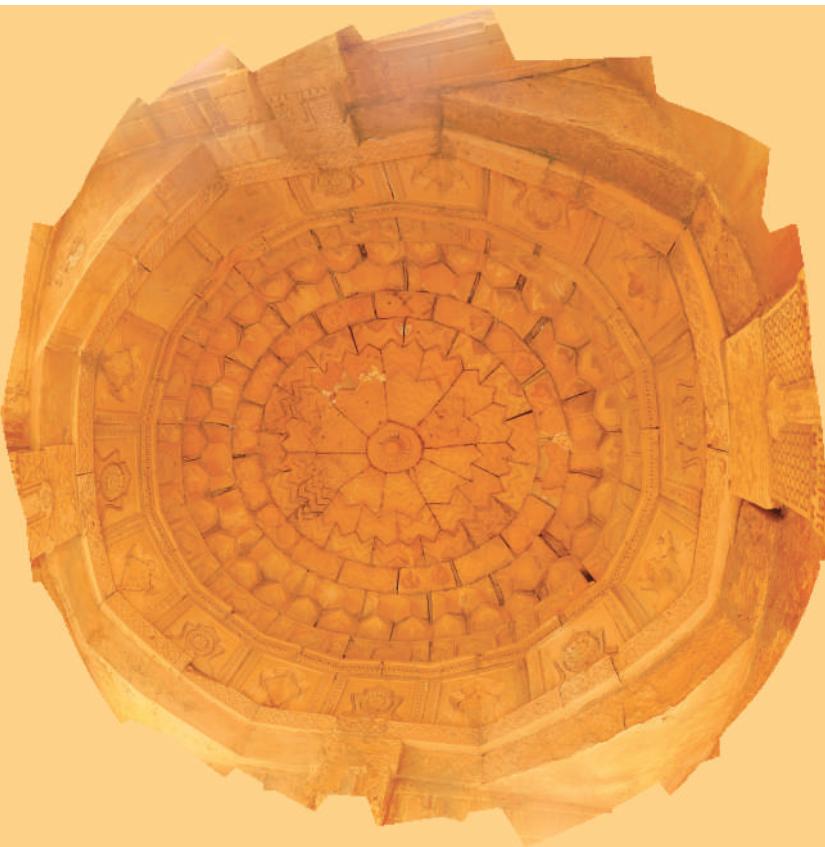
Stitched images. Entire extant dome.

After a detailed discussion by the Experts Committee it was decided that in order to maintain its integrity, the extant dome should not be dis-assembled. The slight deformation and the wide joints that had appeared over time should be accepted and no attempt should be made at aligning any part of the structure.

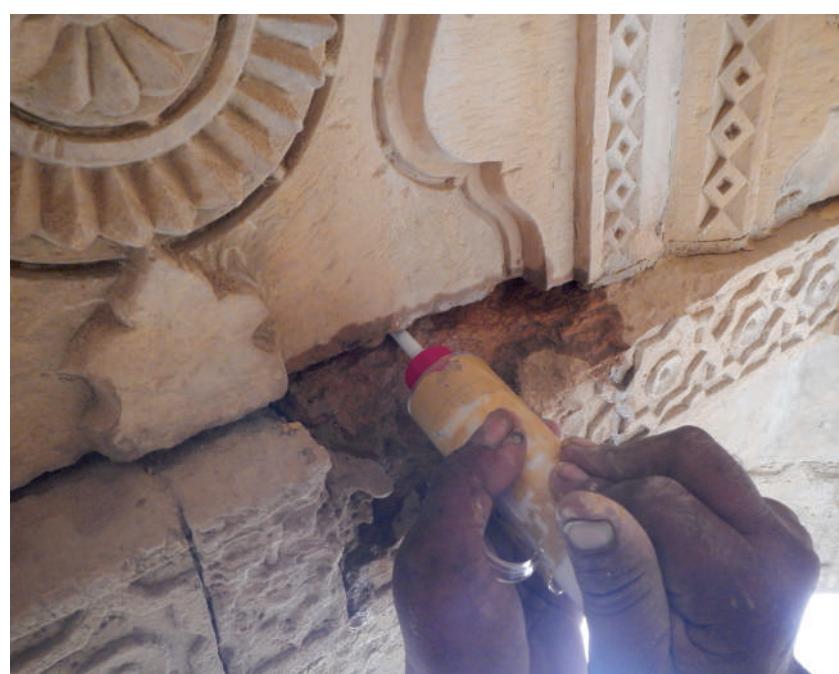
Filling mortar in small joints with an icing gun.

This strategem ensured that the original dome remained safe and was not subject to any danger at any time throughout the implementation process. The treatment was rationalized, adopting different techniques for treating narrow and wide joint widths. The narrow joints were filled through and through by injecting mortar using a household icing gun. Once the joint was filled, pointing was applied following the normal pointing procedure.

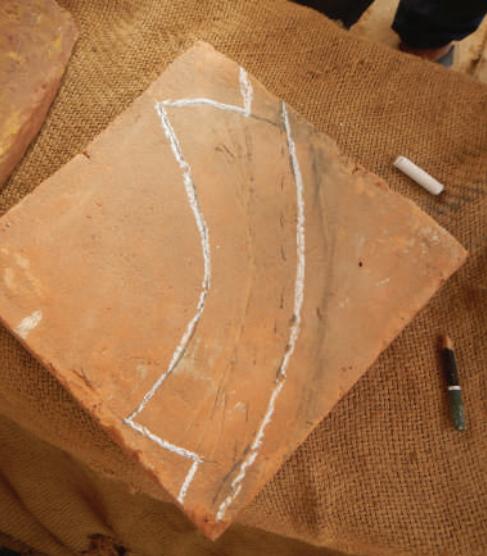
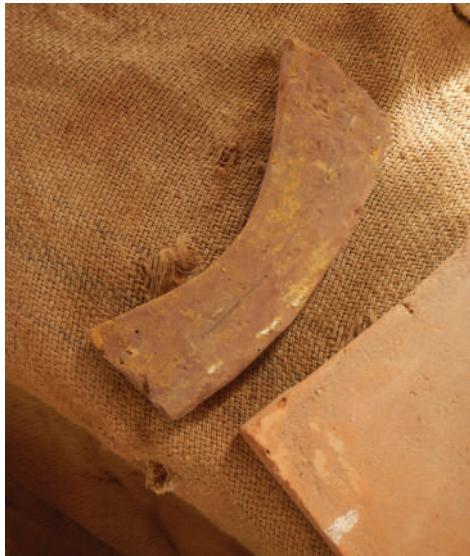
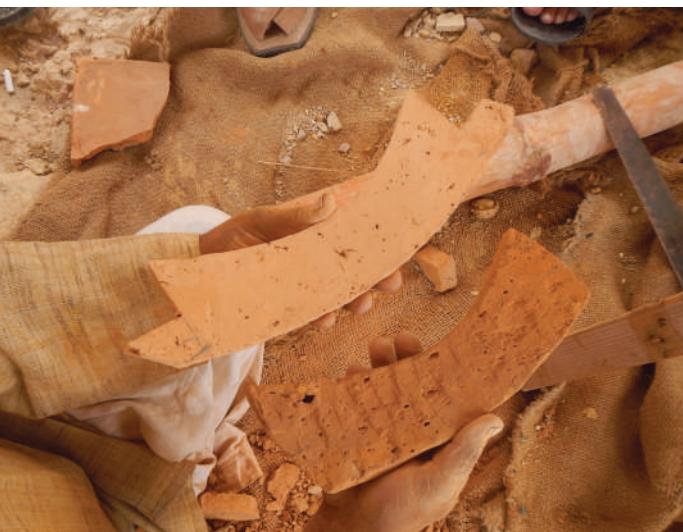
(Above). Stages of profiling terracotta for insertion in dome joints.

Due to the ease of handling, the skilled artisans were able to carve the exact shape and contour needed for each location. Being weaker than stone, it was less likely to develop cracks in case of any movement in the structure, and was thus appropriate for conservation; being of lesser weight than any stone filling, it inflicted minimal weight on the structure. The entire work was carefully supervised. The intervention was carried out carefully by highly proficient master

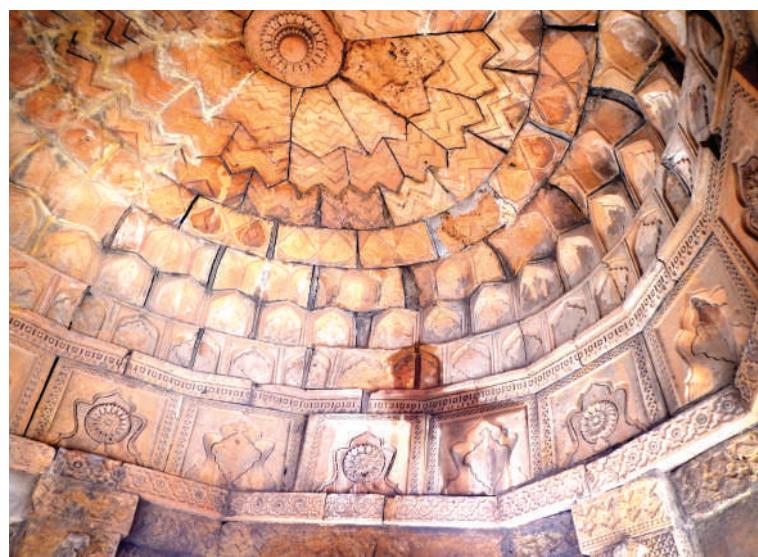
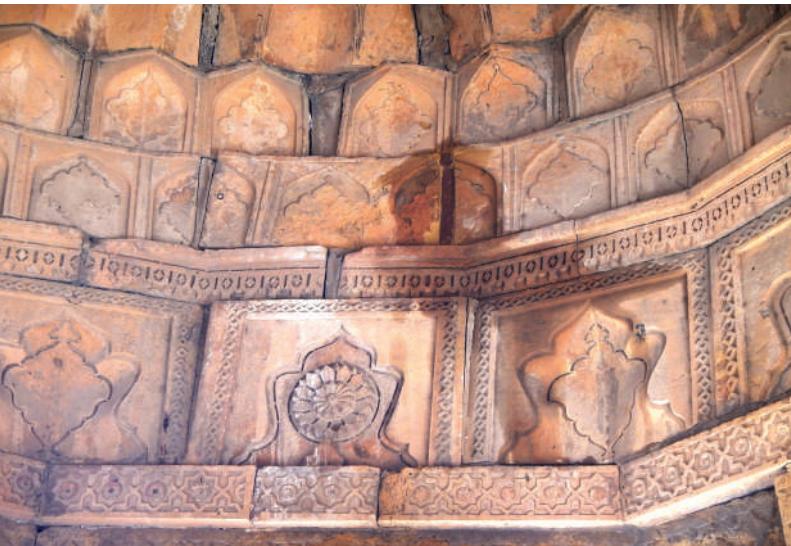
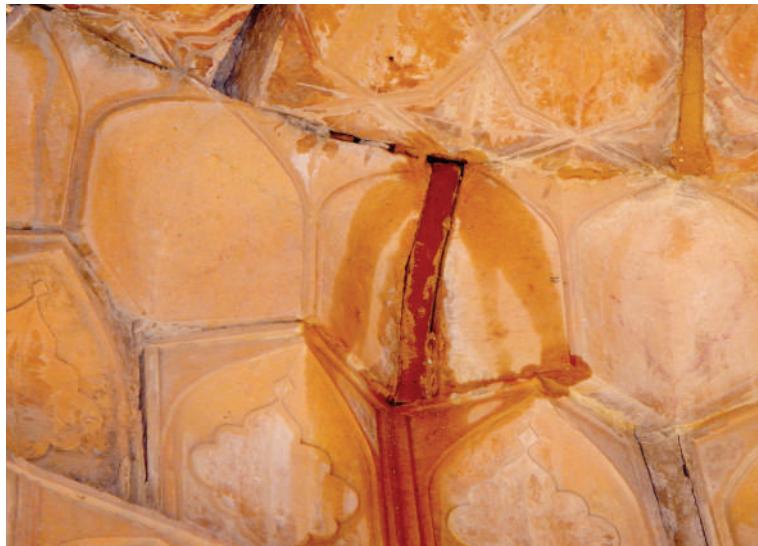
Images recording the process of profiled terracotta infills in large gaps in concentric rings of the extant cupola.

The treatment has stabilized the dome and made it weather proof. The work has been carefully monitored since its execution in August 2015 and no signs of cracks have appeared in 16 months. The profiled terracotta insertions are visually non-disruptive.

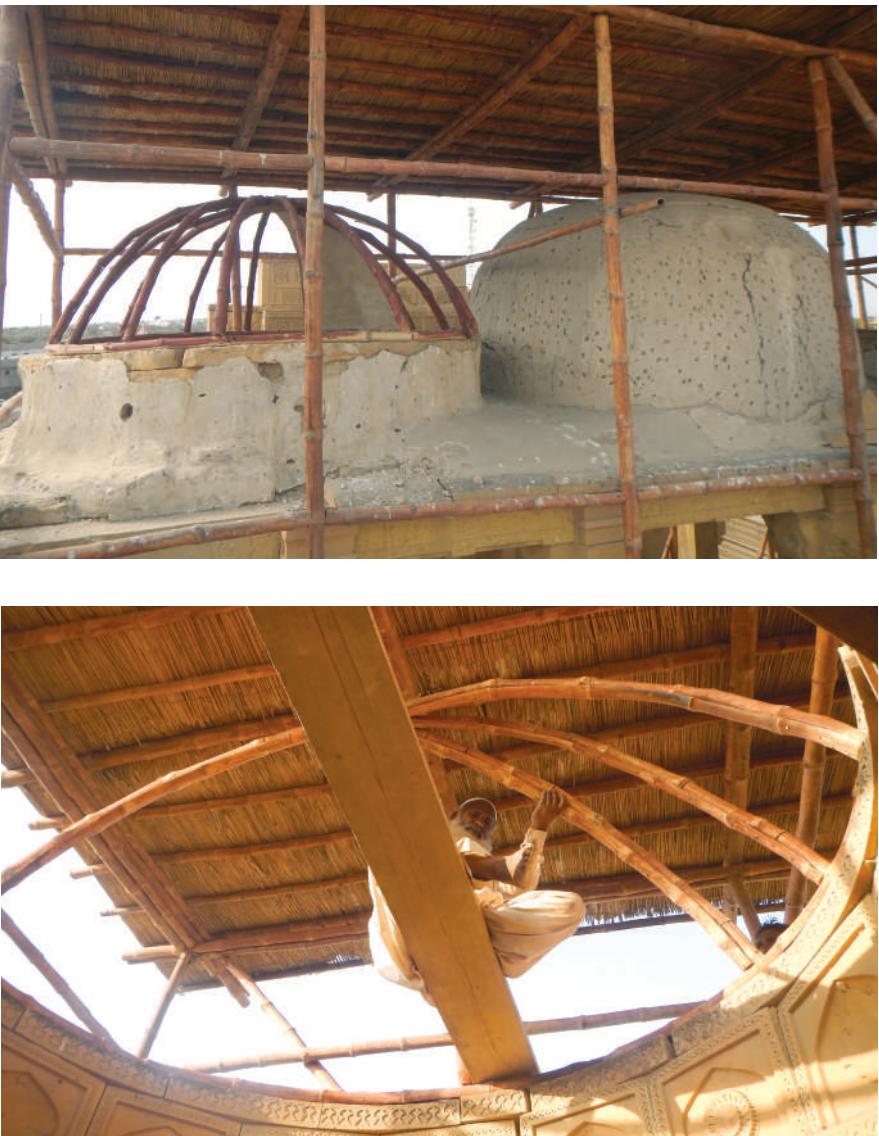
First trial dome on west bay under construction.

It was found that bamboo structure could be built without causing any damage to the original extant stone pieces that lined the periphery of the void. The details of fixing had been worked out carefully and the new dome was therefore stable and strong. However, being the first attempt it was found that the exact profile of the dome had not been achieved and would thus have to be reconstructed. The dismantling of the bamboo dome was surprisingly easy and was achieved without harming the extant structure.

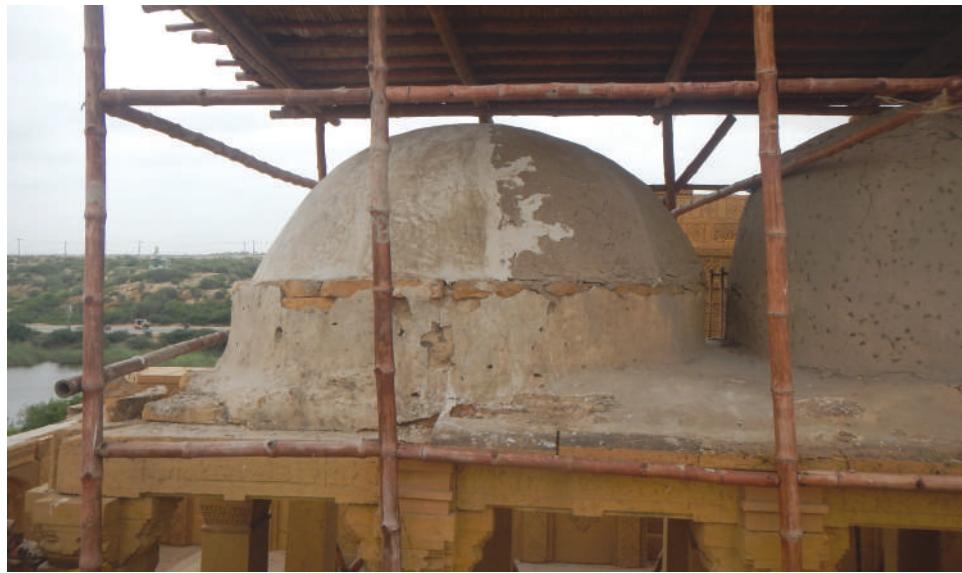
Finishing new dome to match extant central dome.

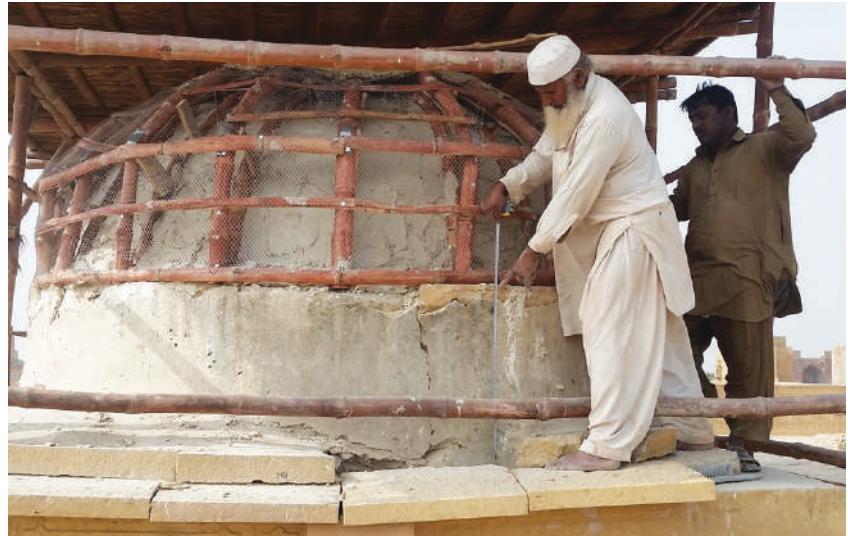
(Right) Ismail Baba constructing double bamboo skeleton with different internal and outer profiles.

With more confidence in achieving a polished output, bamboo domes were constructed on both western and eastern voids. The structures consist of inner and outer skeletons, resulting in two slightly different hemispherical forms that were tied together at intervals with stainless steel plates and bolts.

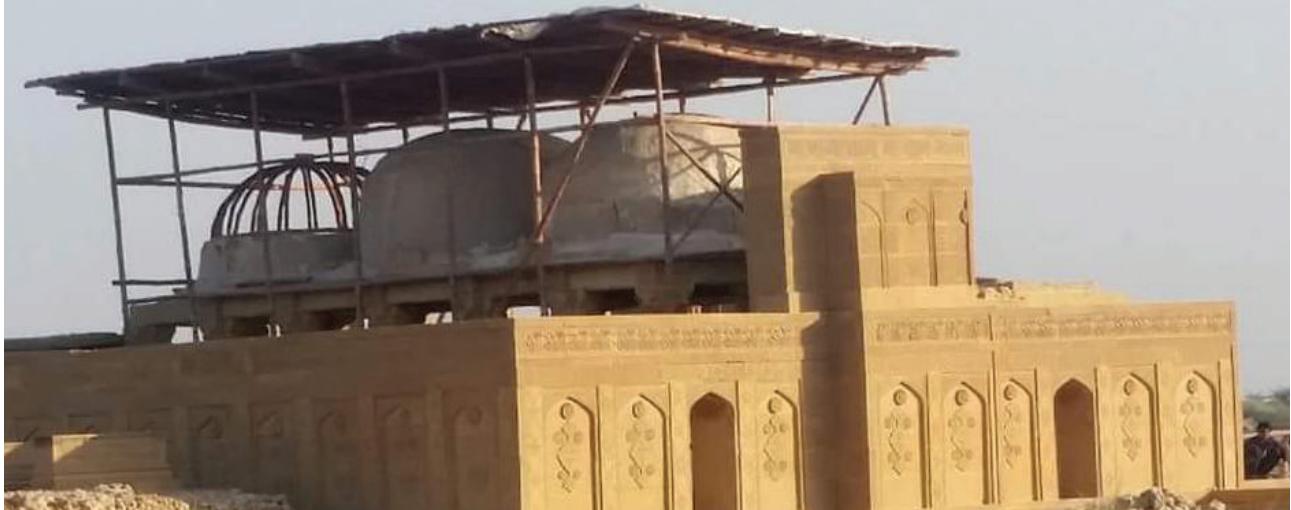
(Above). Construction with double bamboo skeleton to construct divergent internal and outer profiles.

The joists of the bamboo skeletons were anchored carefully into bamboo reinforced lime concrete ring beams. Stainless steel netting was fixed to the external as well as internal skeleton frames

to receive lime / sand / stone dust render, applied in two successive layers.

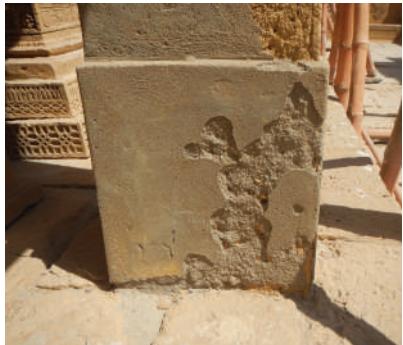
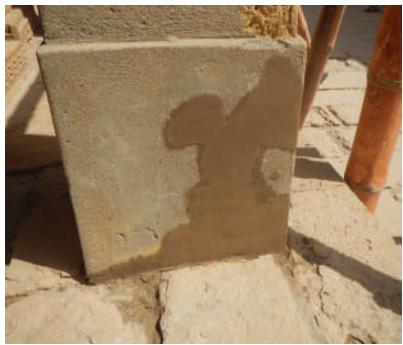
Generally, in many places use of cement was noted as part of interventions carried out at some stage in the past. Although the actual dates could not be determined, but it is likely to have been carried out during the 1960s by the custodians. Due to this treatment many pillars of the Graves Canopy presented an unsightly appearance.

'Before' and 'During' view of sacrificial layer to repair earlier cement intervention.

After testing with sample patches of lime / sand / stone dust mixes, a sacrificial layer was applied at deteriorated surfaces of the shaft to prevent further erosion of the inner core. However, wherever cement mortar had become brittle and likely to cause damage if removed, it was left alone.

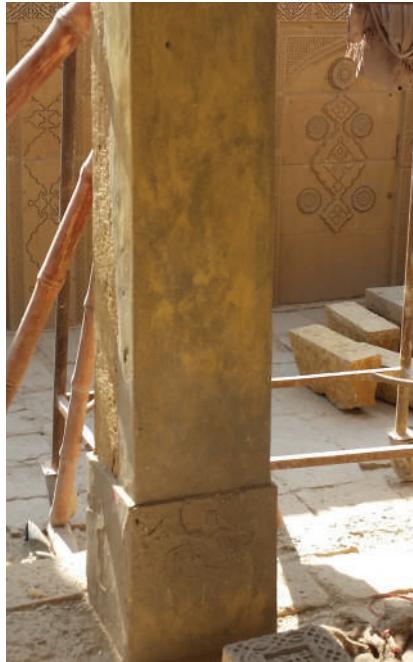
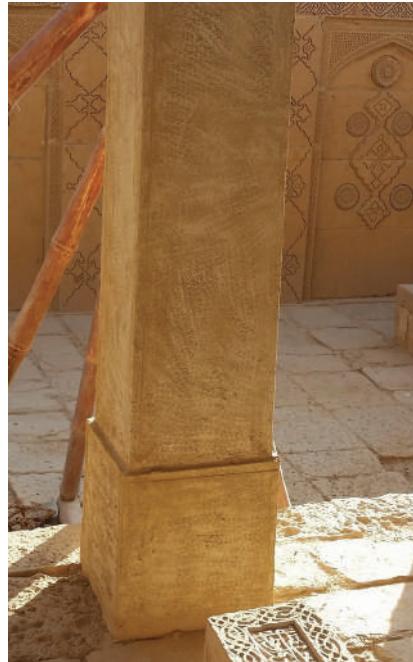
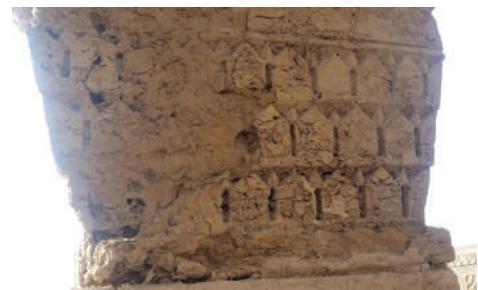
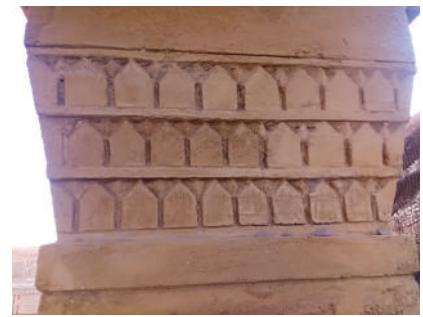
The southwest corner pillar had suffered from excessive erosion where the entire protruding carved capital had become defaced. With painstaking action, using a mix of lime / sand / stone dust, the master artisans were able to replicate the intricately carved features of the capital. The reversible carving technique using sacrificial mortar will prolong the life of the inner core of the capital, at the same time keeping safe its original eroded sur-

Providing sacrificial layers to provide protection to inner eroded core. (Left) 'Before' and 'After' on posts. (Above). Before and 'After' on capitals.

faces. Only those capitals have been restored that suffered from a high level of erosion. At the same time many others which were damaged, have been treated with injection of mortar with a syringe. The injection into the erosion-inflicted net of cavities has not materially altered their character, however, this treatment has provided protection from weathering for the next several years. This painstaking effort was necessary in order to retain the original character of the Graves Canopy at the same time adopt measures in order that the original stone surfaces are protected from further degradation.

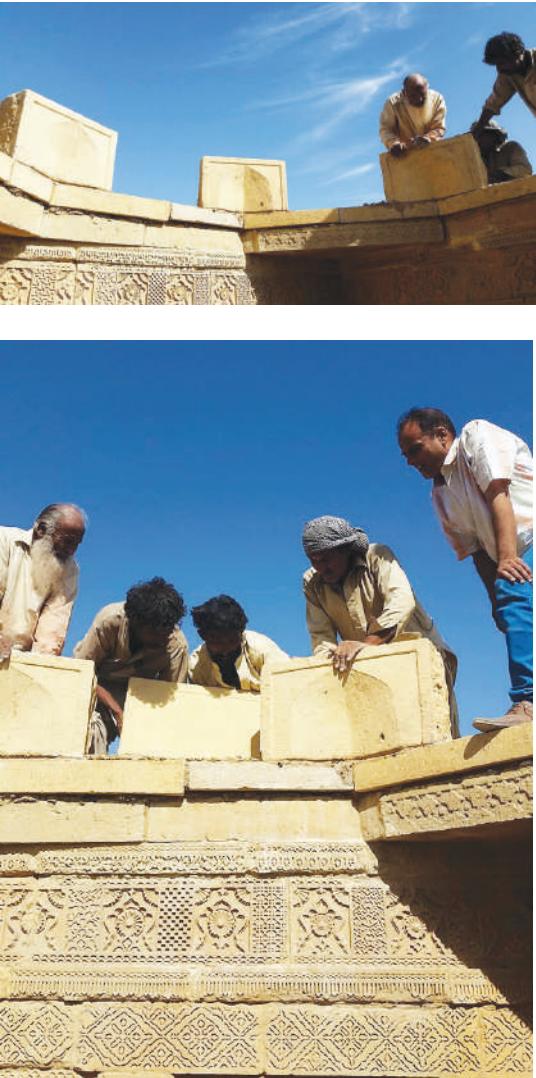
Zenana Chamber. Placement of new stone pieces to form the base for bamboo dome.

The chamber was found in a highly impaired condition. 19thc. archival images show the loss of part of the eastern wall, which may have caused the destabilization and failure of the chamber's roof. Over time the surviving roof stones had become displaced or dislodged. Due to the roof void, rain water had poured freely into the chamber, causing further harm to the interior paving and the sarcophagi. It was difficult to determine the form of the roof initially, except for the corner triangular stone pieces, which indicated a cupola that provided cover. A search for the missing stones was made in the vicinity and those that could be unearthed were used to complete the first row of stones. By stabilizing the triangular corner pieces the phase of transition was completed. Although a flat protective roof had been constructed earlier, however, after a careful study of a recently found 1858 archival photograph, the beginning of a cupola above the phase of transition was established. At this discovery, work on the cupola, similar to those constructed on the Graves Canopy, was begun and although much effort had been expended on the construction of the flat roof, it was dis-

mantled with great care. A careful study of the other cupolas showed that the transition from an octagon to a 16 and 32 sided form was essential before the bamboo cupola could be installed. On new dressed stones a bamboo reinforced lime concrete ring beam has been fixed, above which has risen the double-skeletoned bamboo dome, duly lined with stainless steel netting finished with lime / sand plaster. Thus, a bamboo cupola similar to the two domes in the Graves' Pavilion, has been constructed, providing the Zenana Chamber with originally intended spatial character as well as much needed protection. The dislodged lintol of the door opening has been provided support by inserting thin slabs of dressed stone in the architrave. This unobtrusive intervention was carefully executed using stainless steel bolts in order to prevent the collapse of the wall masonry above the lintol.

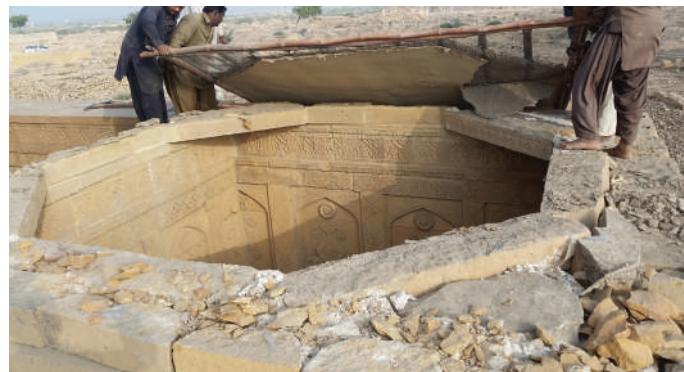
Removing flat bamboo roof to be replaced by bamboo cupola.
