Sepulchre of
Mirza Jan Baba
Father of Isa Tarkhan the Second

Yasmeen Lari
2017

© HERITAGE FOUNDATION OF PAKISTAN 2017

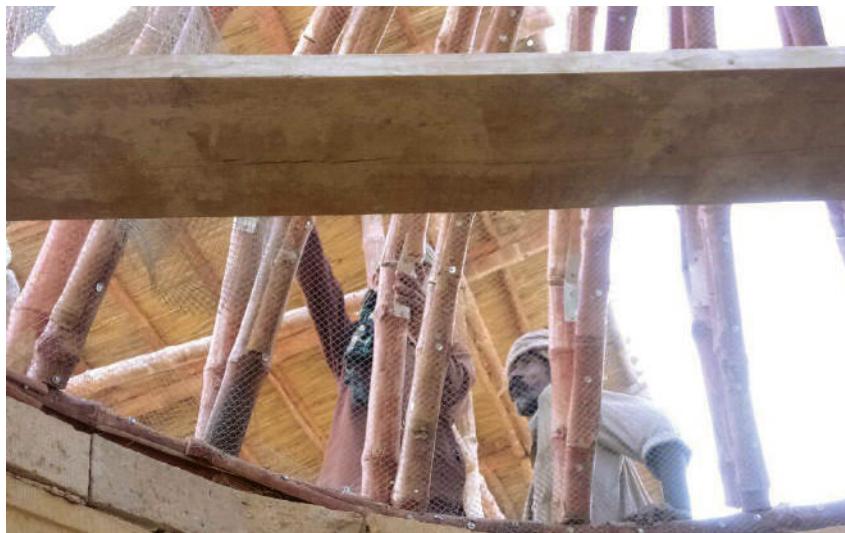
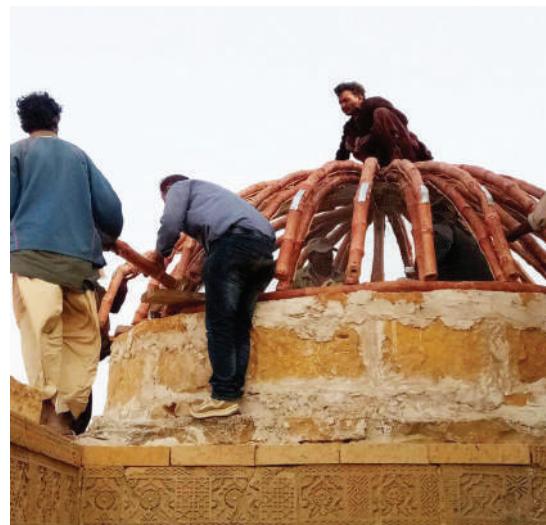
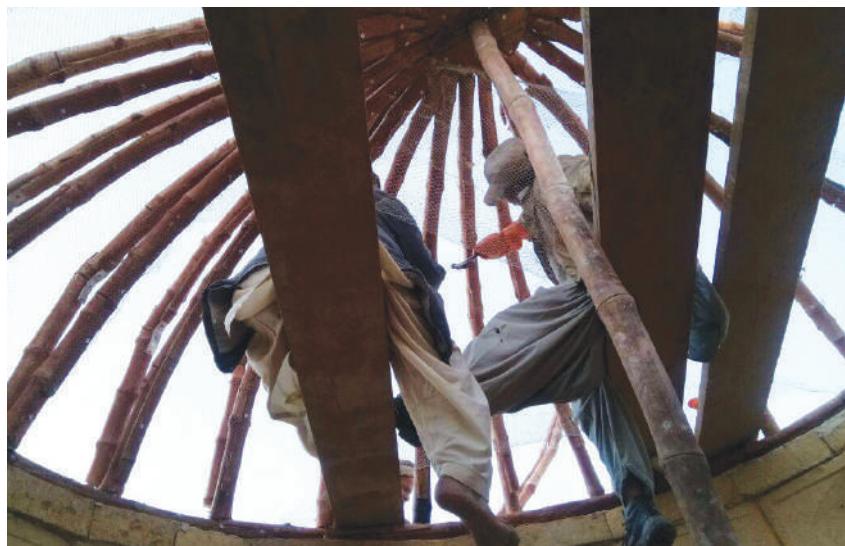
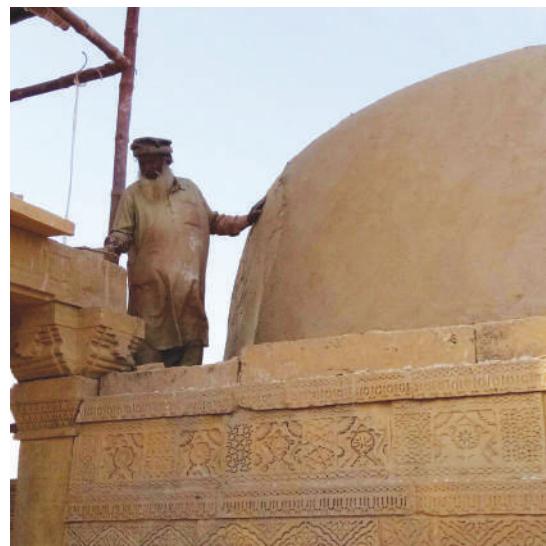
(Above & right) Zenana Chamber. Stages of construction of 2-skeleton bamboo dome.

mantled with great care. A careful study of the other cupolas showed that the transition from an octagon to a 16 and 32 sided form was essential before the bamboo cupola could be installed. On new dressed stones a bamboo reinforced lime concrete ring beam has been fixed, above which has risen the double-skeletoned bamboo dome, duly lined with stainless steel netting finished with lime / sand plaster. Thus, a bamboo cupola similar to the two domes in the Graves' Pavilion, has been constructed, providing the Zenana Chamber with originally intended spatial character as well as much needed protection. The dislodged lintol of the door opening has been provided support by inserting thin slabs of dressed stone in the architrave. This unobtrusive intervention was carefully executed using stainless steel bolts in order to prevent the collapse of the wall masonry above the lintol.

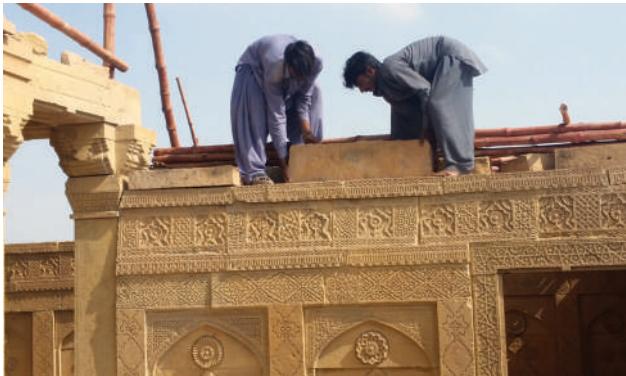
Placing new end pieces to make up loss of stones.

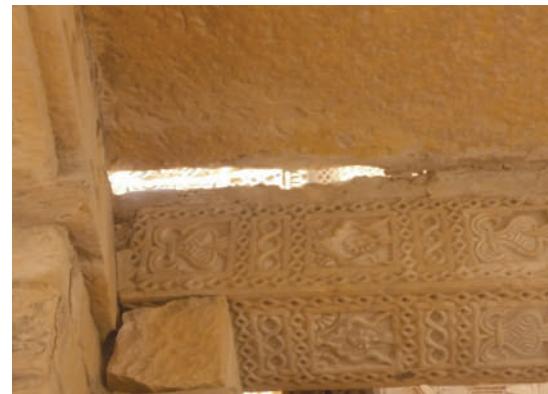
Gaps in roof slabs.

two bays the roof was also completed, but using carved stone slabs from elsewhere. The poor condition of the roof was aggravated due to its exposed location in the southwest. Water seepage further wrecked the stone panels. The rehabilitation of the roof was undertaken through cleaning and repairs and a sloping lime mix water proofing layer was laid at the joints to ensure effective discharge of rain water. The stones edges visible on the west and south were also in a highly ruined state. As all vulnerable points have been sealed, with no danger of water ingress. these have been left without any attempt at renewing them or relaying them.

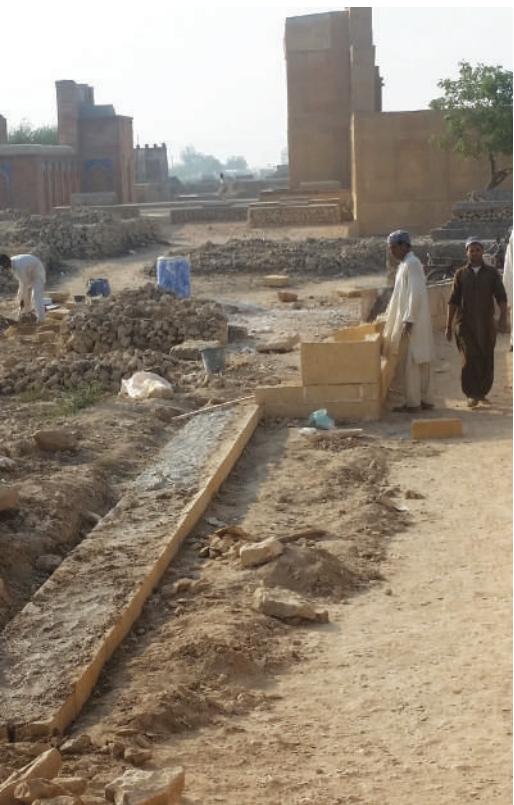
Dwarf wall being restored at east end.

The extant stone pieces were carefully stabilized, but in the new work, instead of carved elements, simply dressed stones, inscribed with the date of intervention, have been used. For a major part of the route, evidence of alignment of the dwarf wall was visible above ground. At the eastern end surface excavation had to be carried out to establish the exact configuration of the dwarf wall. This portion had to be entirely rebuilt, matching

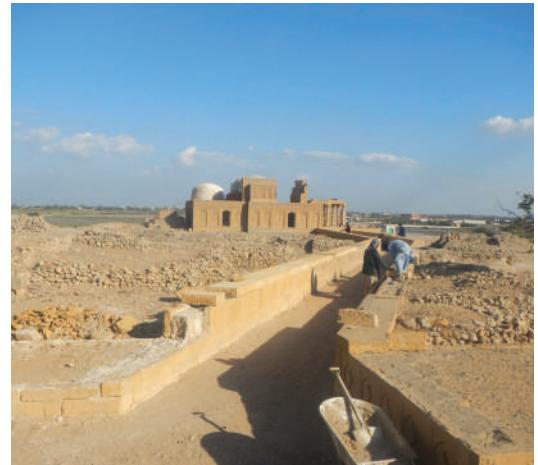
Restoration of Walkway in progress.

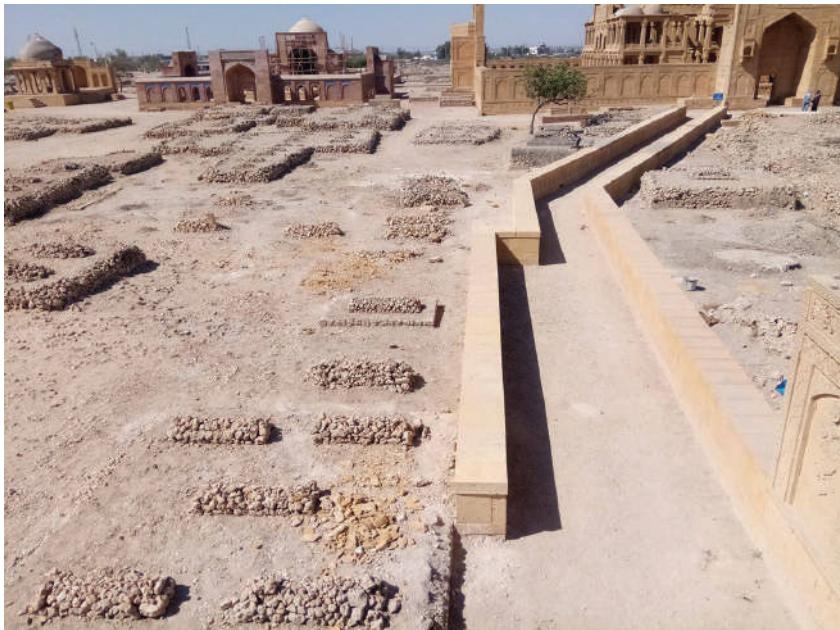
Restored Walkway seen from east. The linkage between the lofty gateway of the tomb of Isa Tarkhan II can be seen.

the existing construction with compatible dressed stone slabs, thus fulfilling the original intent. The terrain consisting of higher ground and several grave platforms surrounding the walkway did not allow any drainage along the north and south dwarf walls. Accordingly, for ease of drainage, the rain water is discharged towards the east to drain at the termination of the Walkway.

The entire Walkway floor has been levelled and covered with light aggregate, finally providing an orderly and impressive arrival experience.

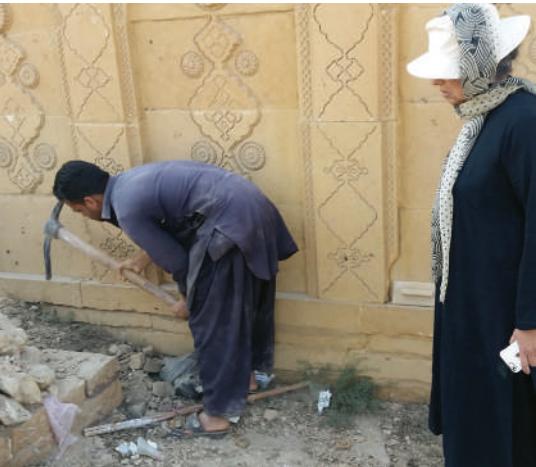
Removing debris from north Perimeter Wall.

Two grave platforms attached on the northern part of the enclosure wall imposed undue stress on the finely carved Perimeter Wall of the mausoleum. To relieve the pressure, the debris next to the Perimeter Wall was carefully removed. Exploratory excavation exposed the finely carved base of one of the platforms, while the other was found to be composed of rubble. The removal of the rubble detached the platforms, releasing earth pressure from the mausoleum wall.

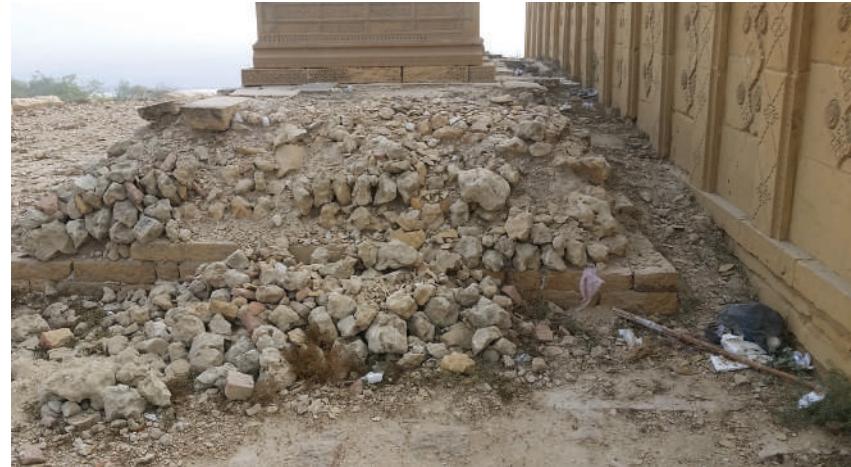
Grave platforms exerting pressure on north Perimeter Wall.

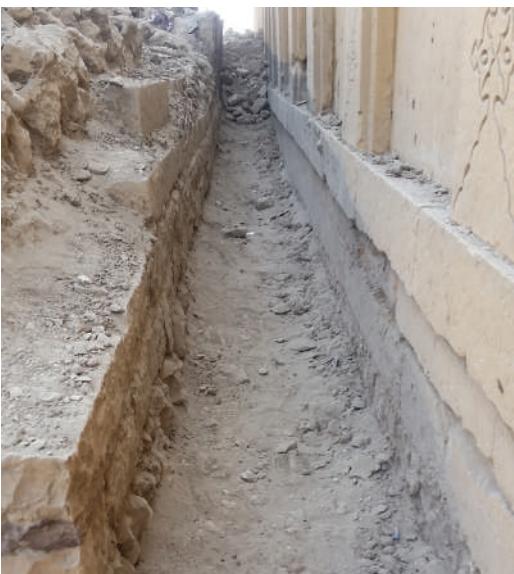
Water disposal passage along north Perimeter Wall.

This passage is being used to drain the rain water, and at the same time preventing seeping of water into the foundation of the historic wall. The provision of plinth protection has allowed clearing of bushes and extra stones that were strewn about in the vicinity.

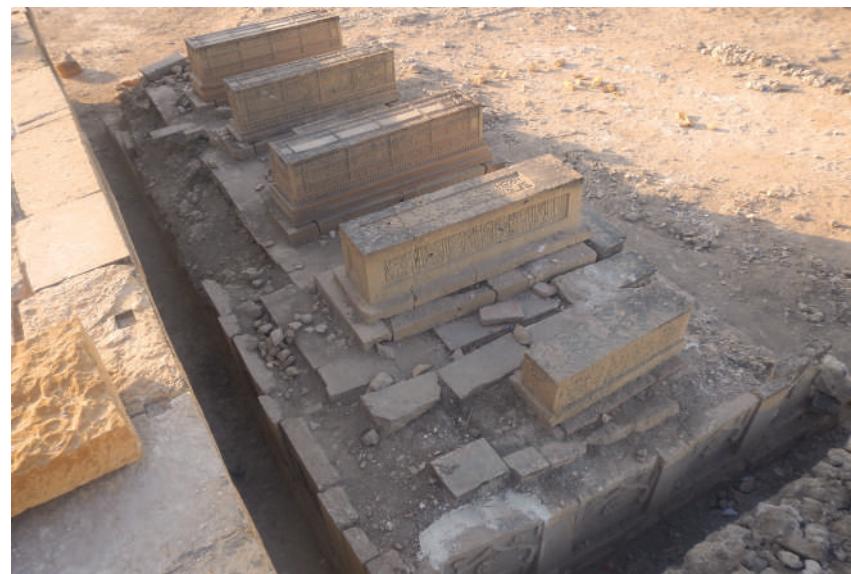
Original platform being restored after removing the debris from north Perimeter Wall.

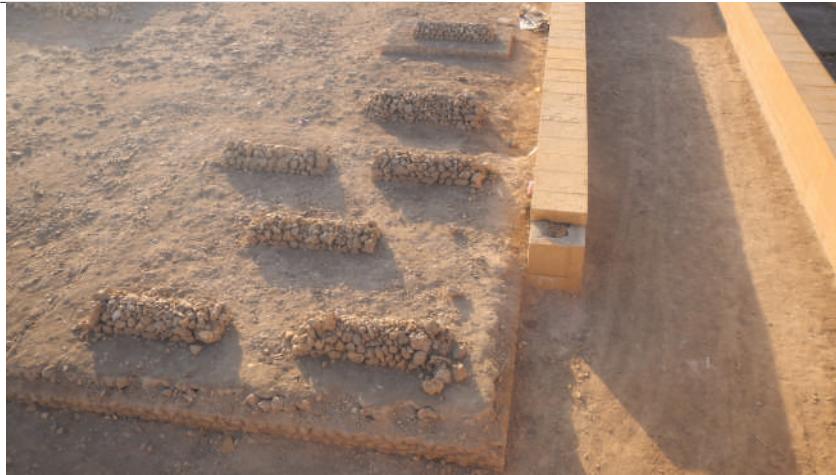
Graves on sides of the monument have been re-assembled in orderly fashion.

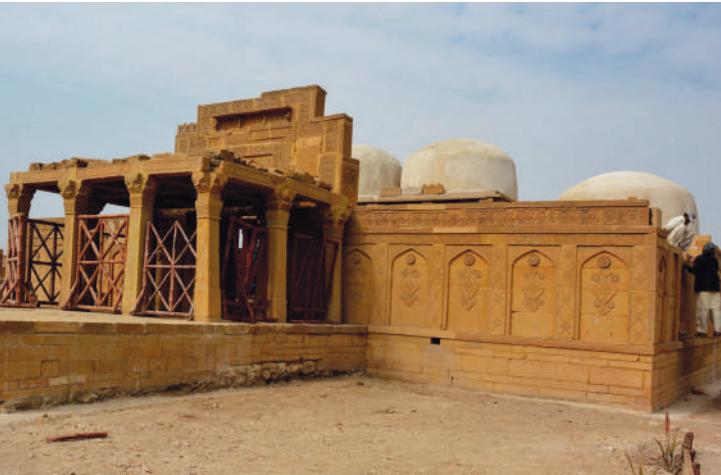
View from southeast. After removing debris and placing unobtrusive plinth protection.

The clearing process has been particularly useful on the eastern side, and created neat surroundings for the mausoleum which was once strewn with rubble and wild growth.

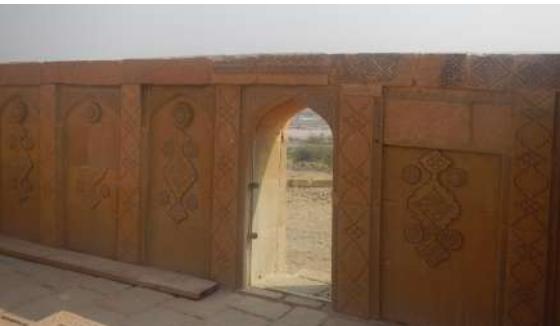
Clear bullet proof glass fixed in openings to prevent entry.

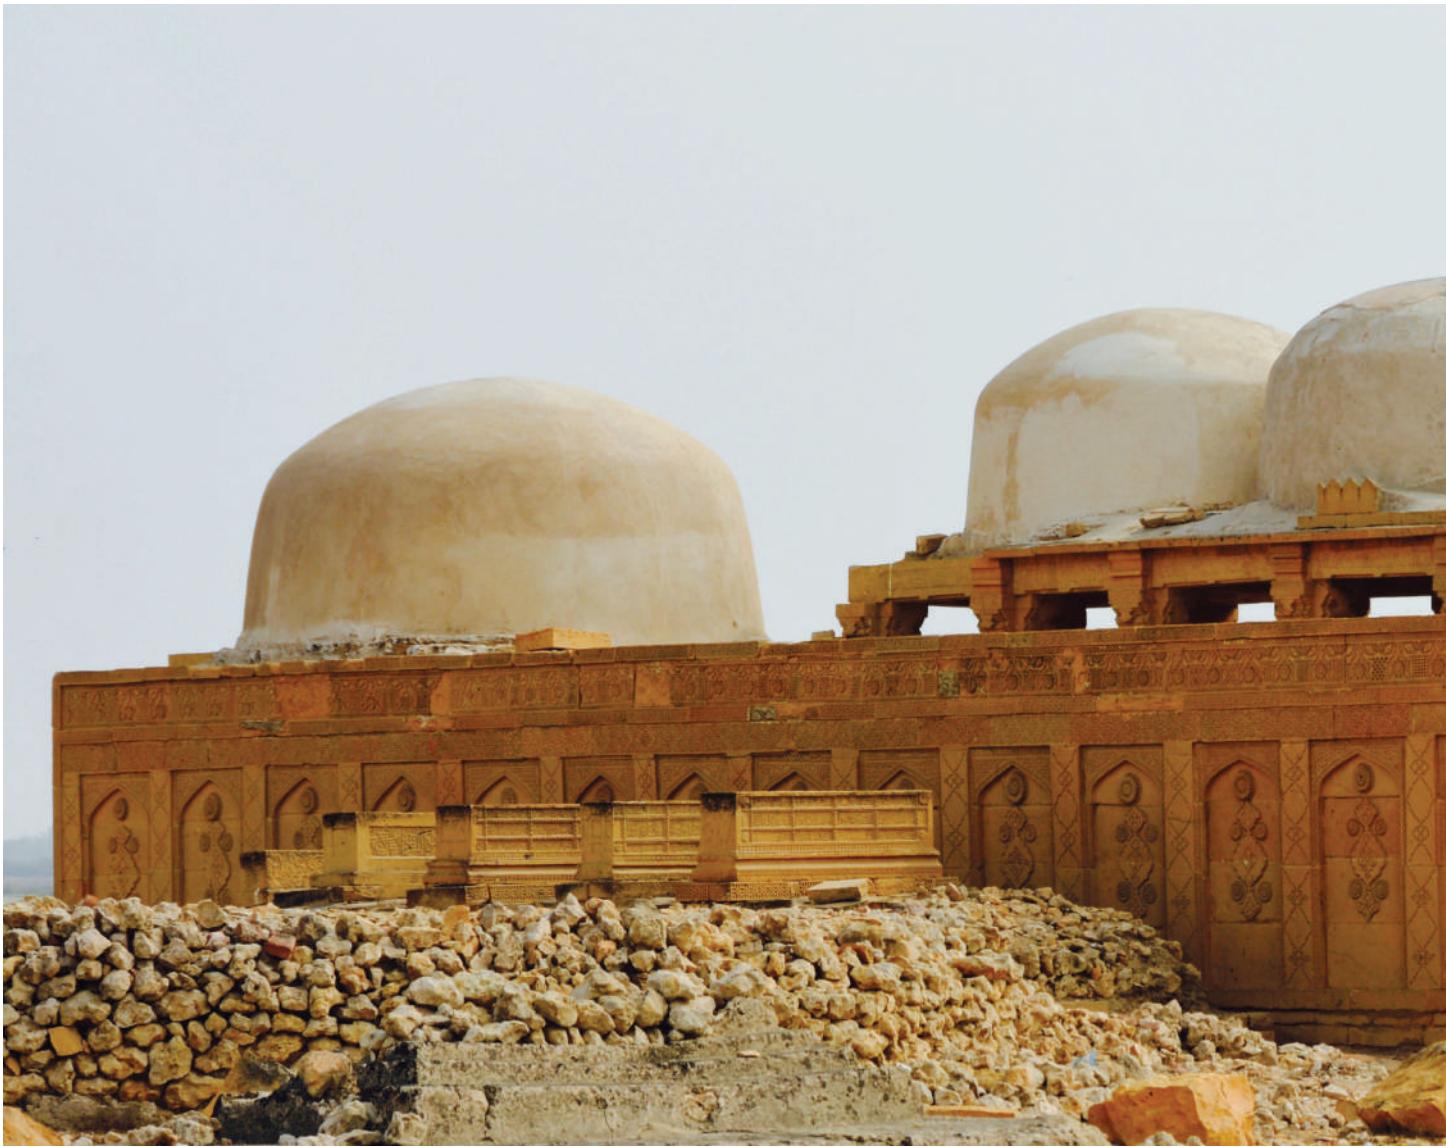
View from northwest. Work nearing completion.

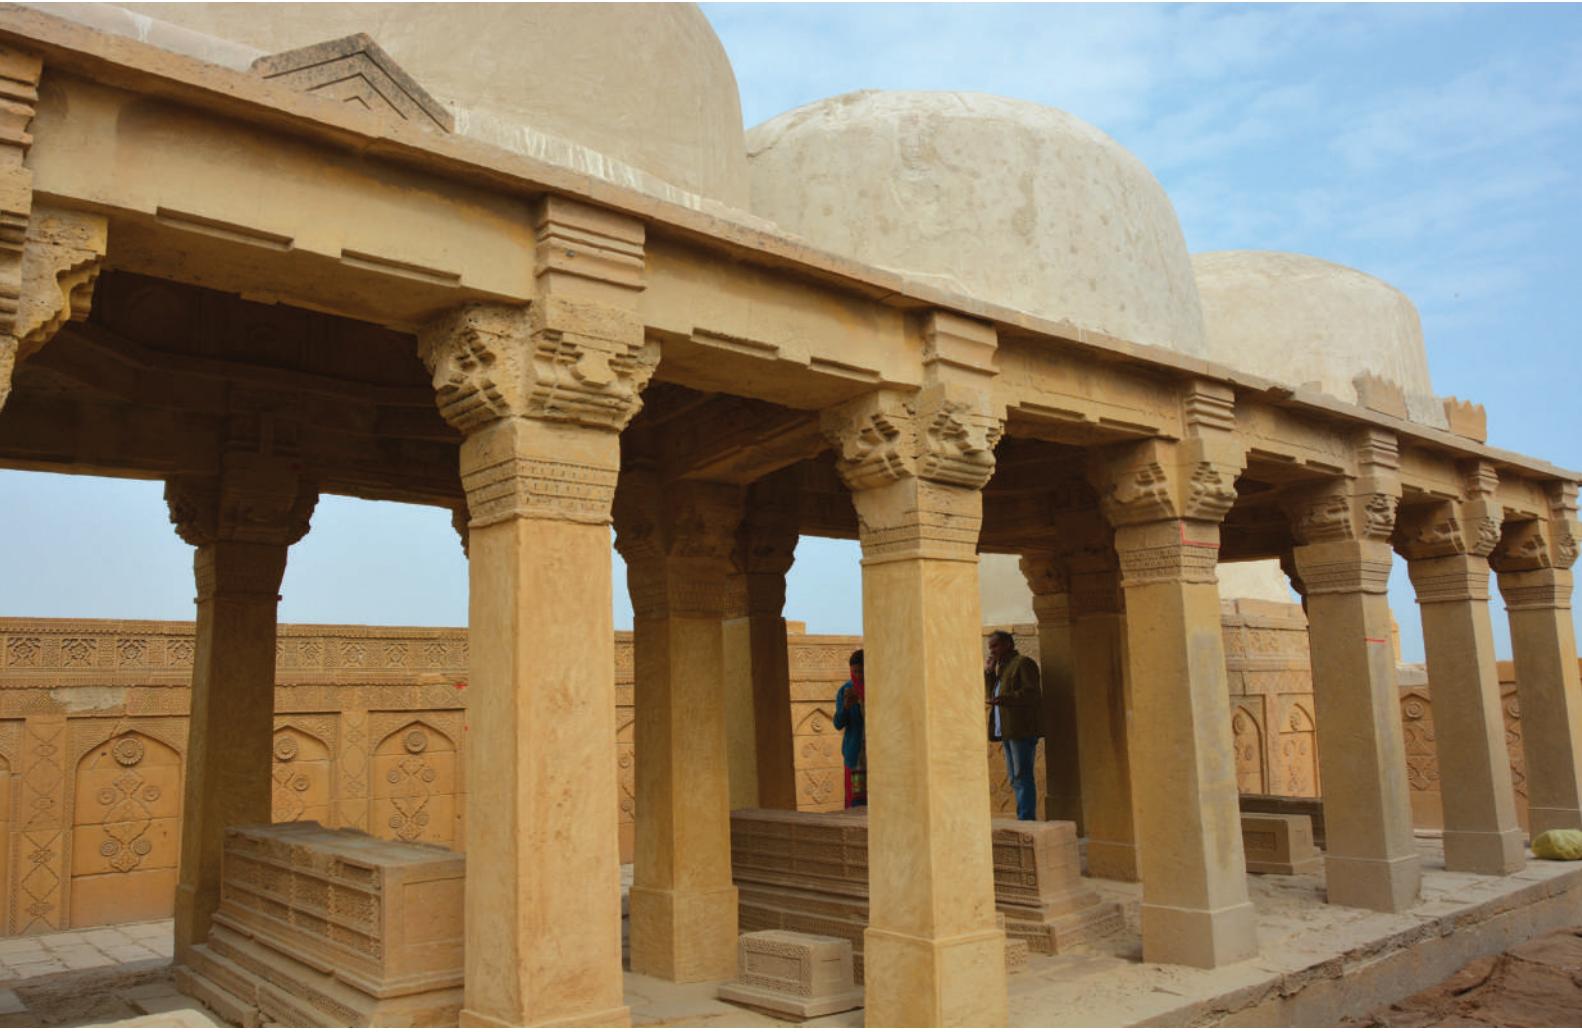
View of Graves Canopy. Work nearing completion.
