CONDITION OF SETHI HAVELI AT THE OUTSET

Condition Survey by Documentation Centre and Heritage Foundation of Pakistan

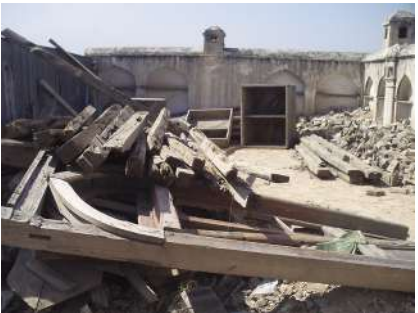
Roof 4/02 before conservation work.

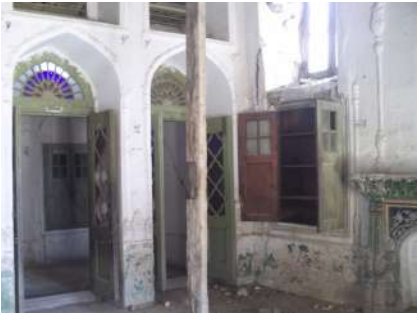
Room 3/16 before conservation work.

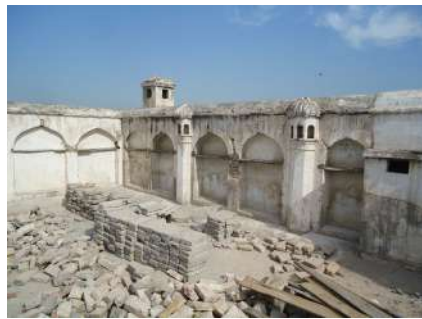
Stacking historic bricks from different locations for reuse.

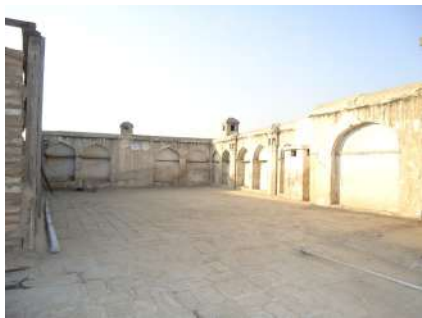
Clearing all unwanted material from roofs before beginning structural stabilization.

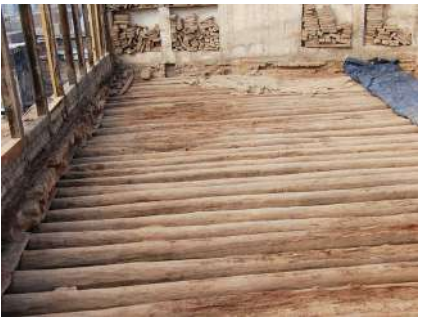
Exposed deodar beams.

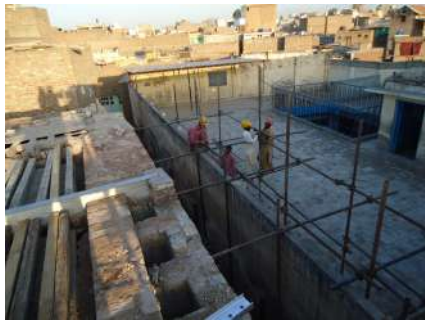
Workers erect scaffolding to begin restoration work on external walls.

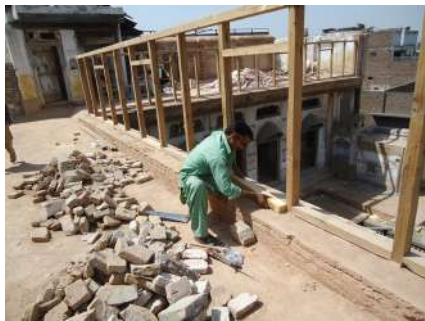
Fixing purdah wall.

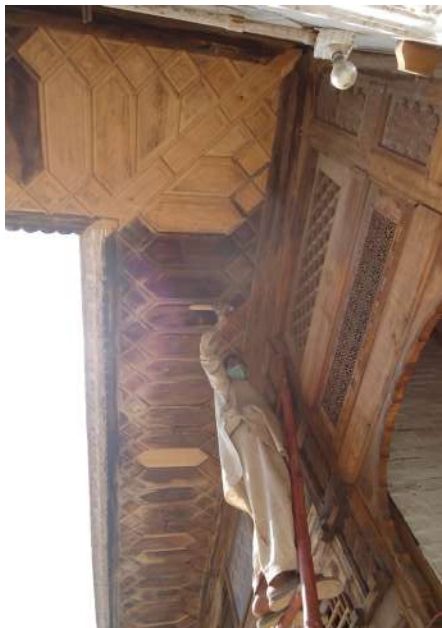
Cleaning tarseem bandi on sun projection.

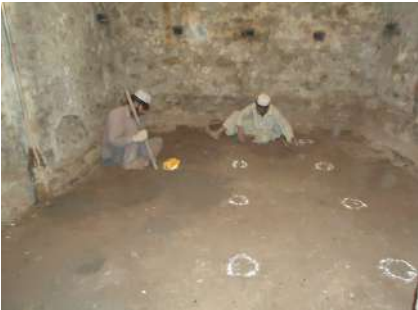
Marks made for boreholes in the basement.

Following the recommendations of the geo-technical expert Engr. Ejaz Shahid, it was decided that the flooring in the basement would be excavated, and bore holes would be drilled at regular intervals. These bore holes would then be filled with gravel stones and sand to discourage any moisture from seeping through. The flooring would then be replaced with the original salvaged bricks laid in the original pattern.

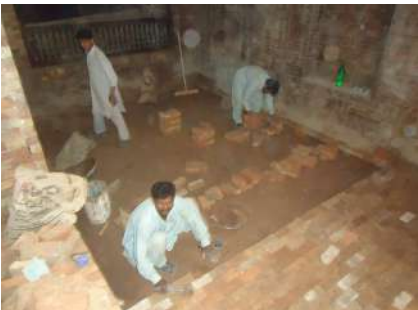
Relaying bricks after filling boreholes.

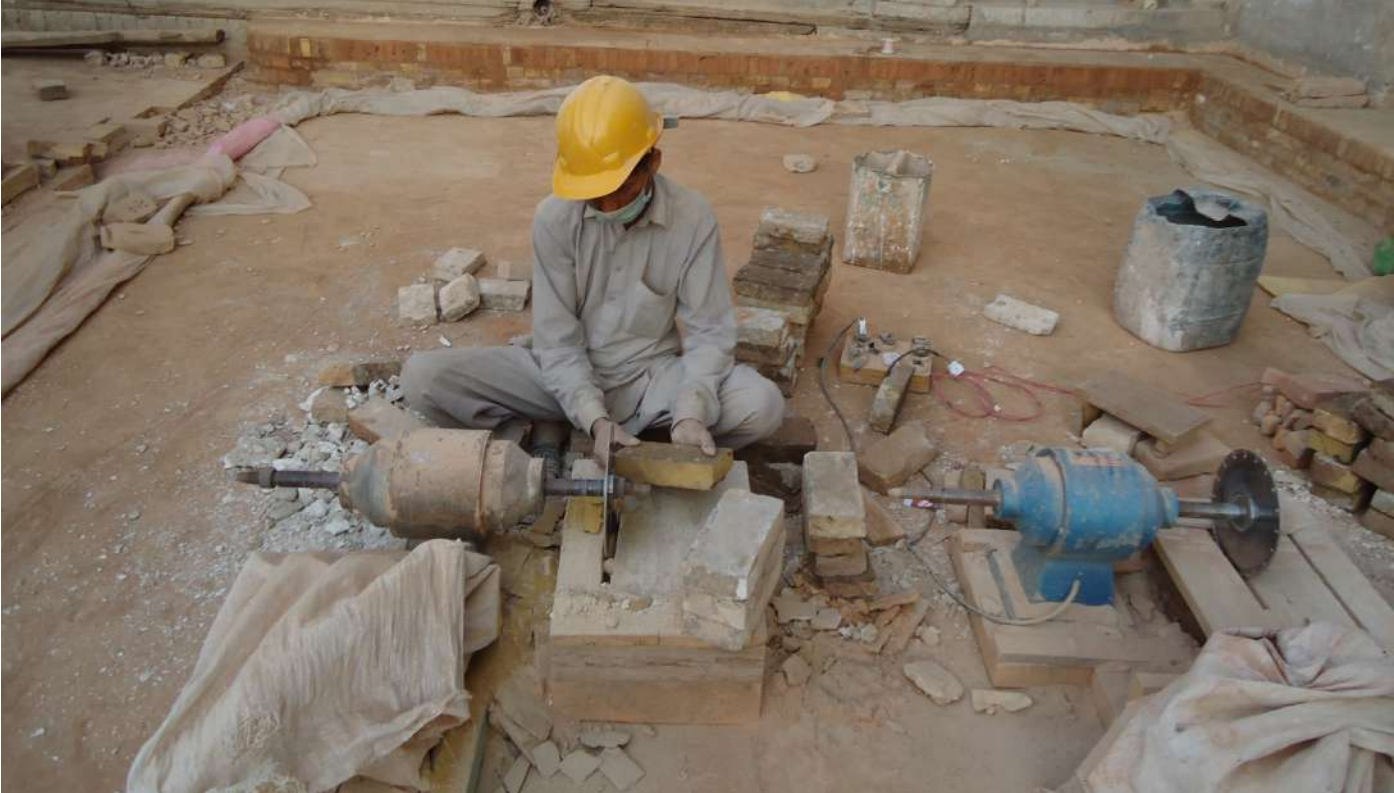
Salvaged brick being trimmed before reuse.

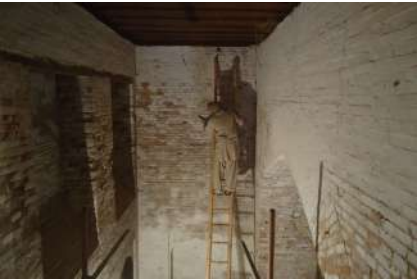
Cleaning masonry.

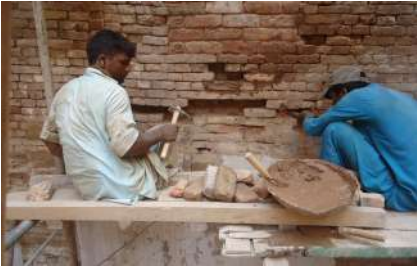
Underpinning brick masonry

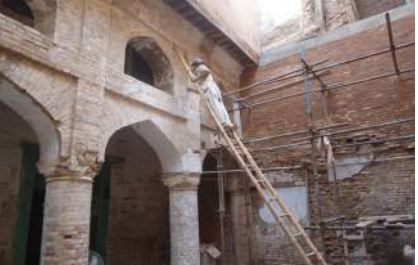
Removal of bricks to expose original openings.

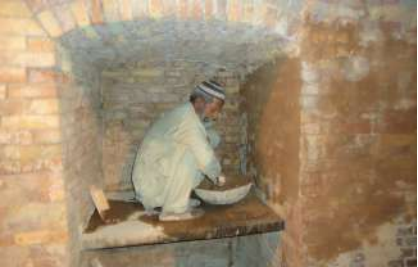
Re-pointing mortar joints in niches.

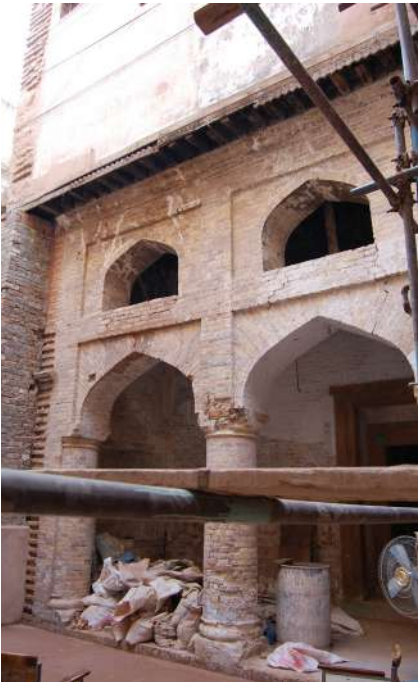
Arches exposed after demolition and removal of later-period brick masonry.

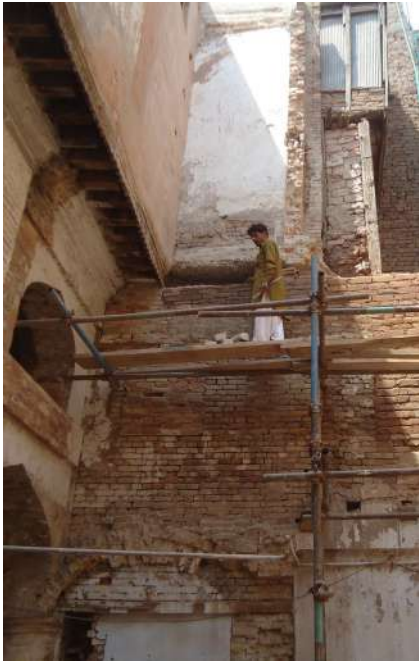
After demolition of Non-historic rear section.

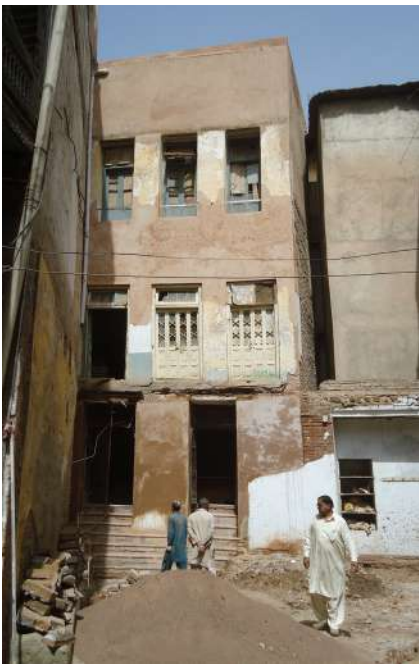
After demolition of Non-historic front section.

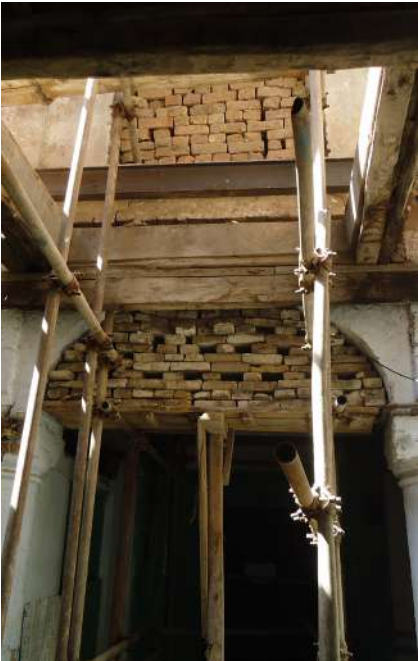
Providing support to Historic section in the rear.

- The entire non-historic portion was provided support through scaffolding erected internally.
- Steel joists were used as diagonal anchors, firmly fixed in reinforced concrete pad foundations to provide support to the façade of the mid-historic parts.
- Steel ropes were used to tie the entire mid-historic section, to restrain it in its place in order to avoid any movement when demolition was initiated.

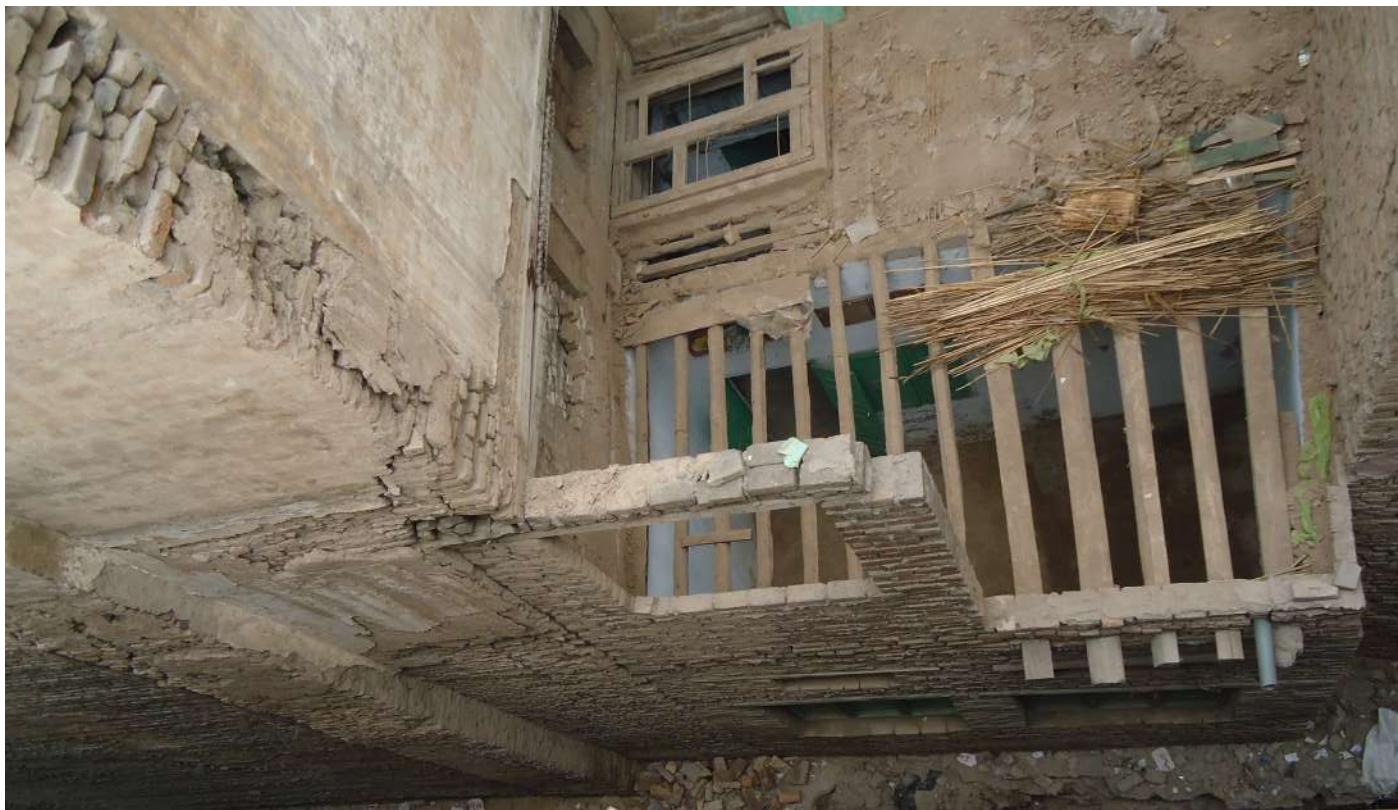
This new construction was extremely poorly built and was in a sad state of repair. It lacked proper foundations and the heavy roof loads had caused the building to sag and tilt. Evidence of the structural failure was visible in the form of deep cracks that appeared all along the rear of the house. Since the non-historic building abutted the mid-historic portion, it posed a grave danger to the latter. It was feared that if this portion was not removed, it would be a cause of irretrievable damage; on the other

During demolition of Non-historic section in the rear.

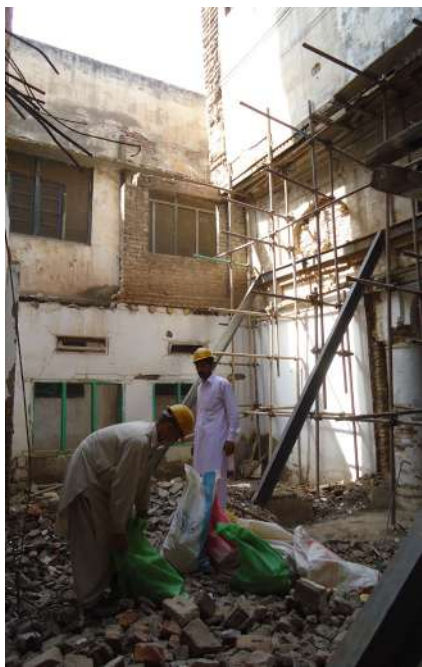
During demolition of Non-historic section in the rear.

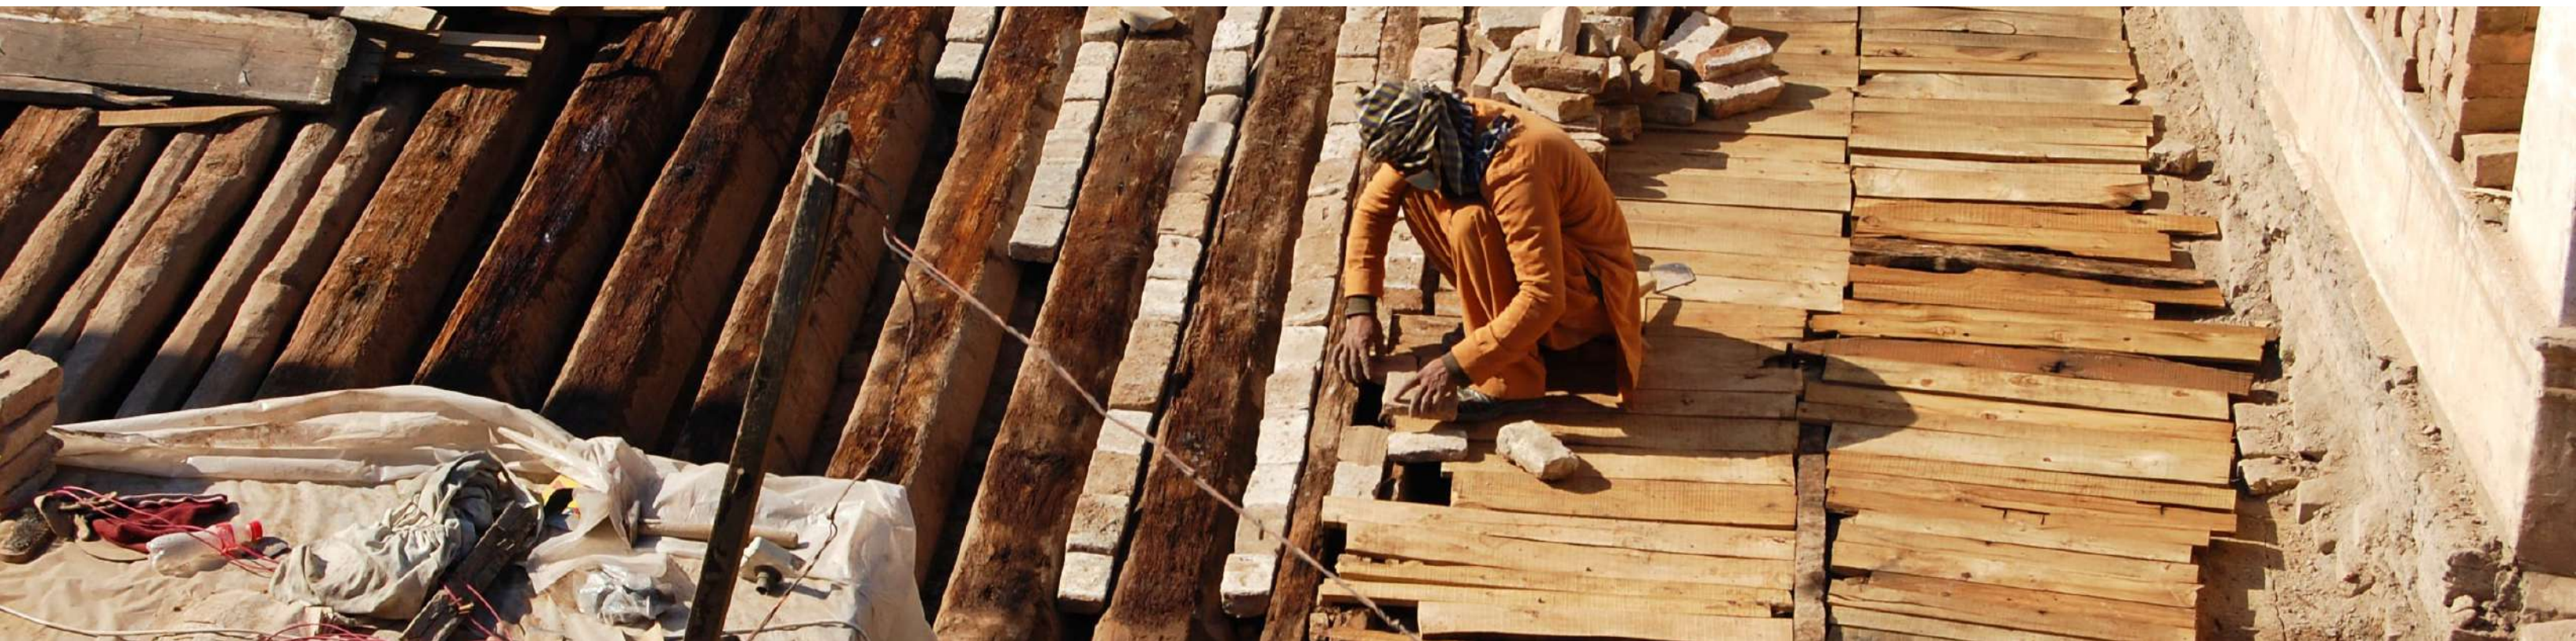
Artisan applies brick and wooden planks to exposed roof.

The void in the centre of the roof, due to the major cracking of the central wooden rafter, had to be rectified in order to provide protection from rainwater and further damage to the structure. The following procedure was carried out:

- Placement of a new steel girder of size 4"x8"x5/8" on the top of the original broken wooden rafter.
- Placement of steel plates at the bottom of the timber rafter. Through this mechanism and with the help of bolts, the original broken timber rafter was gradually lifted in position.
- Placement of new seasoned deodar battens and planks deodar size 4"x 6" and 3/4" planks 8' long.
- The entire roof structure was rehabilitated along with termite treatment and water proofing.

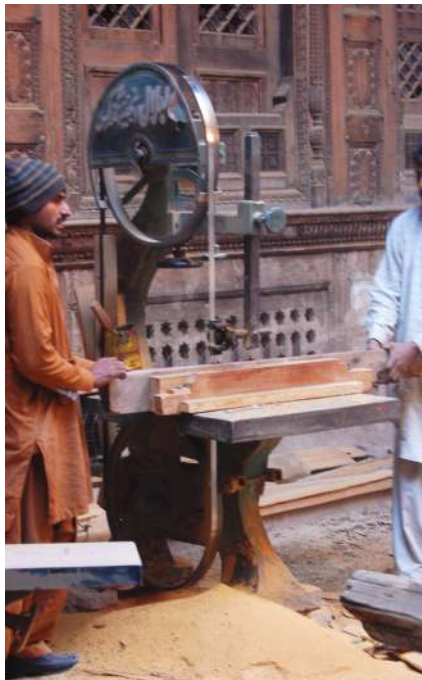
Artisans trim original posts of Purdah Wall to be reused.

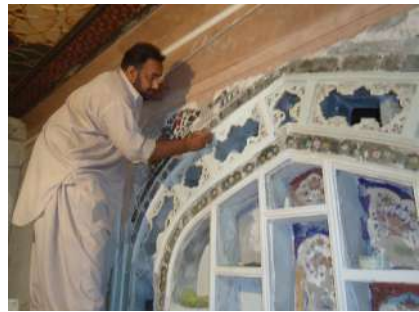
Artisan restores chhinna kbanna.

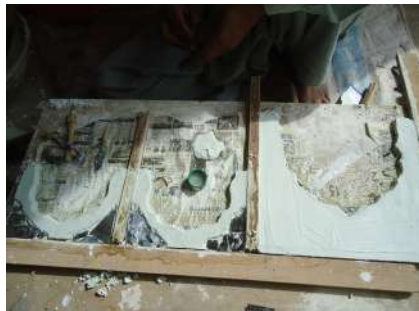
Moulds prepared for chhinna kbanna niches.

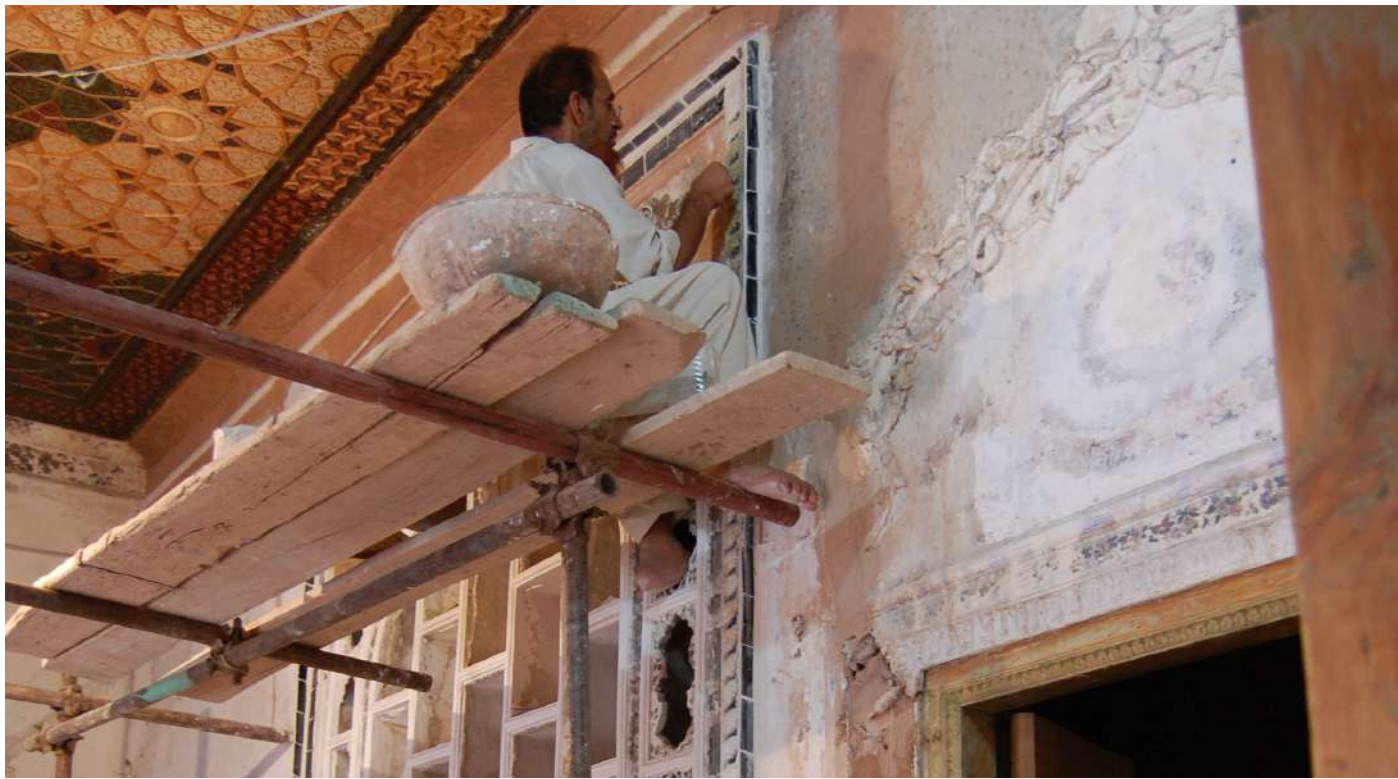
Master artisan prepares stucco tracery around chini kbana.

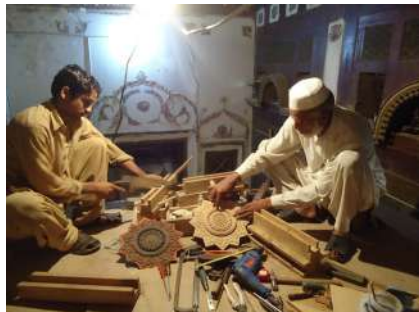
Artisans duplicate intricate tarseem bandi panels.

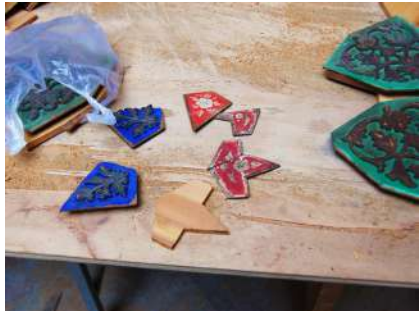
Artisans fabricate each tarseem bandi piece.

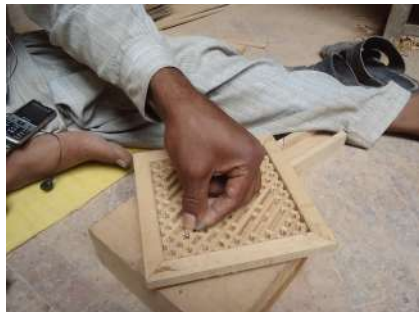
Intricate punjali being fabricated.

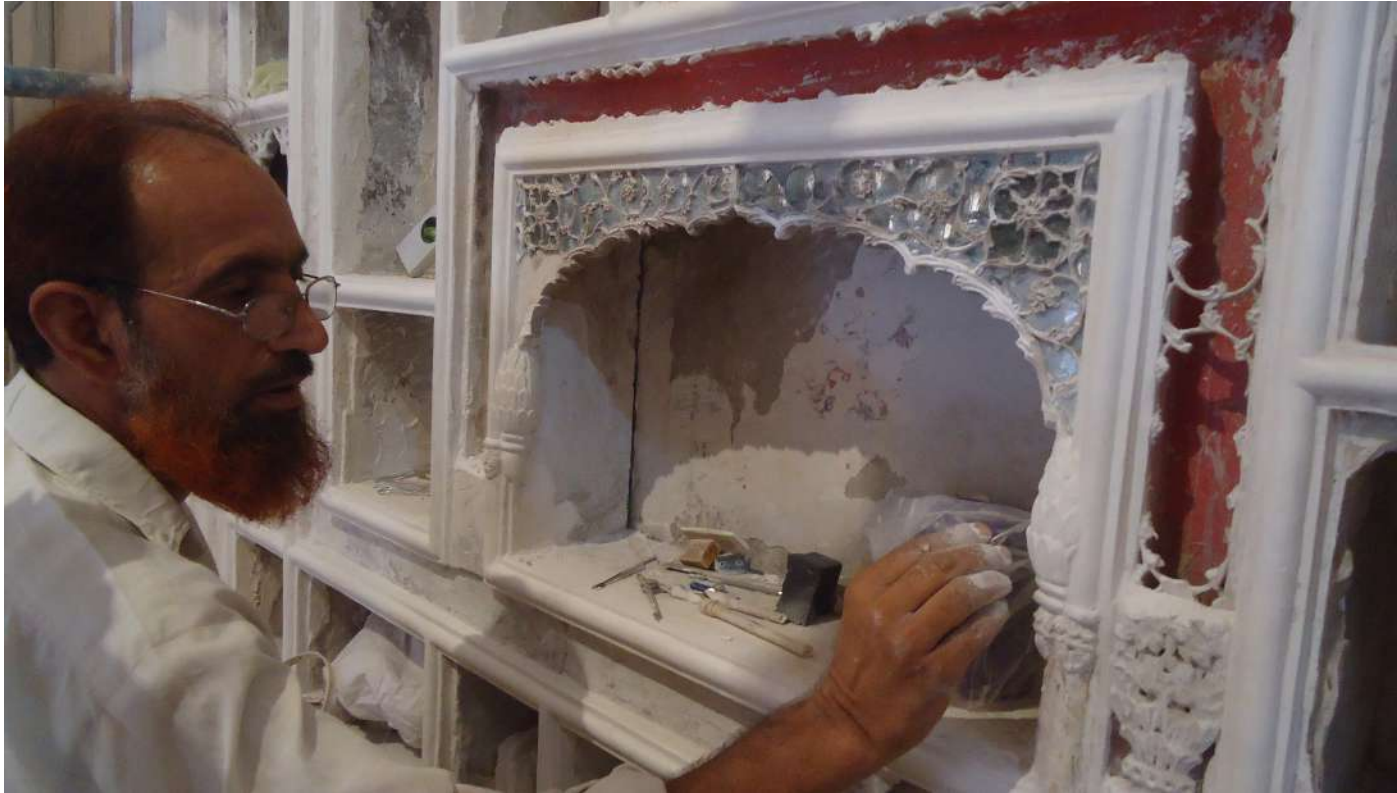
Intricate stucco work being conducted in Room 2/09

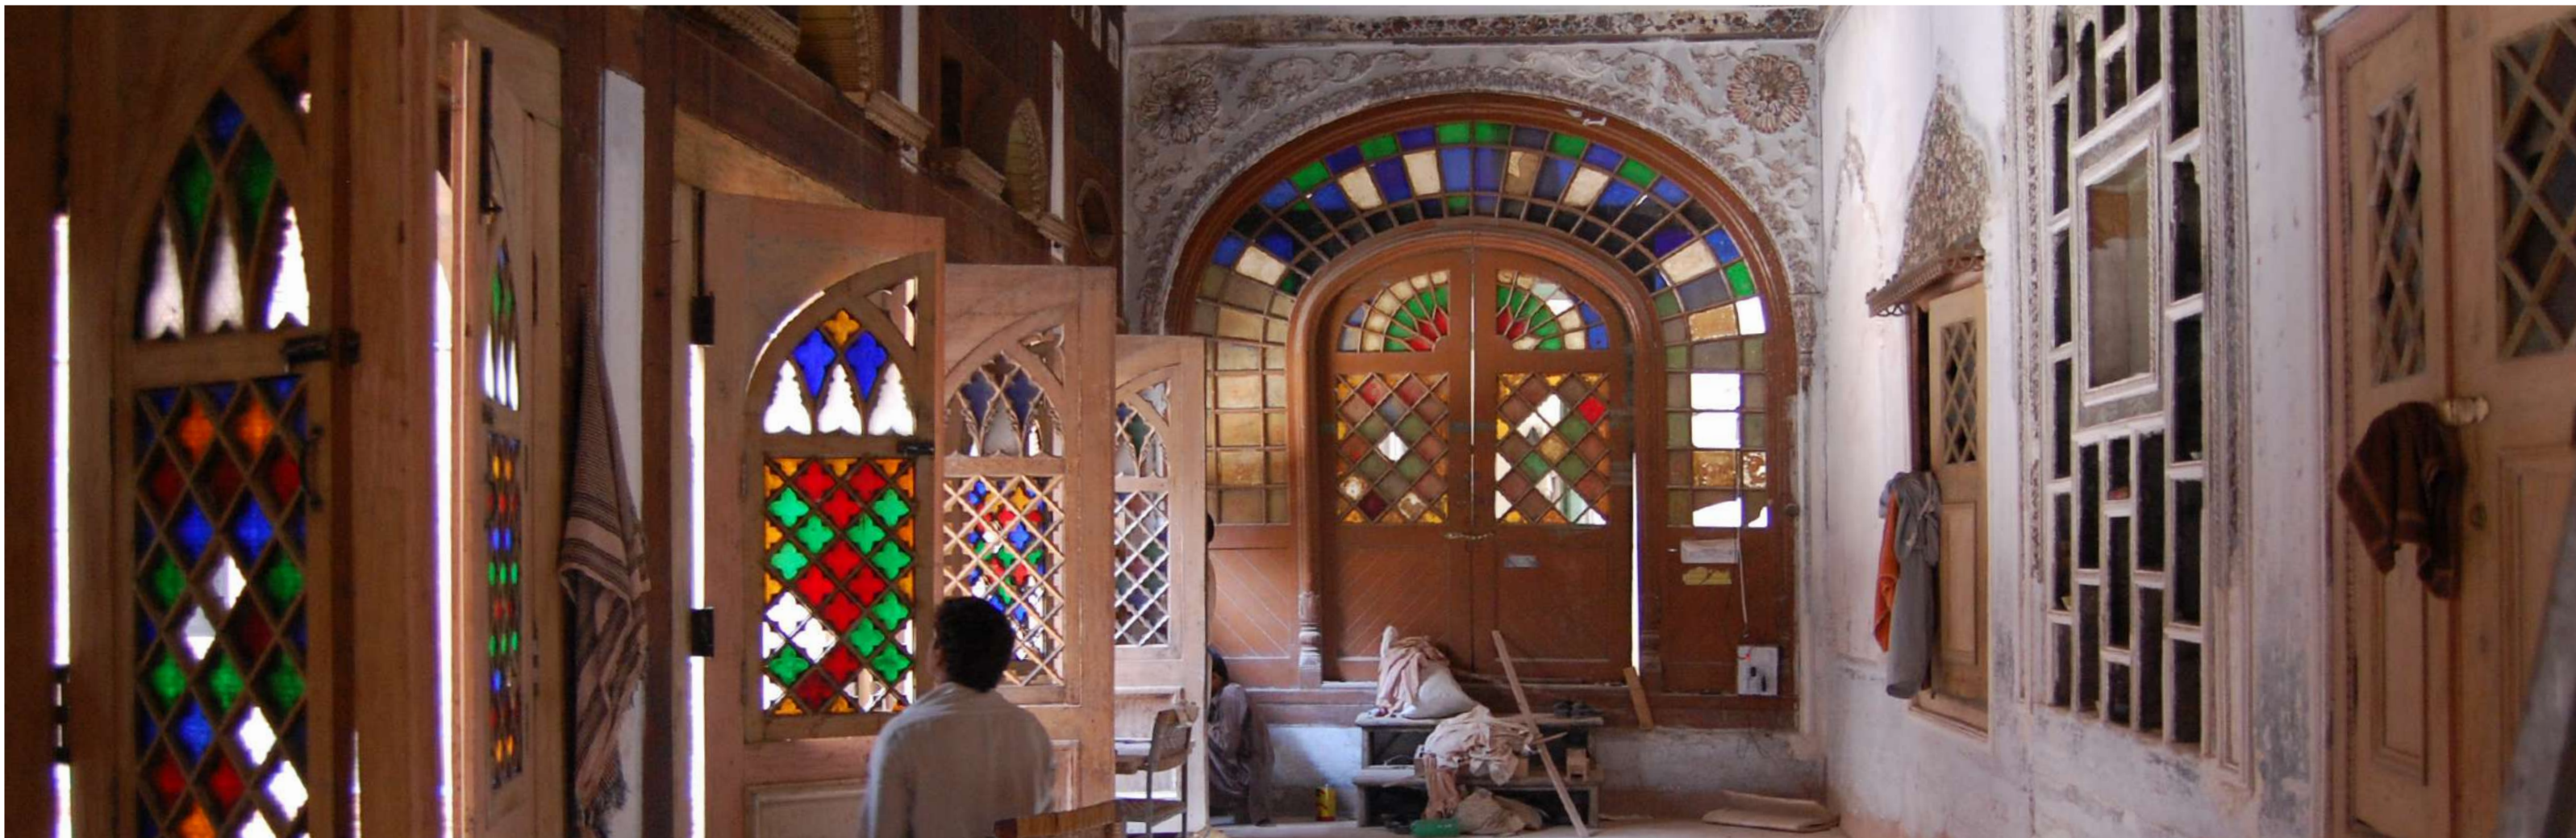
Cleaning doors and windows.

A major effort has consisted of removal of all the paint layers from wooden doors and windows. Repairs have been undertaken to replace broken or lost glass panes, and to repair any glazing beads to make the entire assembly secure.

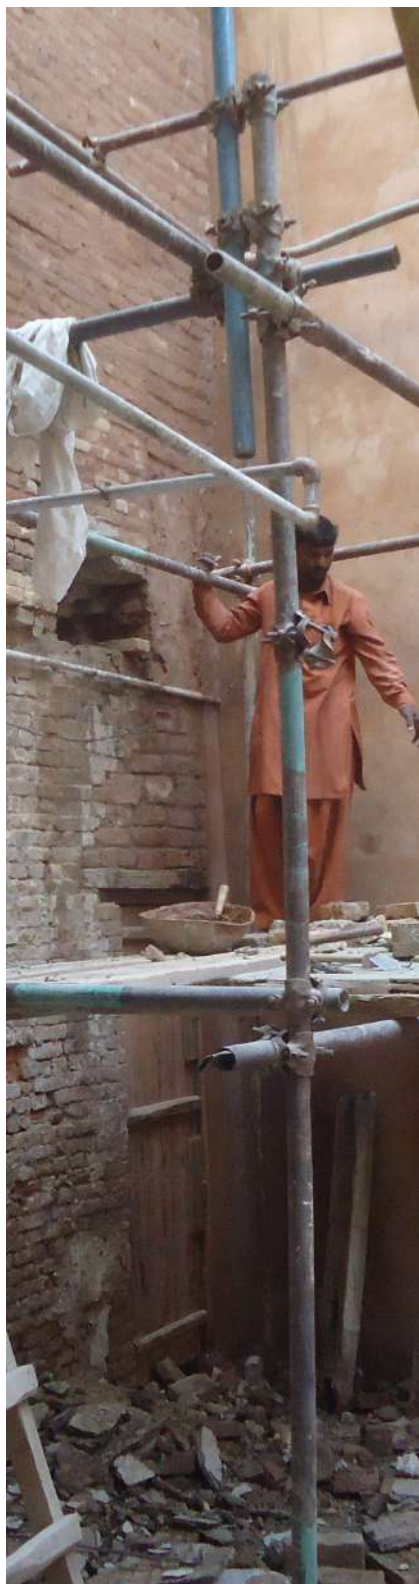
Scaffolding erected so artisans can remove prior interventions and expose original openings.

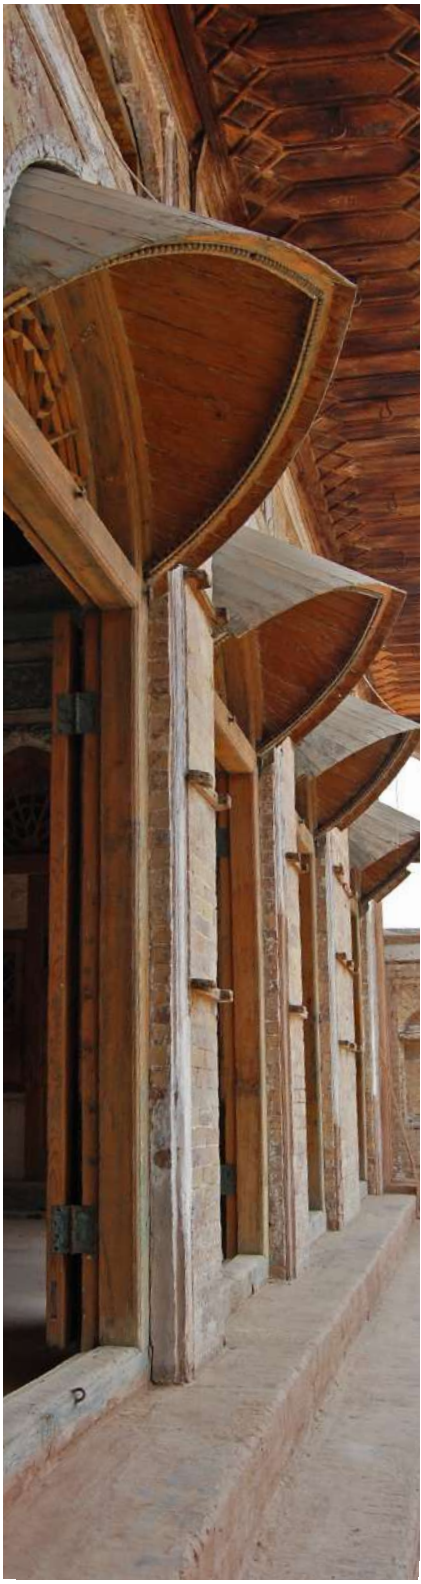
Doorways after restoration and repair

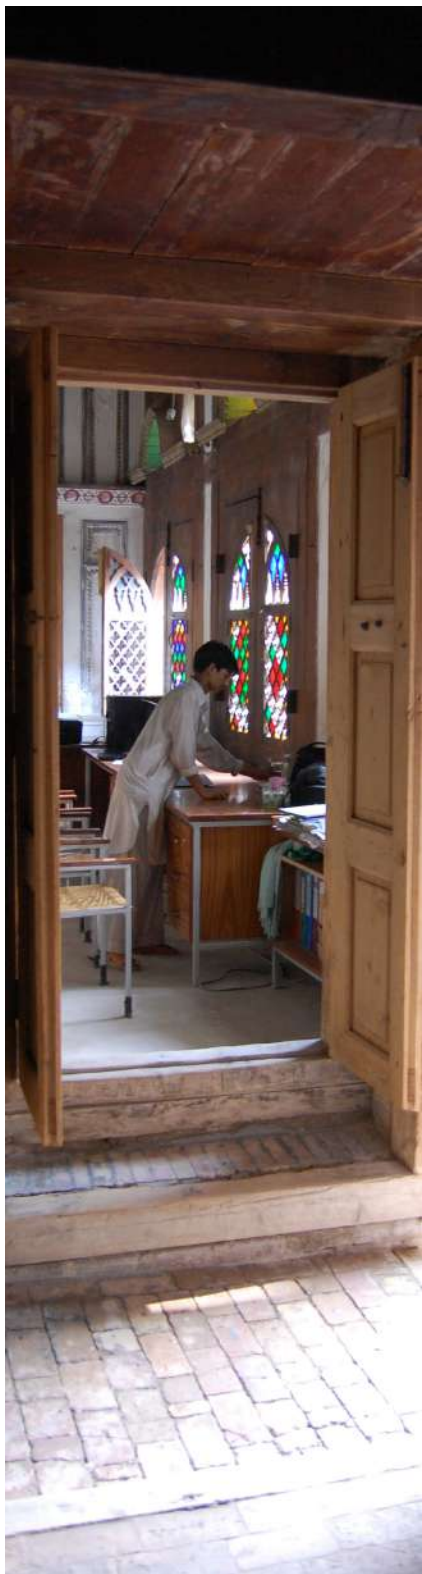
Regular cleaning and maintenance should be ensured

- Maintenance procedures for cleaning must be in place. Due to the varied ornamentation on walls and ceilings, which is extremely fragile in nature, special cleaning methodology must be in place in order to keep the building in an immaculate condition, without damaging or spoiling any of the decorative features.

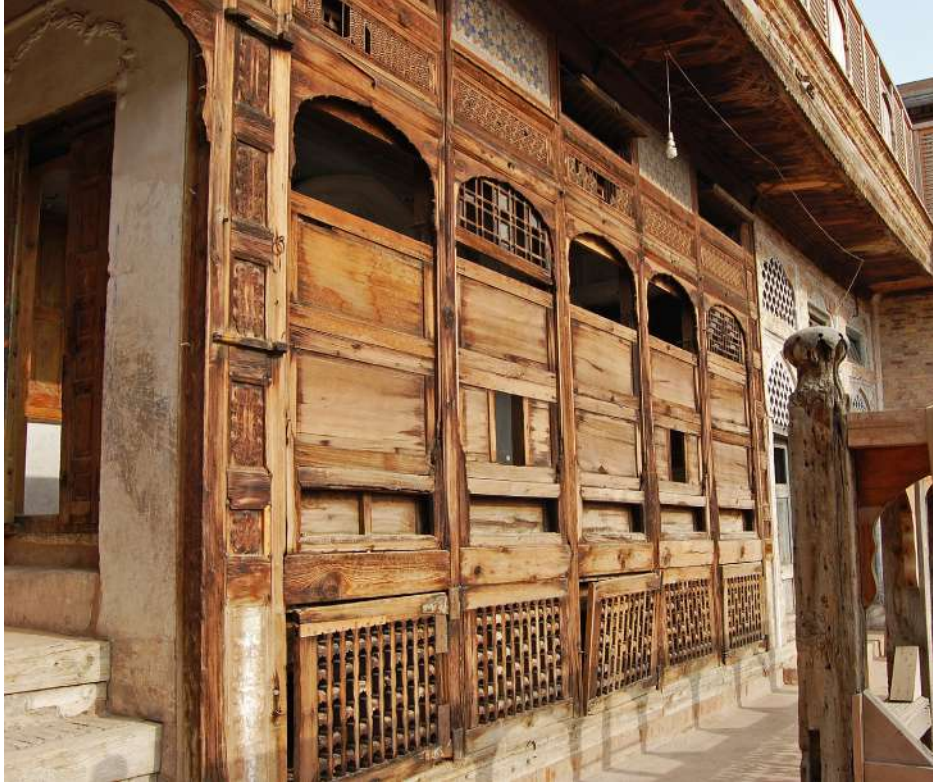
Basta windows on level 3 after cleaning.

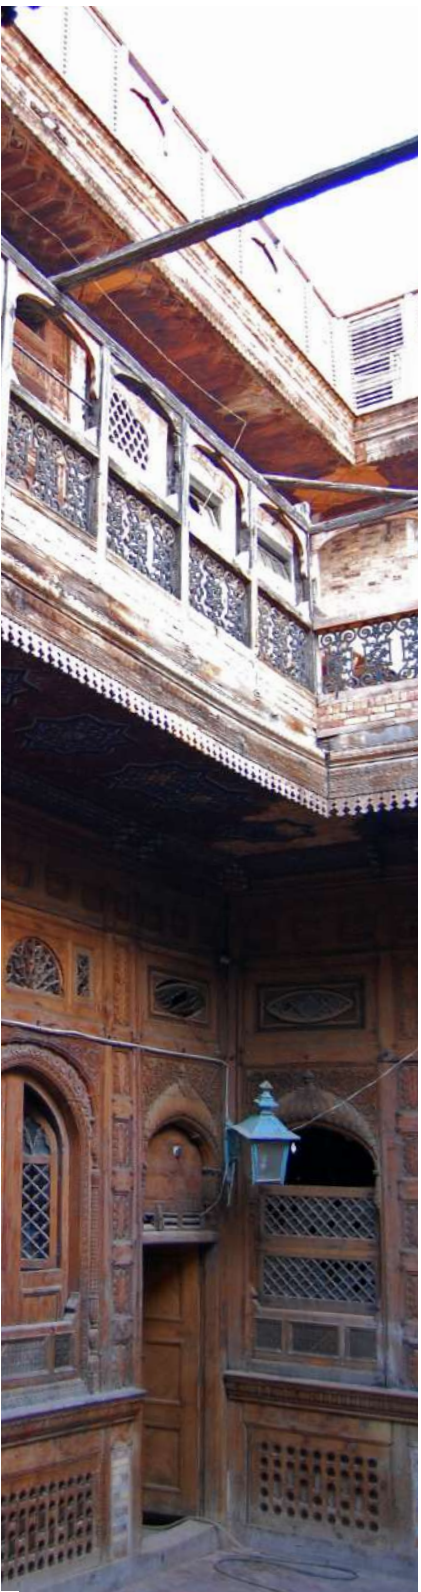
View of internal courtyard after restoration
